**Limited Asbestos and Lead Survey Report**

Ashland Housing Project  
16305, 16309, 16325, 16331, 16331A, 16333  
Kent Avenue  
San Lorenzo, California

RGA Project No: RCD27554

May 4, 2011

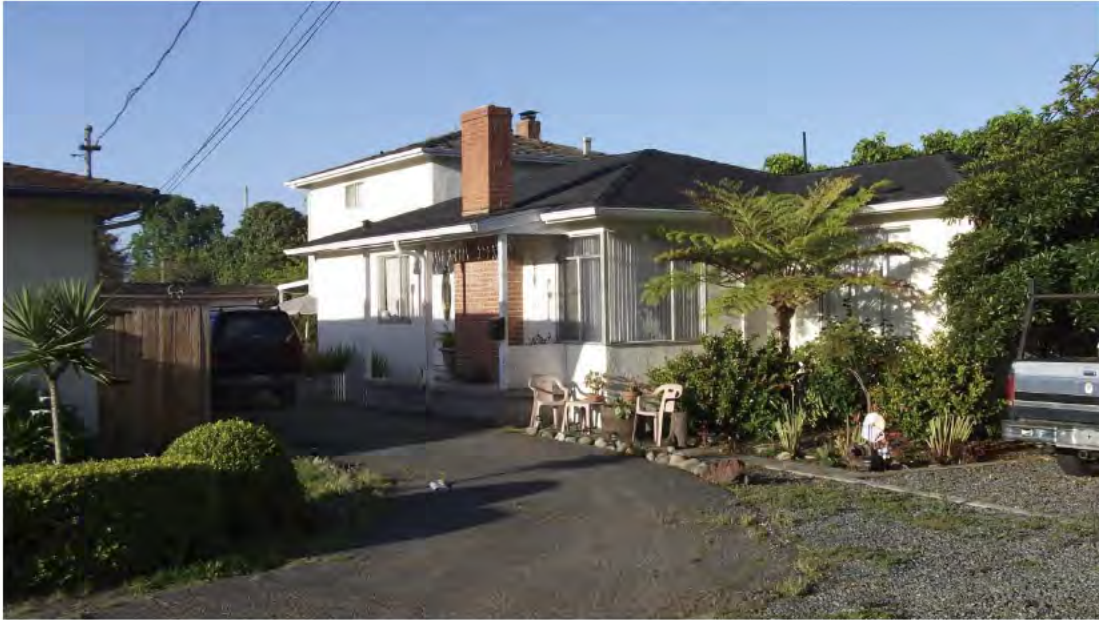
**PHOTO 1.** 16325 Kent Avenue - Single Family Residence plus one-car garage

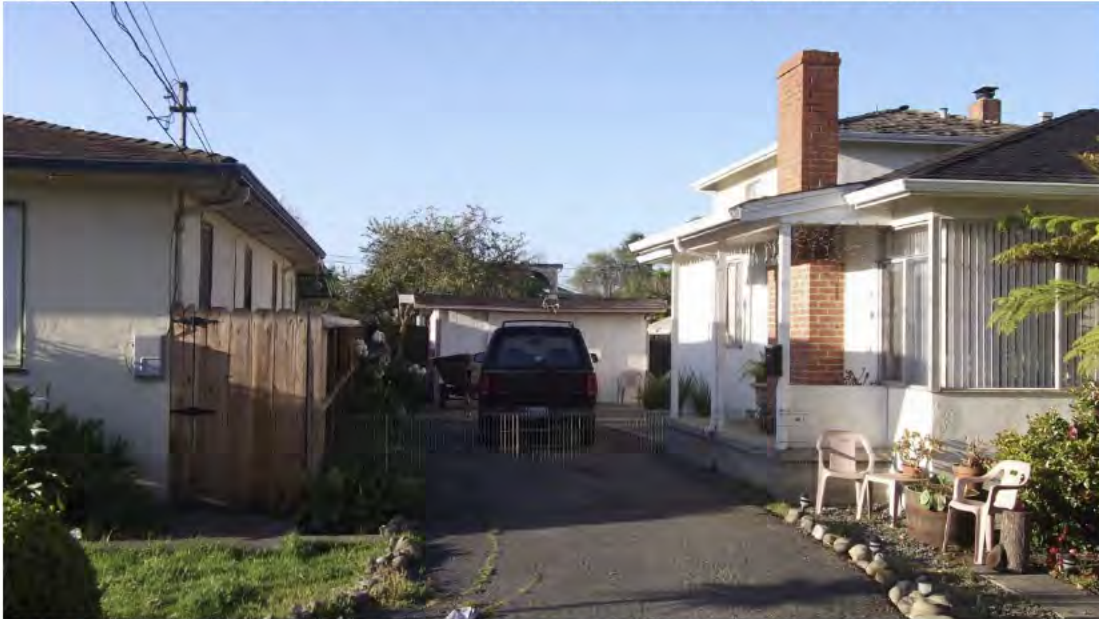
**PHOTO 2.** 16325 Kent Avenue Single Family Residence plus garage

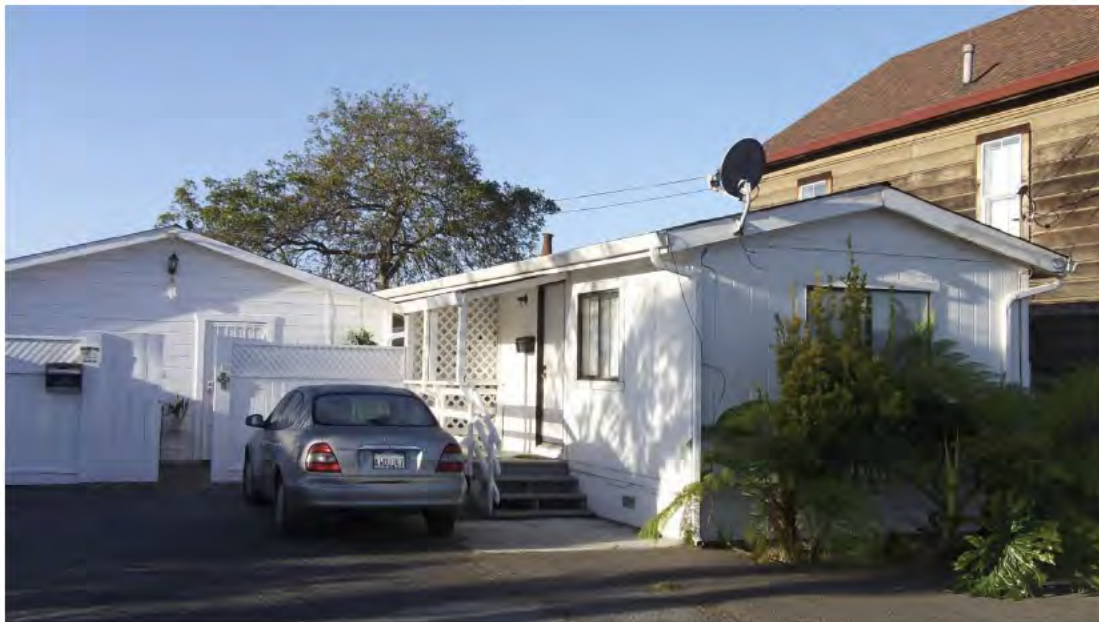
**PHOTO 5.** 16333 Kent Avenue Single Family Residence (modular building)

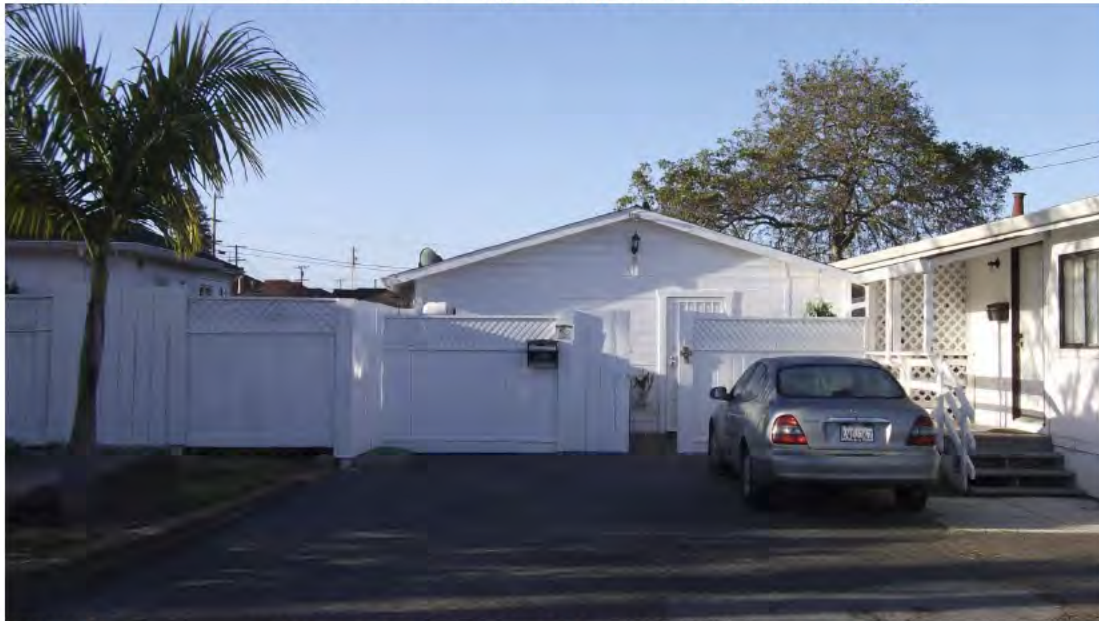
**PHOTO 6.** 16331A Kent Avenue Single Family Residence With No Garage

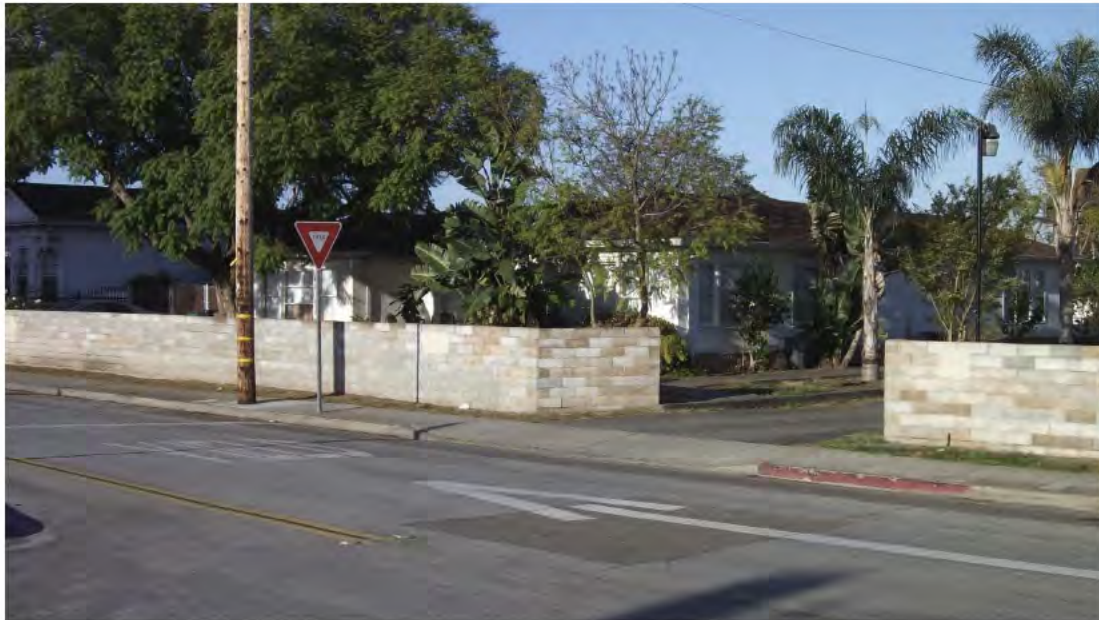
**PHOTO 7.** 16331 Kent Avenue - Single Family Residence with No Garage

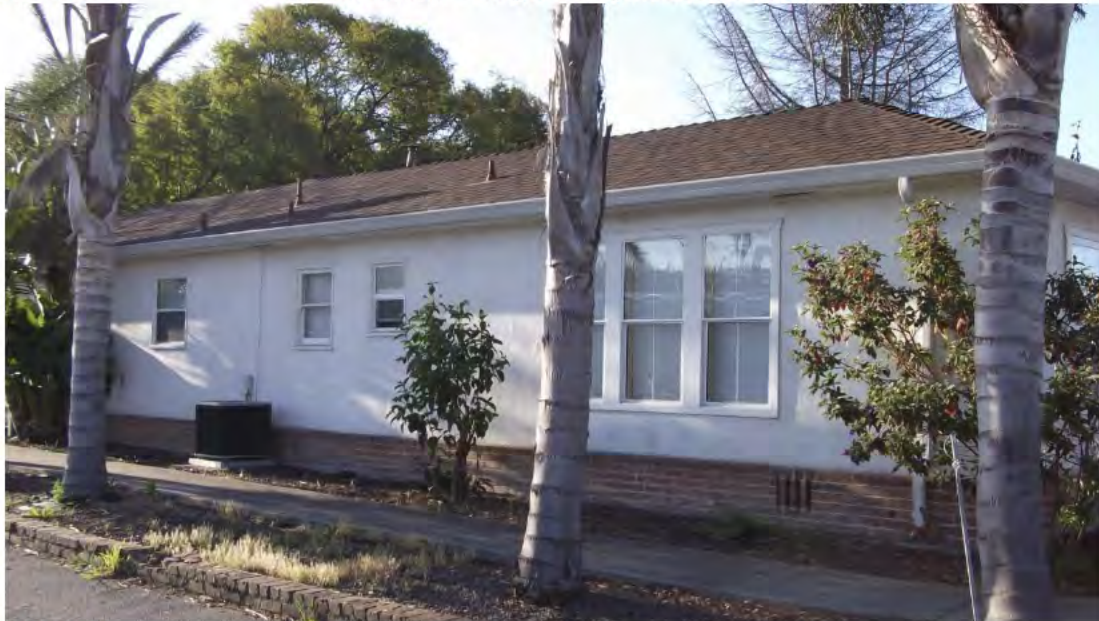
**PHOTO 8.** 16331 Kent Avenue - Single Family Residence with No Garage

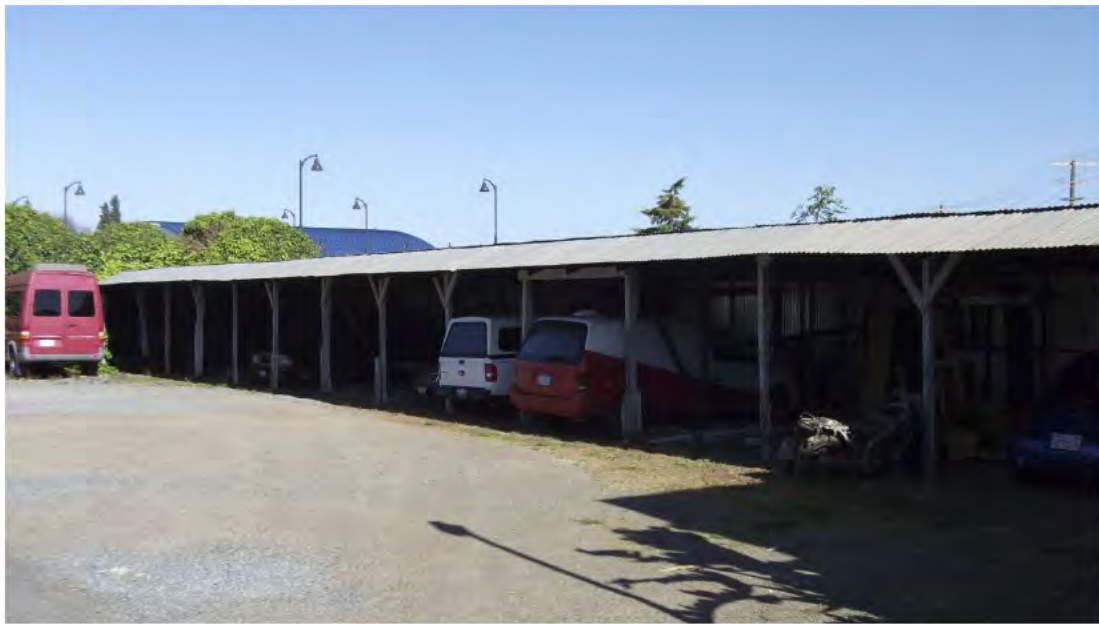
**PHOTO 31.** 16309 Kent Avenue – 14-Car Parking Shed

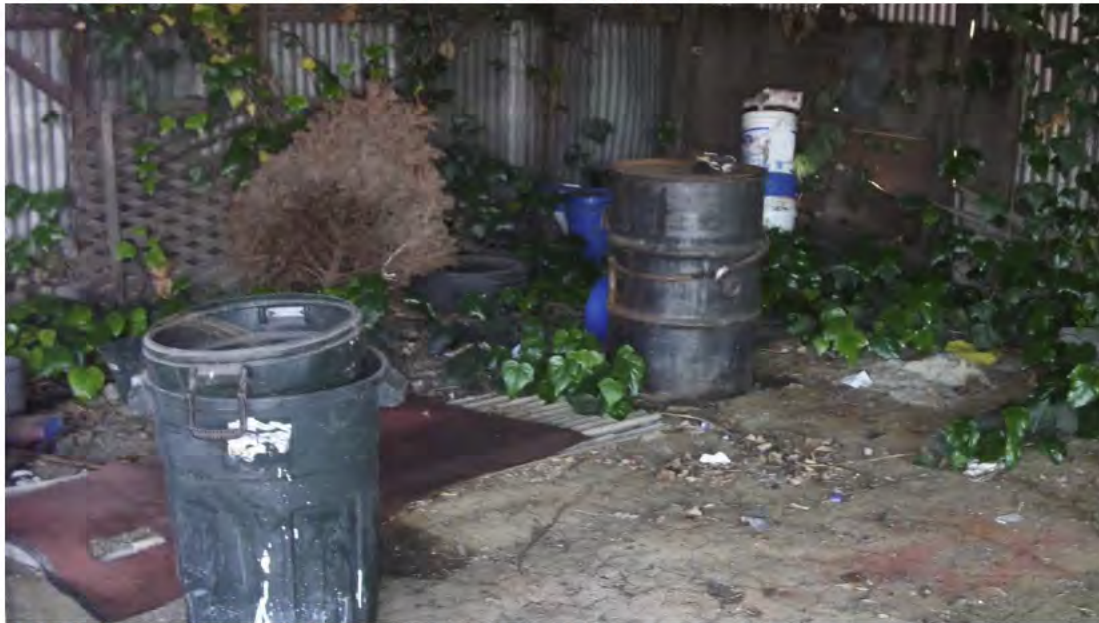
- 1 each 50-gallon drum of used oil;
- 5 each 5-gallon buckets of used oil and paint;
- 10 each quart containers of used oil;
- Miscellaneous petroleum coated metal cans and pans;
- 1 each abandoned motorcycle;
- 50 square feet of petroleum stained soil.

**PHOTO 32.** 16309 Kent Avenue – 14-car Parking Shed with Discarded Oil Drums

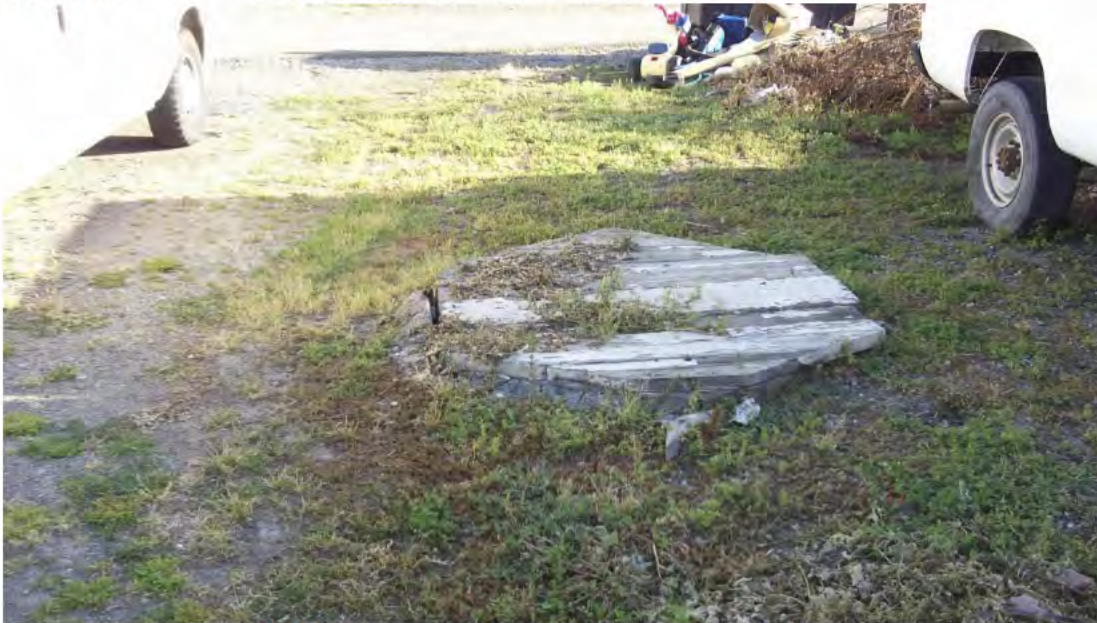
**PHOTO 34.** 16309 Kent Avenue – Damaged Wooden Cover of Water Cistern (sand filled)  
Located in Parking Area West of Unit 17

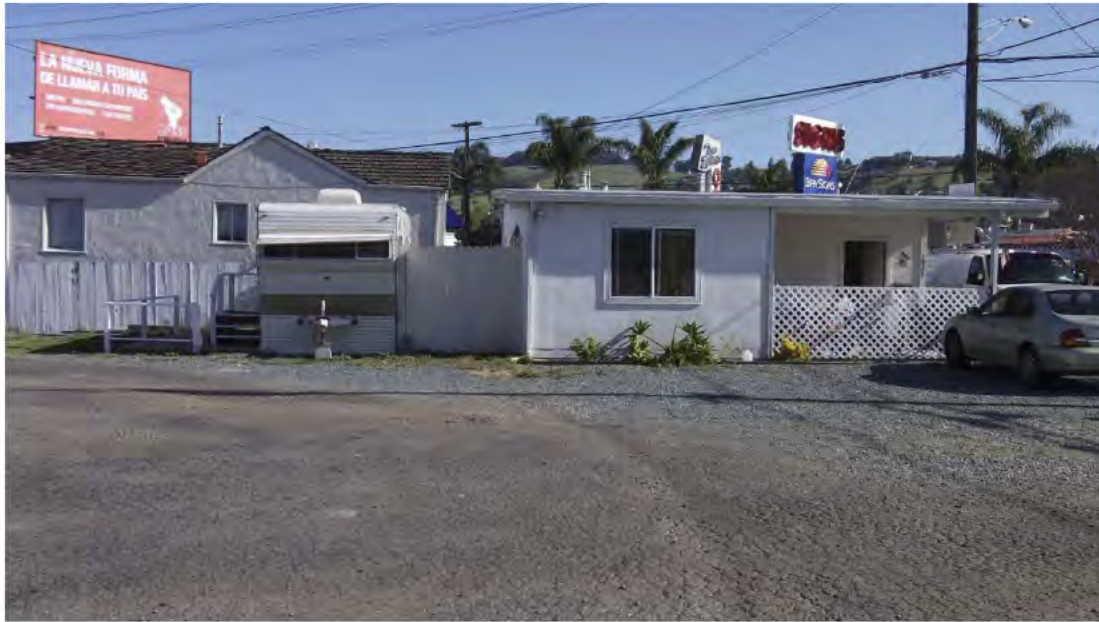
**PHOTO 34.** 16305 Kent Avenue – Single Family Residence with Fenced in Trailer
