Arborist Report

**Jamison Way
Castro Valley, CA**

May 16, 2016

**Arborist Report
Jamison Way
Castro Valley, CA**

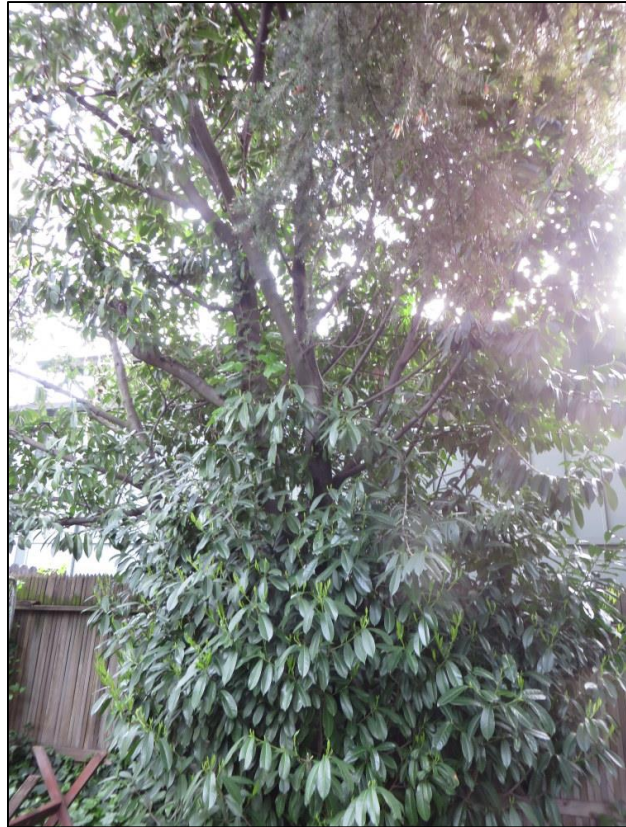
The most common species assessed was English laurel (10 trees, 11% of population). These trees were growing in the center of the property and along the eastern edge. While large enough to be included in this assessment, these plants have a bush form with multiple stems originating at the base (Photo 1).

Photo 1 (top) – English laurel #37 is typical of the bush form of the most common tree on-site.

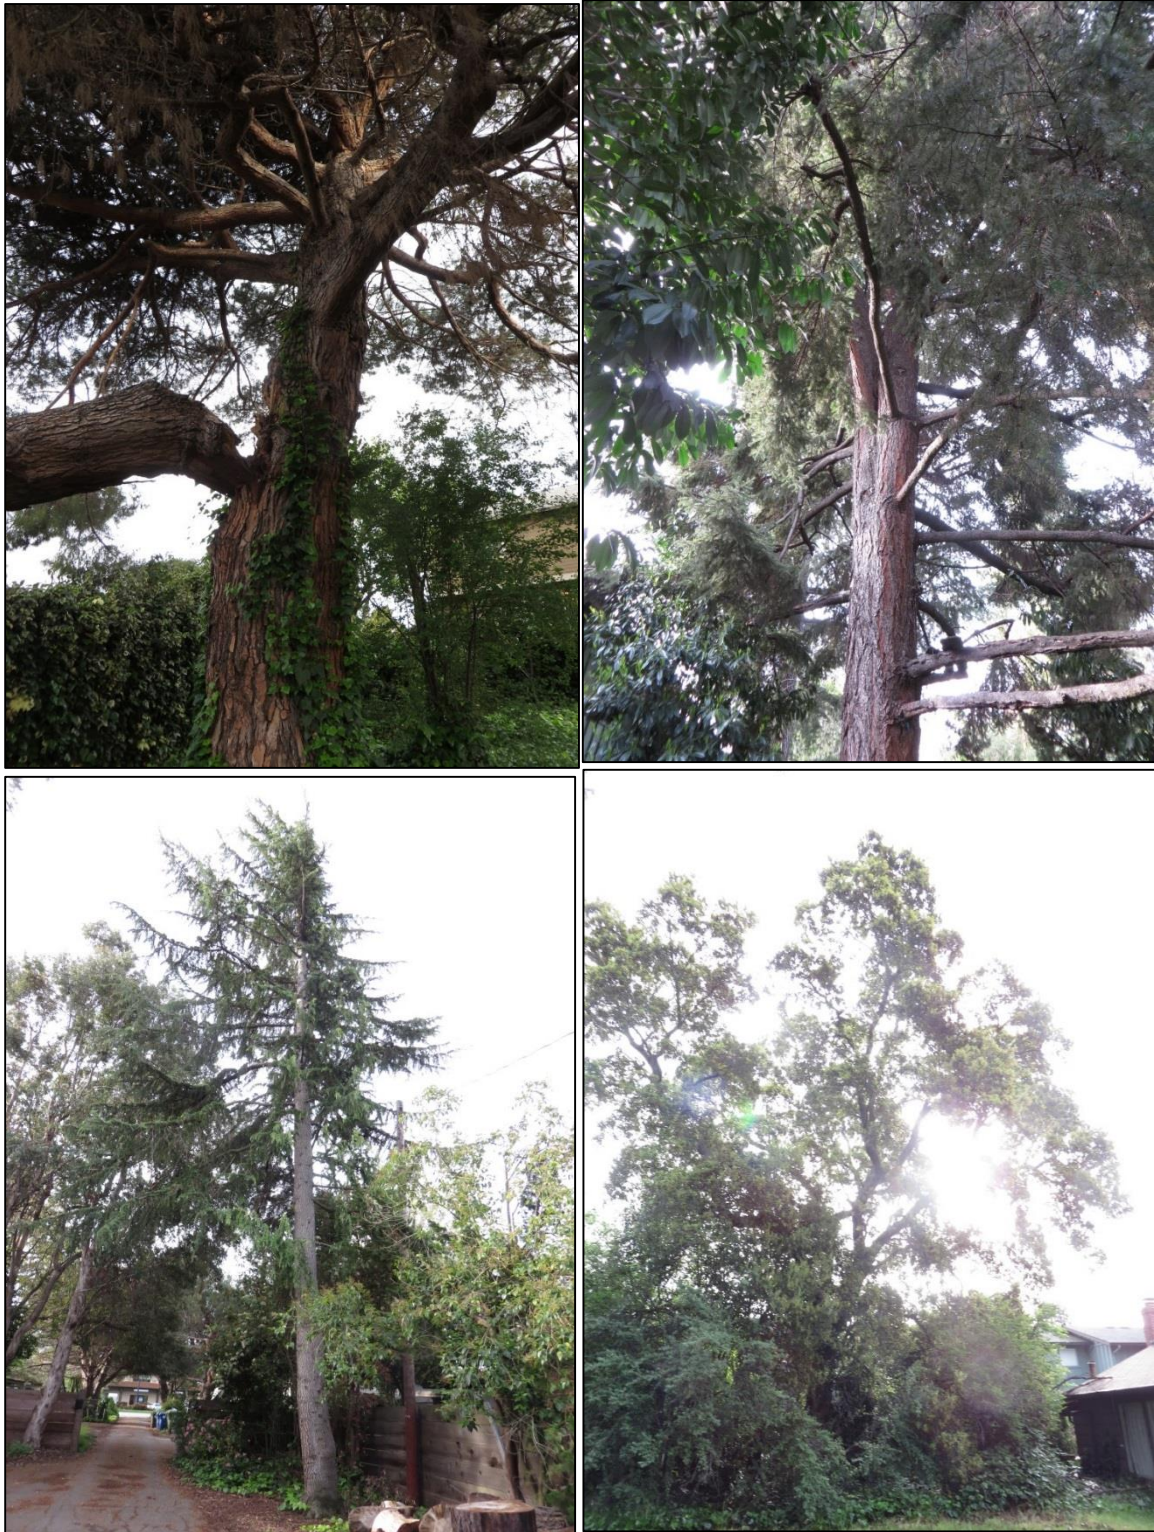
The three largest trees assessed were Italian stone pines (#27, 3 and 67, respectively). Italian stone pine #27 was the largest tree assessed and had a recent branch failure of approximately 36" in diameter (Photo 2). The average trunk diameter of the stone pines was 41" and ranged from 57" to 16". The Italian stone pines ranged from fair (2 trees) to good (2 trees) condition.

- A 35" Douglas fir that had codominant leaders fused back together (Photo 3).
- Two deodar cedars (20" and 23" diameter) that had lost their top (Photo 4).
- An off-site coast redwood (30" diameter) in excellent condition.

Four semi-mature coast live oaks were growing on-site. The three single stemmed trees had an average trunk diameter of 20" and ranged from 15 to 28". Two of the oaks were in good condition, and two were in fair condition. Coast live oak #34 was a dominant tree suppressing many of its neighbors (Photo 5).

Photo 2 (top left) – Italian stone pine #27 recently lost a 36" branch.

Photo 3 (top right) – Douglas fir #39 had a codominant main stem that fused back together.

Photo 4 (bottom left) – Deodar cedar #22 had multiple tops.

Photo 5 (bottom right) – Coast live oak #34 was a dominant tree, suppressing many others.
