Tree Risk Assessment

**San Leandro Creek
Location 1 – Huff Ave.
Alameda County Flood Control**

June, 2010

Tree Risk Assessment
San Leandro Creek
Location 1, Huff Ave.
Alameda County Flood Control

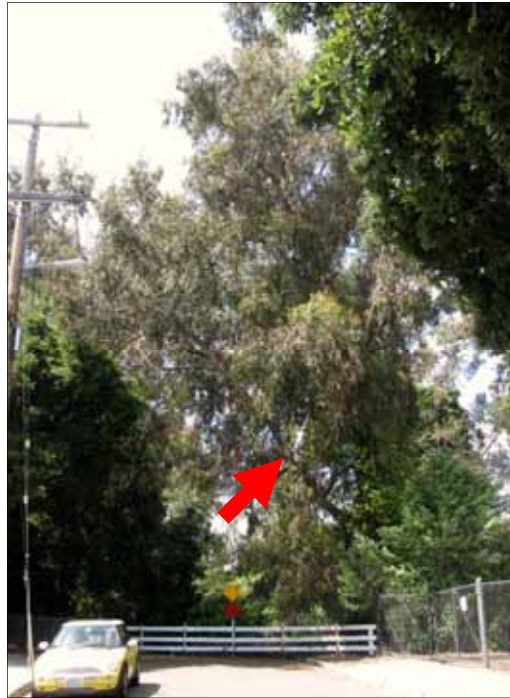
Diameter class	48-60"
# trunks	1
Height	114'
Position	upper bank
Bank; slope	south, 1:1
Vines on trunk?	yes
Comments	Spreading crown heavily weighted towards W; large branch extending over driveway at 1111 Huff; trunk obscured by ivy.

Left: Tree #201; arrow indicates branch extending over parking area and driveway.

Potential targets	Private property (1111, 1115, 1119, 1130 Huff Ave., 963, 965, 971 Lee); parking on Huff Ave., creek, bank
Most likely failure mode	Whole tree failure during storm: tall, leaning tree exposed to strong winds on steep slope with wet soil.
Most likely targets	Lean and heavy weight on W will likely direct failure towards 1111, 1115 Huff and parking on Huff., bank
Failure potential	3
Size of part	3
Target rating	4
Risk rating	10
Risk reduction options	To reduce risk, remove SW branch; to eliminate risk, remove tree.

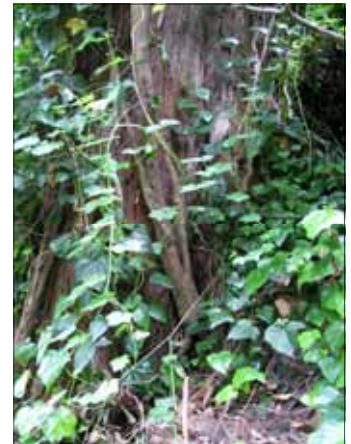
Right: Base of tree, west side

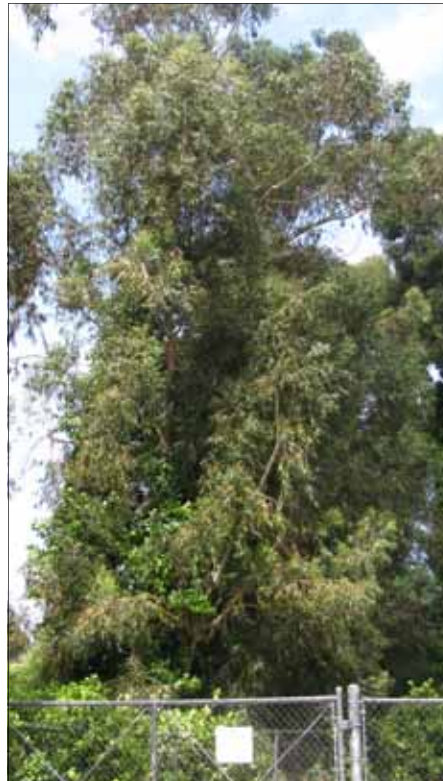
Diameter class	36-48"
# trunks	2
Height	98'
Position	upper bank
Bank; slope	south, 1:1
Vines on trunk?	yes
Comments	Asymmetric canopy extending to S; trunk obscured by ivy.

Left: #202, south side

Possible targets	Private property (1111, 1115, 1119, 1130, Huff Ave., 965, 971 Lee, parking at 524 Callan); parking on Huff Ave., creek, bank
Most likely failure mode	Whole tree failure during storm: tall, asymmetric tree exposed to strong winds on steep slope with wet soil.
Most likely targets	Heavy weight on S will likely direct failure towards 1130 Huff Ave, parking on Huff, bank
Failure potential	2
Size of part	2
Target rating	4
Risk rating	8
Risk reduction options	To reduce risk, prune to reduce weight on S.; to eliminate risk, remove tree.

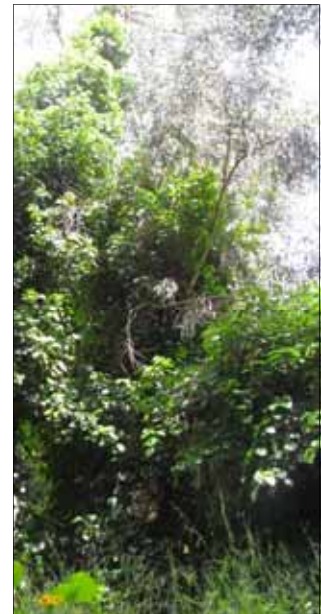
Below: #202, west side, trunk engulfed in ivy.

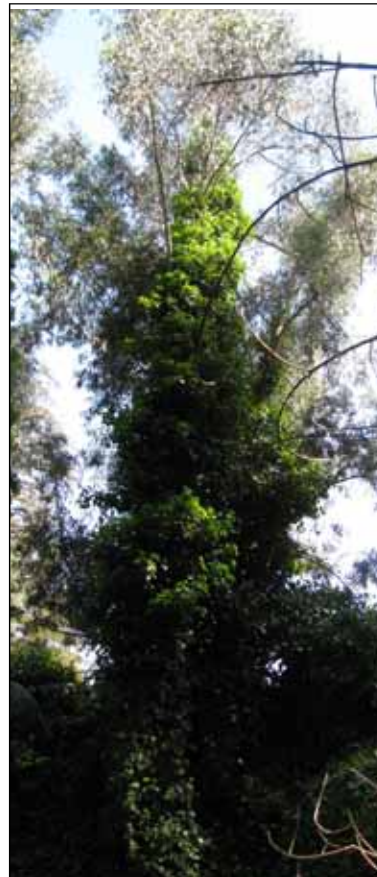
Diameter class	36-48"
# trunks	1
Height	108'
Position	upper bank
Bank; slope	south, 1:1
Vines on trunk?	yes
Comments	Small cavity on lower trunk; trunk obscured by ivy.

Left: Tree #203 viewed from the north

Possible targets	Private property (1111, 1115, 1119, 1130 Huff Ave., 965, 971, 981 Lee, parking at 524 Callan); parking on Huff Ave., creek, bank
Most likely failure mode	Whole tree failure during storm; tall tree exposed to strong winds on steep slope with wet soil.
Most likely targets	Tree will most likely fall across the creek onto 965, 971, 981 Lee Ave., bank, creek
Failure potential	3
Size of part	2
Target rating	3
Risk rating	8
Risk reduction options	To eliminate risk, remove tree.

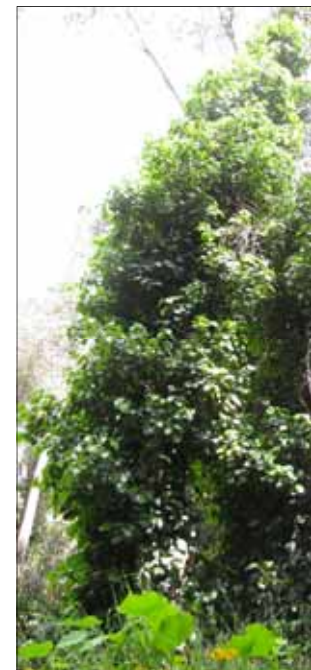
Below: #203, west side, trunk engulfed in ivy.

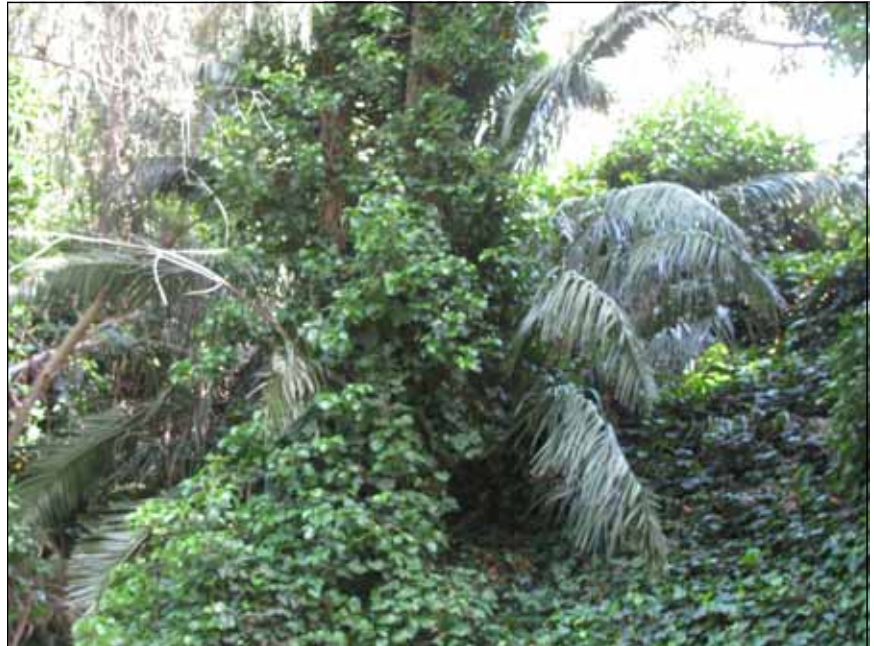
Diameter class	12-18"
# trunks	1
Height	22'
Position	upper bank
Bank; slope	south, 1:1
Vines on trunk?	yes
Comments	Trunk approximately 4' tall.

Above: Tree #204 (only fronds visible)

Possible targets	Creek bank
Most likely failure mode and target	Dead frond falling onto bank
Failure potential	1
Size of part	1
Target rating	1
Risk rating	3
Risk reduction options	none

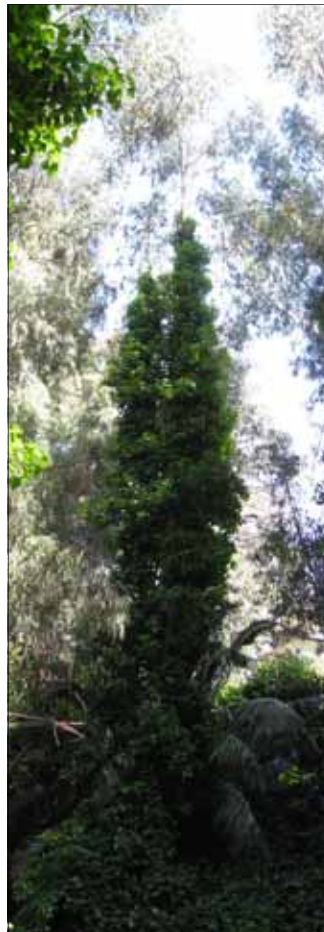
Left: Tree #205, north side

Diameter class	18-24"
# trunks	2
Height	106'
Position	upper bank
Bank; slope	south, 1:1
Vines on trunk?	yes
Comments	Slight lean; codominant trunks arise at 3'; trunks obscured by ivy.

Possible targets	Private property (1130 Huff Ave., 965, 971, 981 Lee; parking at 524 Callan); parking on Huff Ave., creek, bank
Most likely failure mode	Whole tree failure during storm: tall, tree exposed to strong winds on steep slope with wet soil.
Most likely targets	Tree will most likely fall across the creek onto 965, 971, 981 Lee Ave., bank, creek
Failure potential	3
Size of part	2
Target rating	3
Risk rating	8
Risk reduction options	To eliminate risk, remove tree.

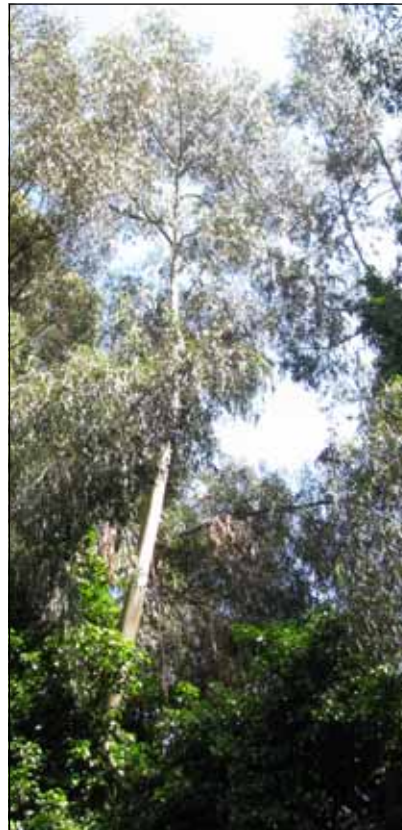
Left: Tree #206

Diameter class	18-24"
# trunks	1
Height	94'
Position	lower bank
Bank; slope	south, 1:1
Vines on trunk?	yes
Comments	Asymmetric trunk; leaning NW.

Possible targets	Private property (1130 Huff Ave., 965, 971, 981 Lee, parking at 524 Callan); creek, bank
Most likely failure mode	Whole tree failure during storm: tall, tree exposed to strong winds on steep slope with wet soil.
Most likely target	Tree will most likely fall across the creek on 965, 971, 981 Lee Ave., bank, creek
Failure potential	4
Size of part	2
Target rating	3
Risk rating	9
Risk reduction options	To eliminate risk, remove tree.

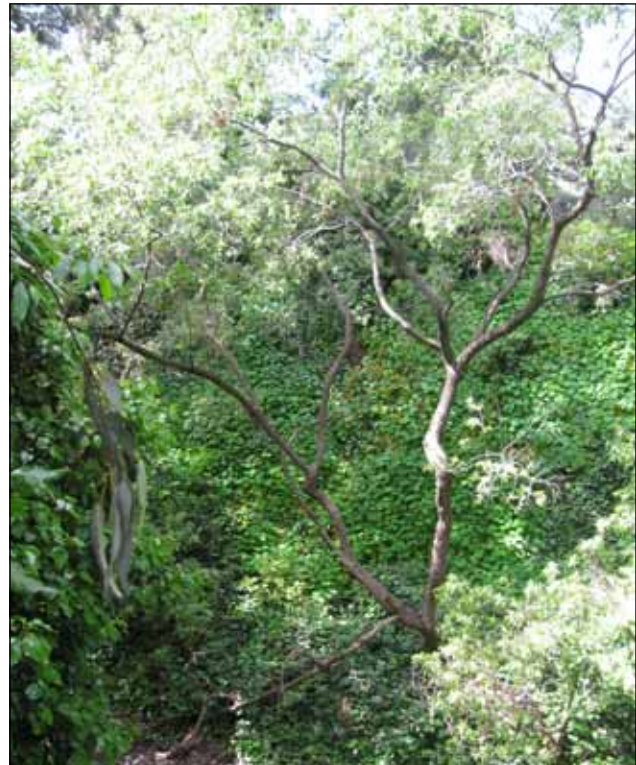
Above: Tree #207

Diameter class	12-18"
# trunks	1
Height	45'
Position	bench
Bank; slope	north; 2:1
Vines on trunk?	yes
Comments	leaning south; stump sprout

Possible targets	bank, creek
Most likely failure mode	Decayed trunk break at weakest point
Most likely targets	Trunk falling into creek, bank
Failure potential	3
Size of part	2
Target rating	1
Risk rating	6
Risk reduction options	Coppice tree to reduce risk

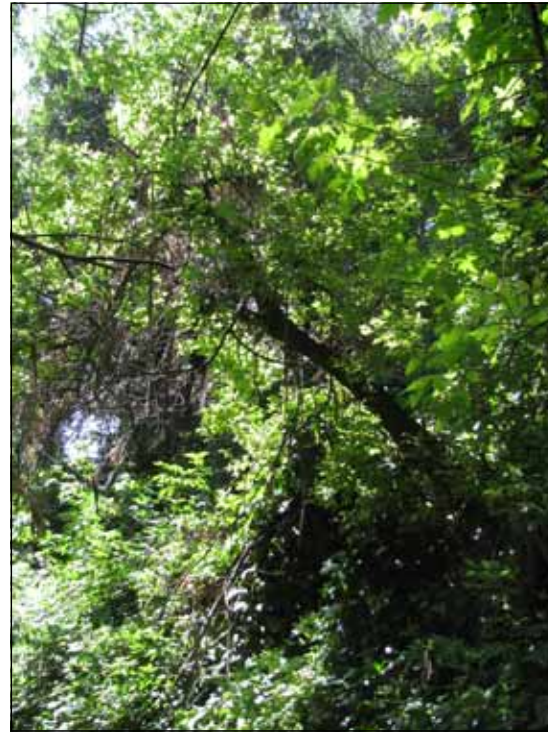
Above: Tree #208

Diameter class	6-12"
# trunks	1
Height	34'
Position	bench
Bank; slope	north; 2:1
Vines on trunk?	yes
Comments	Leaning south; stump sprout; extensive decay

Possible targets	bank, creek
Most likely failure mode	Decayed trunk break at weakest point
Most likely targets	Trunk falling into creek, bank
Failure potential	3
Size of part	2
Target rating	1
Risk rating	6
Risk reduction options	Coppice tree to reduce risk.

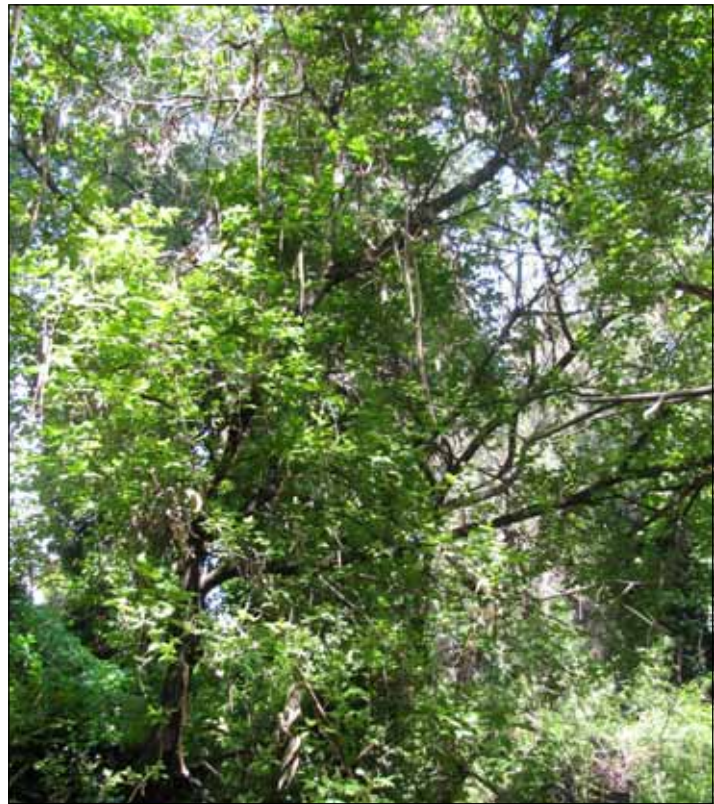
Above: Tree #209

Diameter class	6-12"
# trunks	1
Height	27'
Position	lower bank
Bank; slope	north; 1.5:1
Vines on trunk?	yes
Comments	Leaning south over creek; stump sprout; extensive decay

Possible targets	bank, creek
Most likely failure mode	Decayed trunk break at weakest point
Most likely targets	Trunk falling into creek, bank
Failure potential	3
Size of part	2
Target rating	1
Risk rating	6
Risk reduction options	Coppice tree to reduce risk.

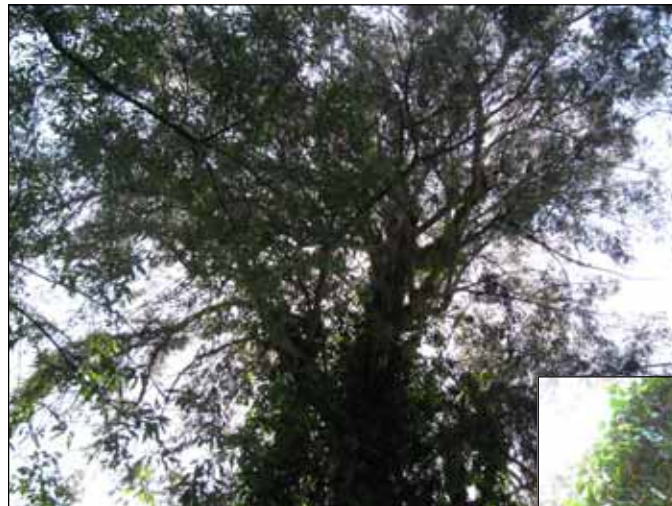
Top: Crown of #210

Diameter class	48-60"
# trunks	1
Height	138'
Position	upper bank
Bank; slope	north, 1.5:1
Vines on trunk?	yes
Comments	Wide-spreading crown with many large branches arising from old pruning cuts; previously topped; trunk obscured by ivy; small pocket trunk decay.

Possible targets	Private property (1111, 1115 Huff Ave., 961, 963, 965, Lee, 450 Callan, 494 Woodland Park); parking on Huff Ave., creek, bank.
Most likely failure mode	Failure of one or more large scaffold branches arising at old topping cut, under strong winds.
Most likely targets	Large scaffold branch falling onto 963 Lee, bank, creek.
Failure potential	3
Size of part	3
Target rating	3
Risk rating	9
Risk reduction options	To eliminate risk, remove tree.

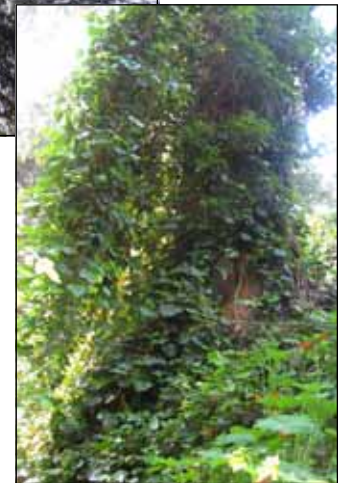
Right: Base of tree #210, engulfed in ivy

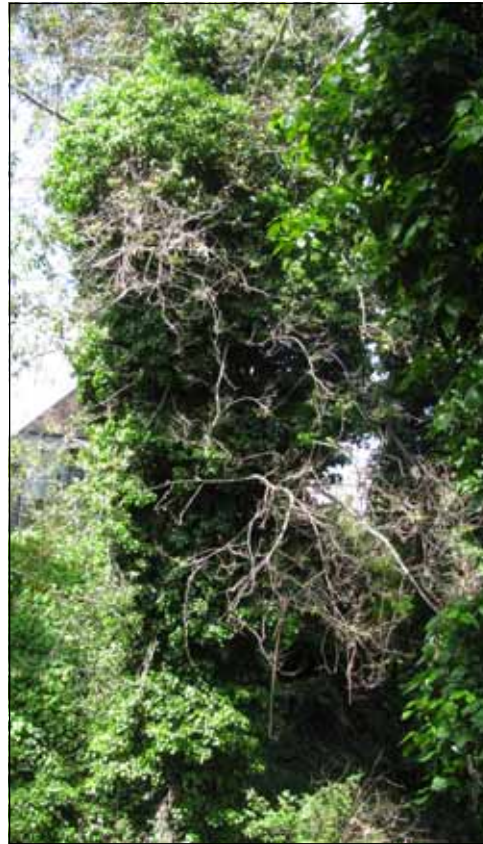
Left: Tree #211

Diameter class	24-36"
# trunks	1
Height	123'
Position	lower bank
Bank; slope	north, 1.5:1
Vines on trunk?	yes
Comments	Engulfed in ivy; not much canopy showing; defoliated by anthracnose.

Possible targets	Private property (1111, 1115 Huff Ave., 963, 965, 971, 981 Lee); parking on Huff Ave., creek, bank.
Most likely failure mode	Trunk failure due to decay that is common present in old sycamores (trunk obscured by vines) and/or soil failure in storm.
Most likely targets	Whole tree failure onto parking on Huff, bank, creek.
Failure potential	2
Size of part	1
Target rating	3
Risk rating	6
Risk reduction options	Coppice tree to reduce risk.

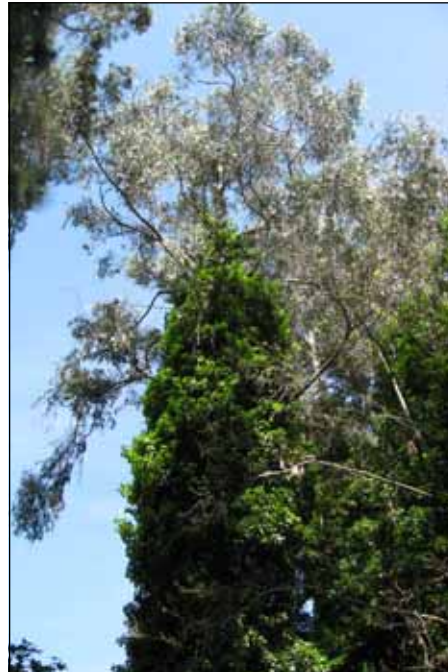
Left: #212 viewed from the southeast.

Diameter class	48-60"
# trunks	1
Height	105'
Position	upper bank
Bank; slope	north, 1.5:1
Vines on trunk?	yes
Comments	Leaning north; trunk decay; trunk obscured by ivy.

Possible targets	Private property (1111 Huff Ave., 963, 965, 971, 981 Lee); parking on Huff Ave., creek, bank.
Most likely failure mode	Whole tree failure during storm; aggravated by lean; tall, tree exposed to strong winds on steep slope with wet soil.
Most likely targets	Because of N lean, whole tree is most likely to fail onto 963, 659, 971 Lee Ave., bank.
Failure potential	4
Size of part	3
Target rating	4
Risk rating	11
Risk reduction options	To eliminate risk, remove tree.

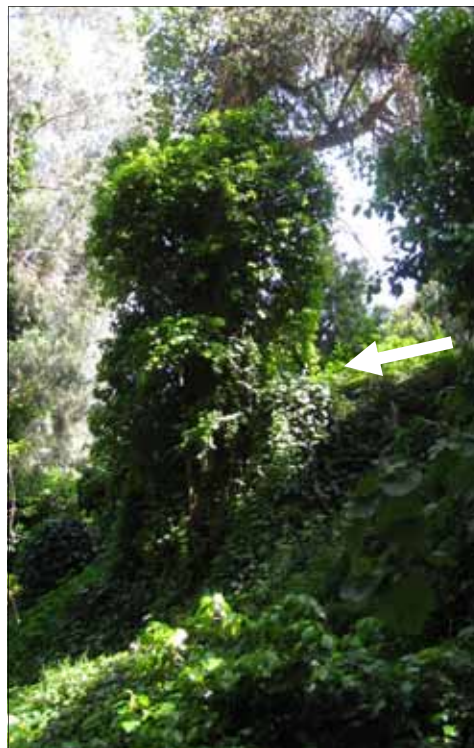
Diameter class	18-24"
# trunks	2
Height	32'
Position	upper bank
Bank; slope	north, 1.5:1
Vines on trunk?	yes
Comments	Extensive decay; completely over-grown with ivy.

Tree #213 hidden from view by dense ivy.

Possible targets	bank, creek
Most likely failure mode	Decayed trunk break at weakest point
Most likely targets.	Trunk falling onto bank
Failure potential	4
Size of part	2
Target rating	1
Risk rating	7
Risk reduction options	Coppice tree to eliminate risk

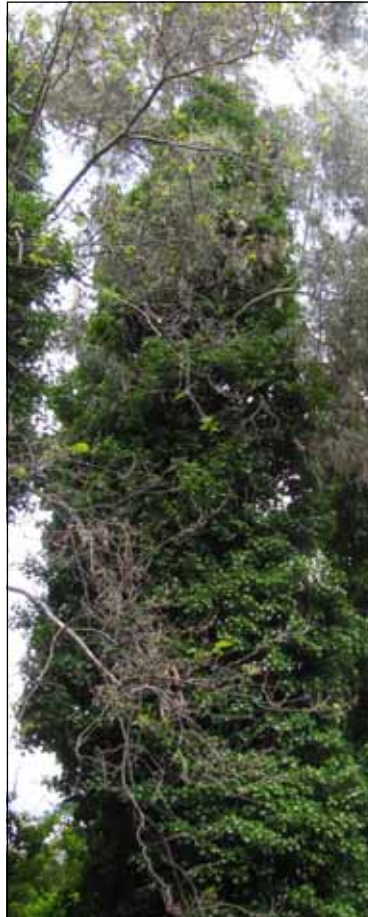
Left: Tree #214

Diameter class	>72
# trunks	2
Height	134'
Position	bench
Bank; slope	North, 1.5:1
Vines on trunk?	yes
Comments	Massive tree with dense ivy growth.

Possible targets	Private property (1111, 1115, 1130 Huff Ave., 963, 965, 971, 981 Lee, parking at 524 Callan); parking on Huff Ave., creek, bank
Most likely failure mode	Whole tree failure during storm: tall, tree exposed to strong winds on steep slope with wet soil.
Most likely targets	Tree will most likely fall across the creek onto 1111, 1115, 1130 Huff Ave., bank, creek
Failure potential	2
Size of part	2
Target rating	3
Risk rating	7
Risk reduction options	To eliminate risk, remove tree.

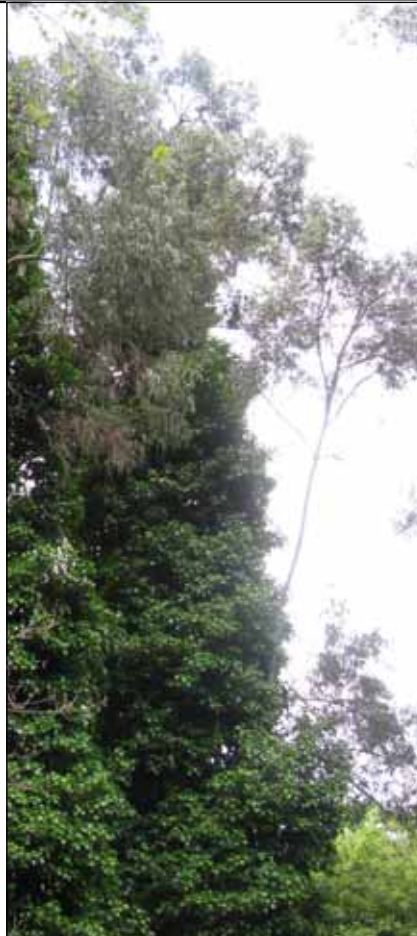
Tree # 215

Diameter class	36-48"
# trunks	1
Height	119'
Position	bench
Bank; slope	north, 1.5:1
Vines on trunk?	yes
Comments	Codominant with tree #214; trunk obscured by ivy.

Possible targets	Private property (1130 Huff Ave., 963, 965, 971, 981 Lee, parking at 524 Callan); parking on Huff Ave., creek, bank
Most likely failure mode	Whole tree failure during storm: tall, tree exposed to strong winds on steep slope with wet soil.
Most likely targets	Tree will most likely fall across the creek onto Huff Ave., parking, bank, creek
Failure potential	2
Size of part	2
Target rating	3
Risk rating	7
Risk reduction options	To eliminate risk, remove tree.
