INVESTMENT ADVISORY FACILITY CONDITION REPORT

County of Alameda – MLKJ Way
1918 Martin Luther King Jr. Way
Oakland, California 94612

December 6, 2022
Partner Project Number: 22-388732.1

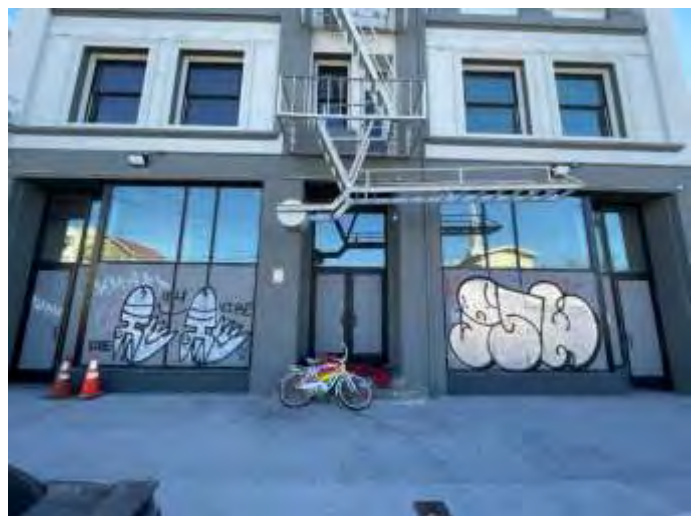
12. Three entrances at front elevation

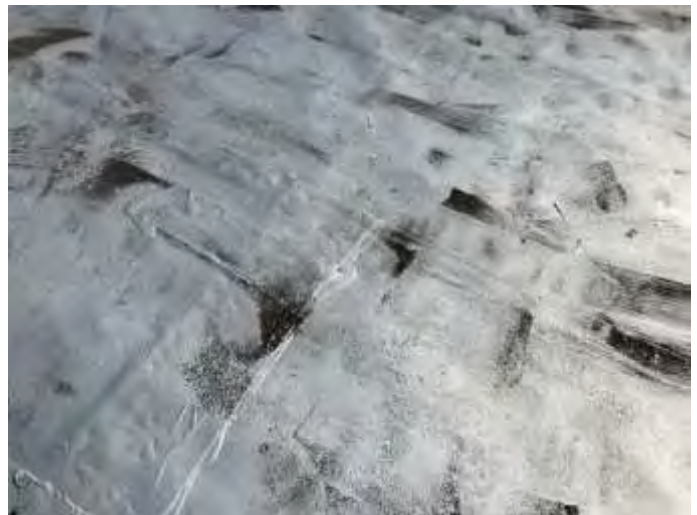
16. Aluminized emulsion coating

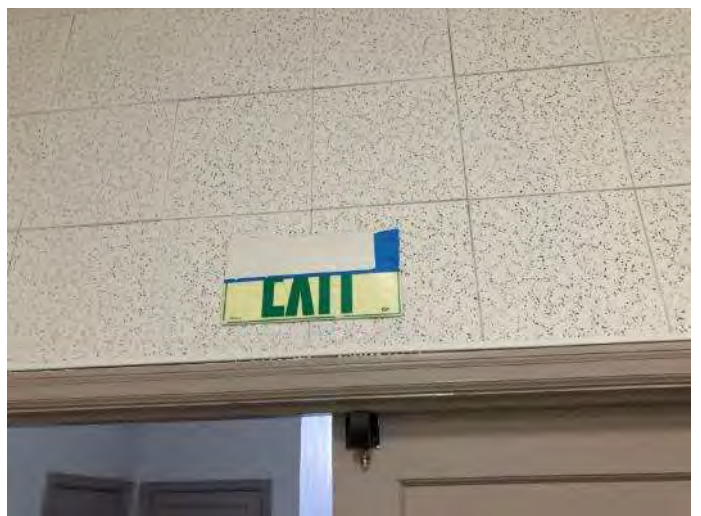
66. Broken exit sign in the 1st floor open area

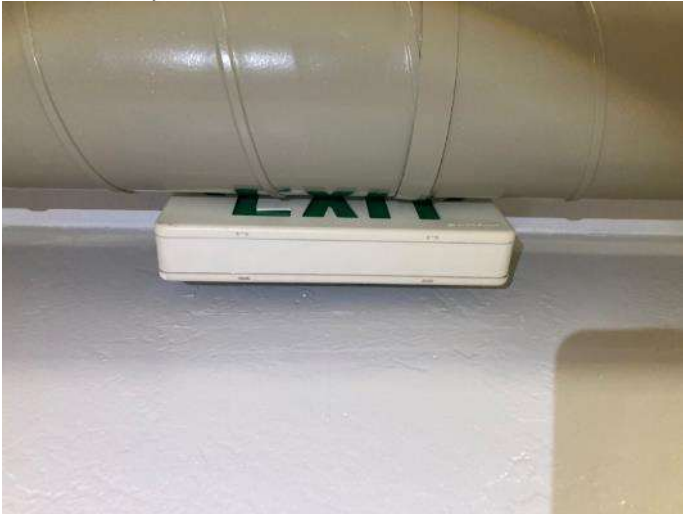
67. Exit sign in basement obstructed by HVAC duct

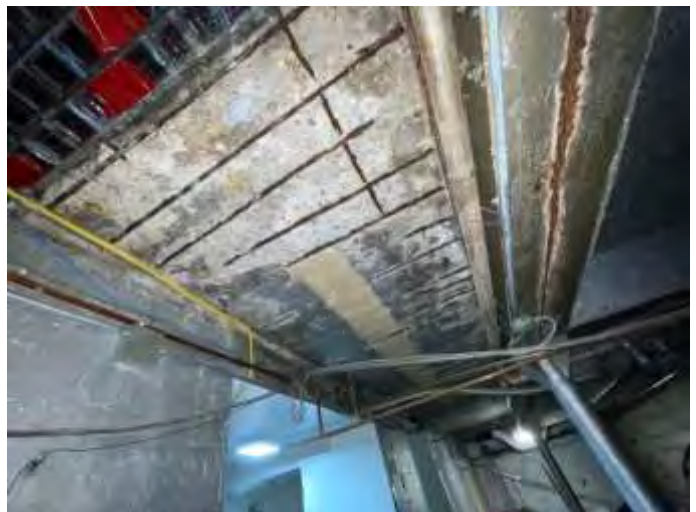
- Concrete at the underside of the municipal sidewalk located within the basement of the subject property has significantly deteriorated from moisture intrusion. Active moisture intrusion was observed. Spalling concrete is evident over the length of the basement under the sidewalk. The reinforcing rebar in the concrete has become exposed, and rusting is evident throughout the underside of the sidewalk deck.
- The building was originally designed as an unreinforced masonry structure. Seismic upgrades have been performed but may be inadequate to meet the client's current requirements. The probable maximum loss (PML) appears to be significant at this time. This is pending the scenario expected loss (SEL) report from Partner, but at this time, the SEL appears to be approximately 35%.

78. Exposed rebar was observed on the underside of the sidewalk in the basement

3.0 Site Improvements							
3.2.3	Repairing of the municipal sidewalk located within the basement is strongly recommended. Additional reinforcing of this basement area to support the sidewalk above may be needed. Some sidewalk replacement with new metal decking and concrete fill may be required. Some foundation work may also be required at the basement and sidewalk. Cleaning all rust off the wide flange I-beams and providing a rust inhibitor sealer is also recommended	1	ALLOW	\$500,000	\$500,000		\$500,000

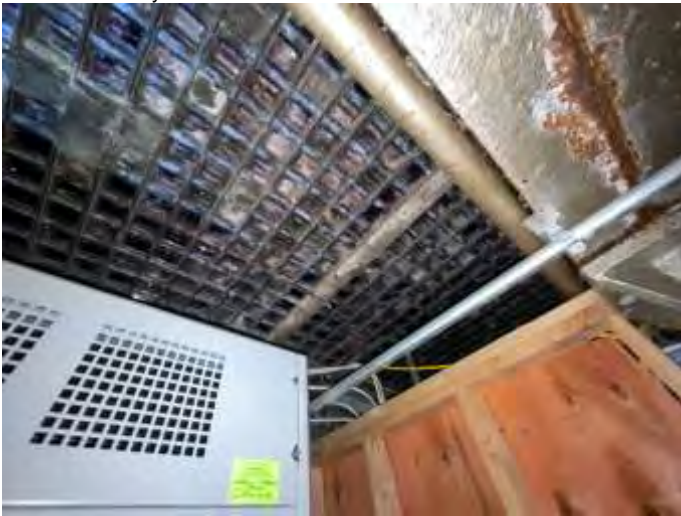
79. Exposed glass block was observed on the underside of the sidewalk in the basement

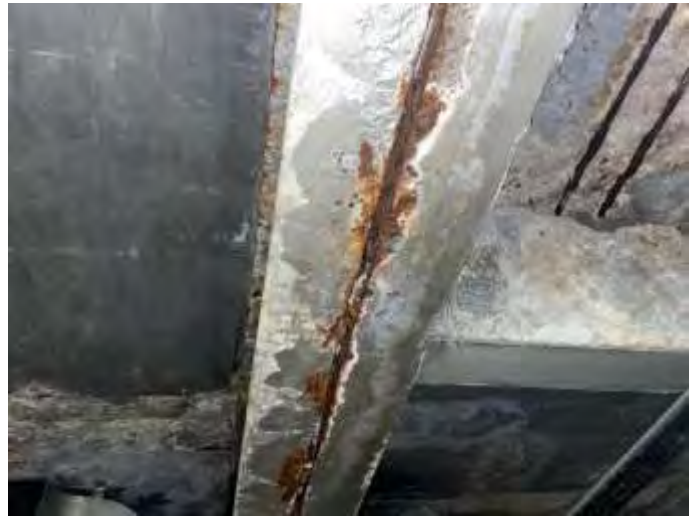
80. Rusted rebar and efflorescence were observed on the underside of the sidewalk in the basement

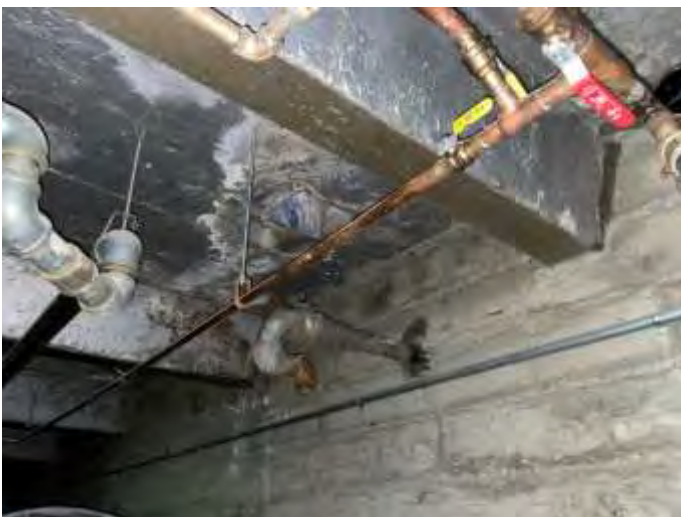
81. Moisture intrusion was observed on the underside of the sidewalk in the basement

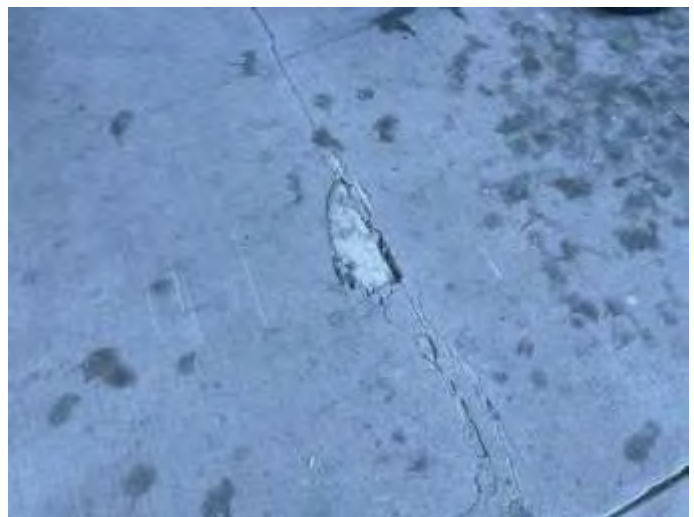
82. Deteriorating thin concrete poured sidewalk

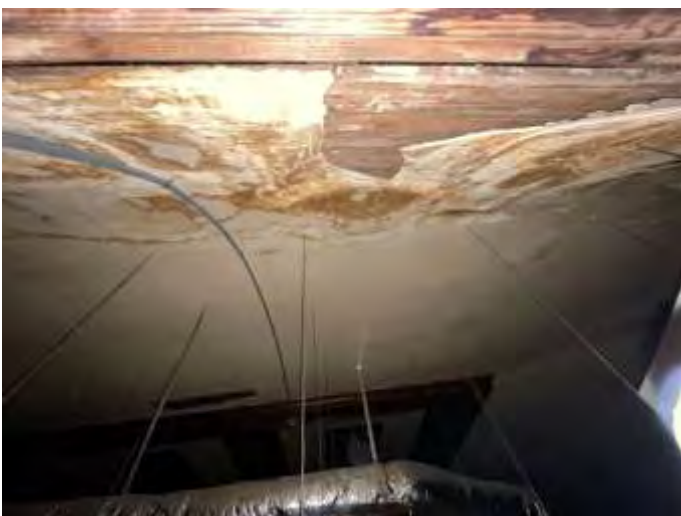
- The attic space above the auditorium lacks ventilation which appears to create excessive moisture content in the air space of the attic. In time, the wood stud framing could accumulate the excessive moisture and get heavier as a result, which could potentially collapse the ceiling systems.

83. Moisture intrusion in the attic space above the auditorium

4.2	Proper ventilation of the attic space above the auditorium is recommended	1	ALLOW	\$15,000	\$15,000		\$15,000
4.3.3	Some interior door thresholds pose a potential trip hazard due to the threshold transition being greater than ½ inch in height. Providing a solution to all interior threshold transitions greater than ½ inch height is recommended	1	ALLOW	\$6,500	\$6,500		\$6,500

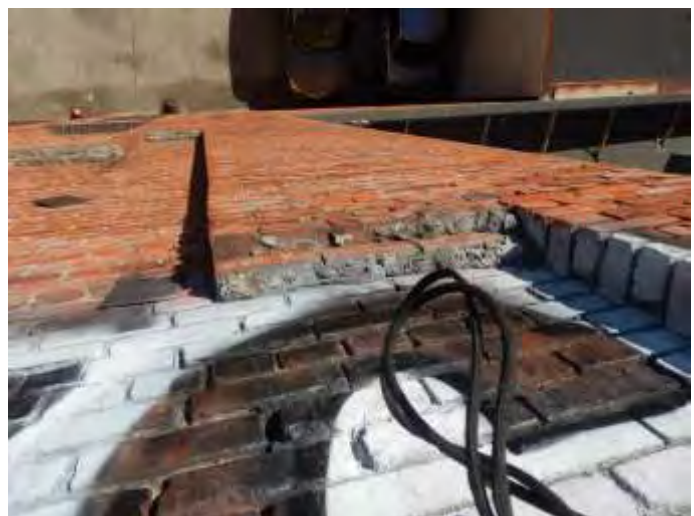
84. Deterioration of the masonry brick on the upper part of the rear elevation and graffiti

4.4.3	A solid-core wood door was observed to be missing in the attic. Installation of missing doors is recommended	1	EA	\$3,000	\$3,000		\$3,000
4.3.1	Repointing, tuck and pointing, and sectional replacement of the masonry mortar is recommended	14,000	SF	\$100		\$1,400,000	\$1,400,000

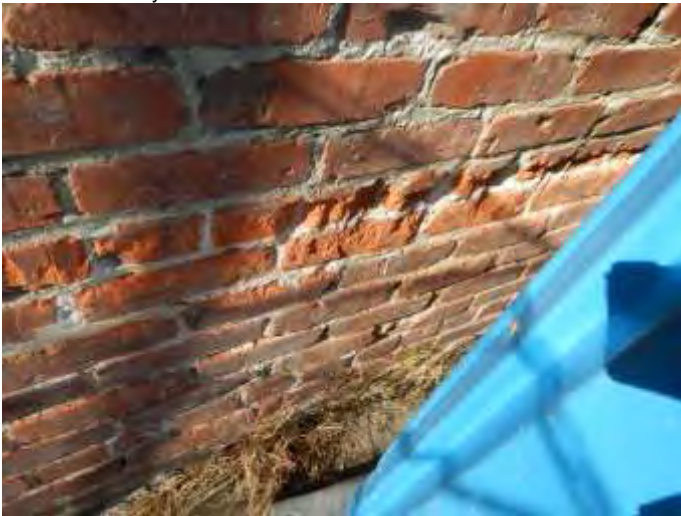
85. Deterioration of the masonry brick at the ground floor rear elevation

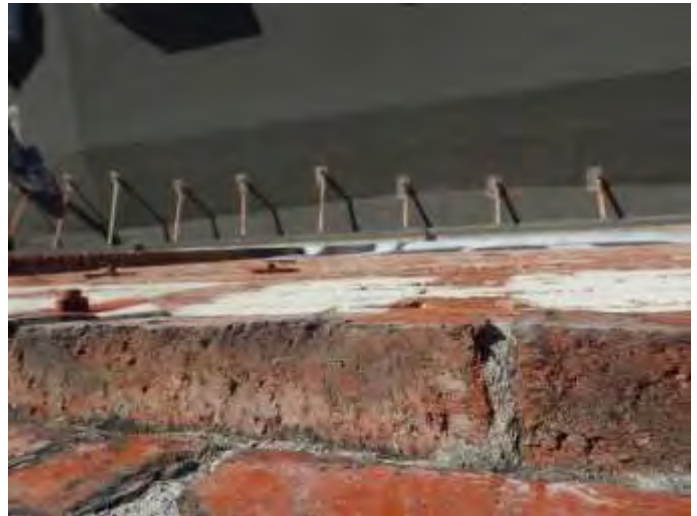
86. Close up of deteriorated mortar and brick coursing

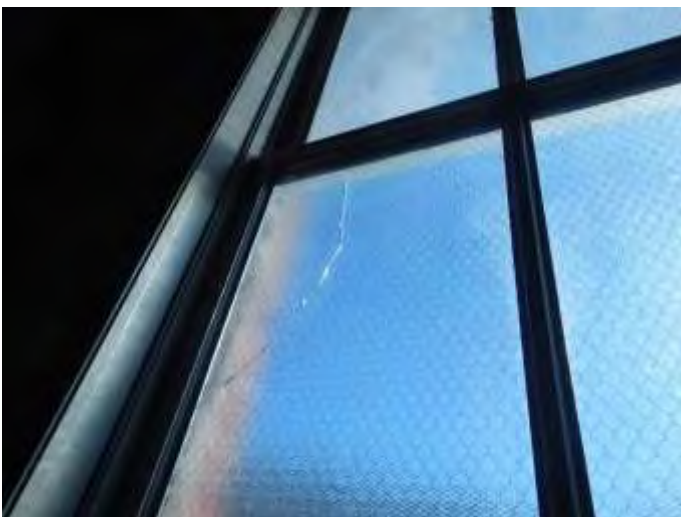
87. Cracked original window glazing

4.3.2	Replacement of the older window units is recommended	1	ALLOW	\$45,000		\$45,000	\$45,000
4.3.2	The metal security bars at the rear elevation appeared to be rusted and need to be cleaned. This can be done in conjunction with the cleaning of the exterior walls recommended in Section 4.3.1.	1	ADVISORY	\$0.00

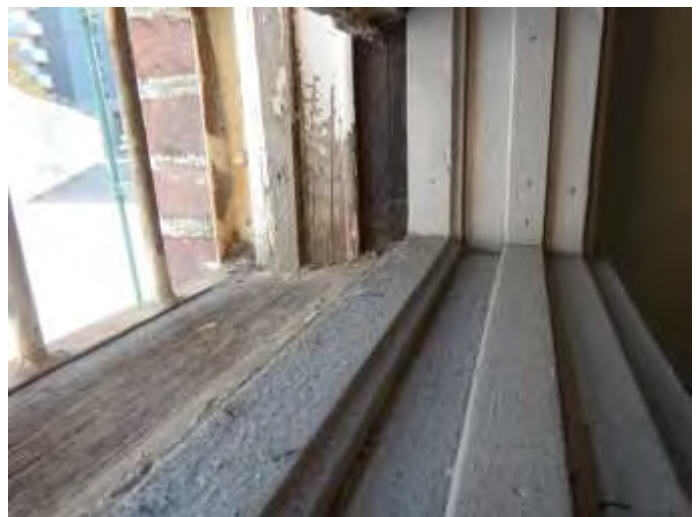
88. Rotted wood window frame

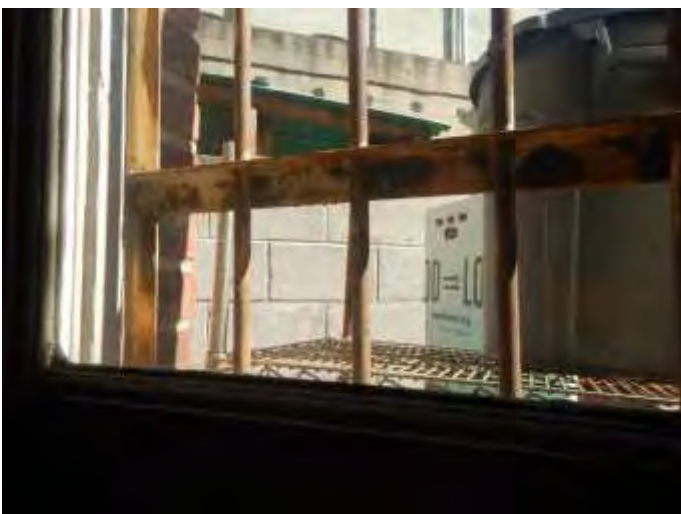
89. Rusted metal security bar at the ground floor rear elevation

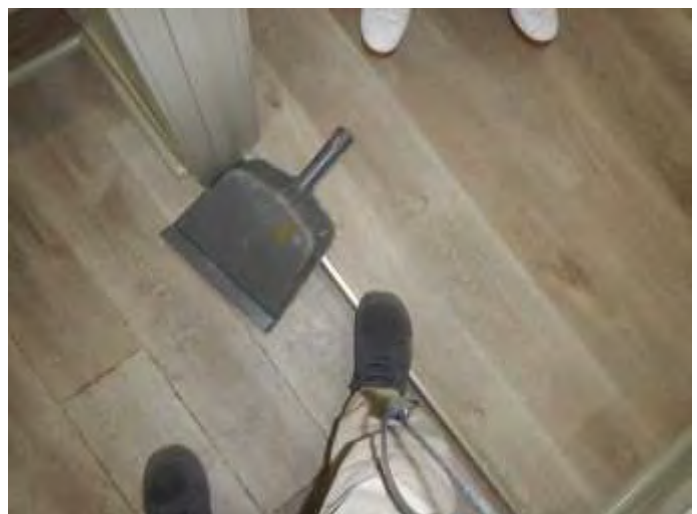
90. Door threshold transition trip hazard

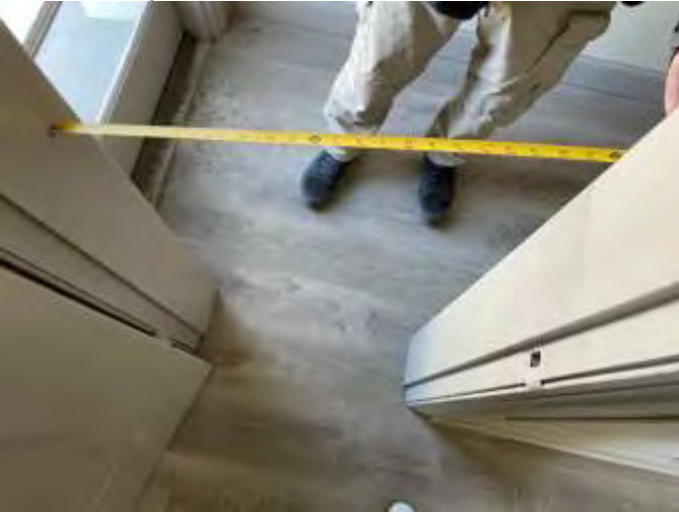
91. Some doorways have 22" openings

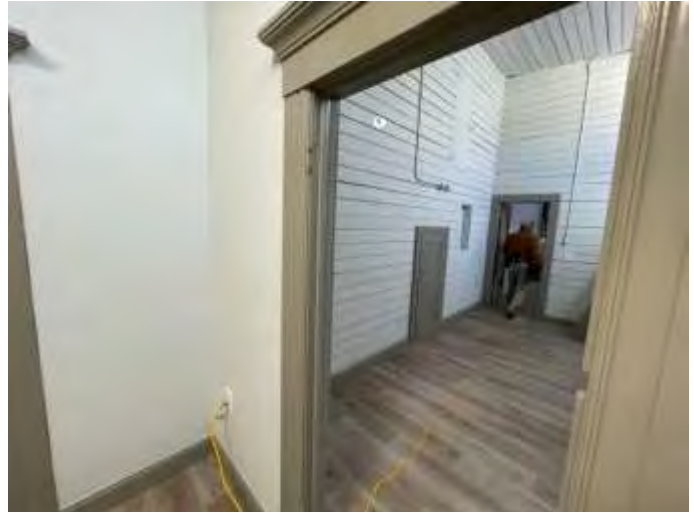
92. Missing door in the attic space

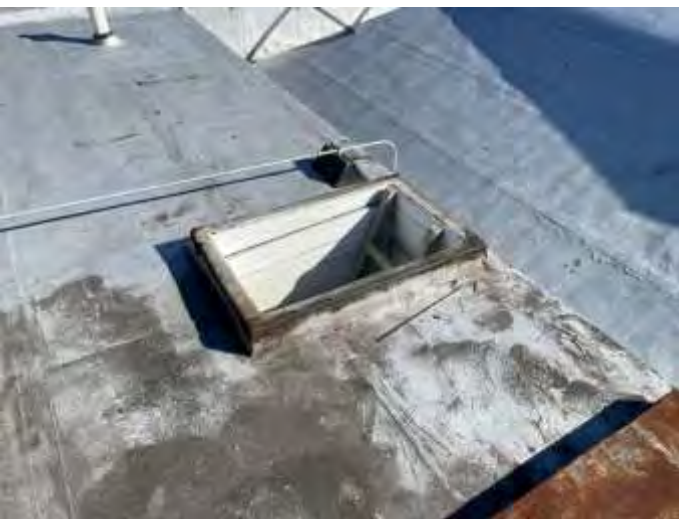
93. A proper roof hatch with safety rails needs to be installed

4.4.1	Replacing the roof hatch with a new unit that includes safety railing is recommended	1	EA	\$4,000	\$4,000		\$4,000

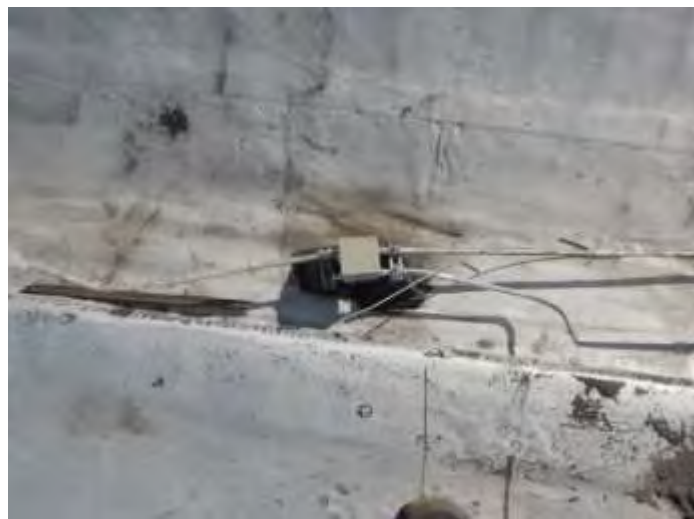
94. Junction box positioned within stormwater discharge path

5.3	Re-locate the roof junction box to be clear of the stormwater discharge path, and perform necessary electrical repairs and service for junction boxes, conduits, GFCI outlets and associated electrical components, including all that may be identified by IR scan [CURSORY COST - contingent upon contractor's proposal]	1	EA	\$7,500	\$7,500		\$7,500

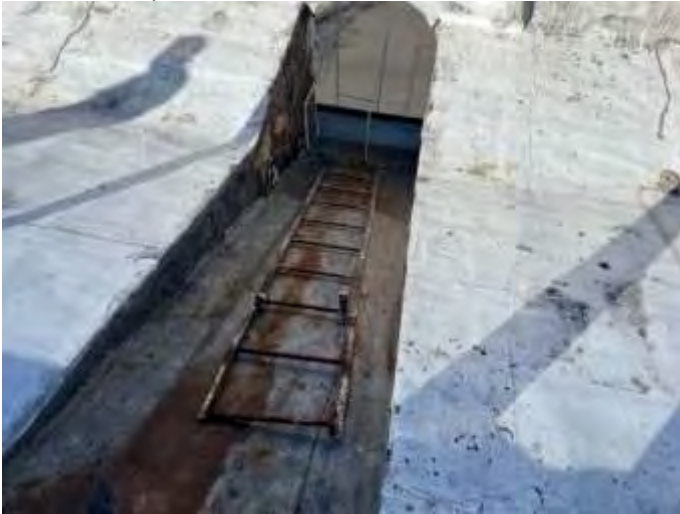
97. Unsafe fire escape access from roof

4.5	The fire escape is deemed unsafe to use. Making the fire escape safe, repairing the damaged section of the roof, certification of the fire escape, and balancing the pivoting ground floor stair/ladder is recommended	1	ALLOW	\$25,000	\$25,000		\$25,000

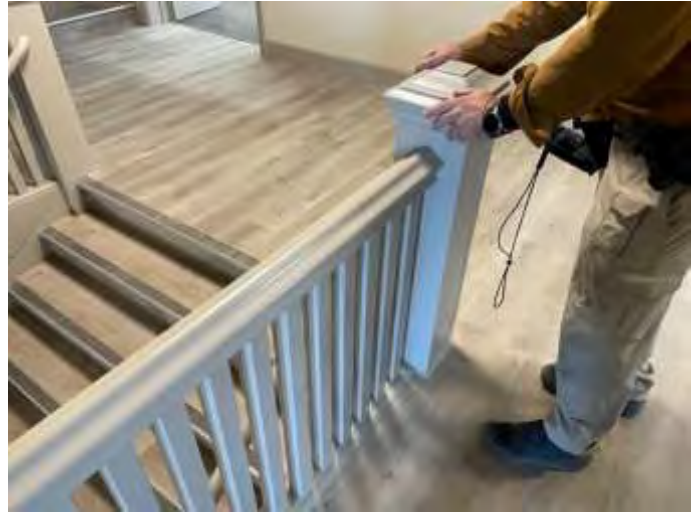
98. Guardrails throughout the subject property are too low and pose a fall hazard

4.5	The interior stairways have existing guardrails that are not mounted properly, are too low, and pose a potential fall hazard. Proper installation of guardrails to meet current safety standards is recommended	1	ALLOW	\$10,000	\$10,000		\$10,000

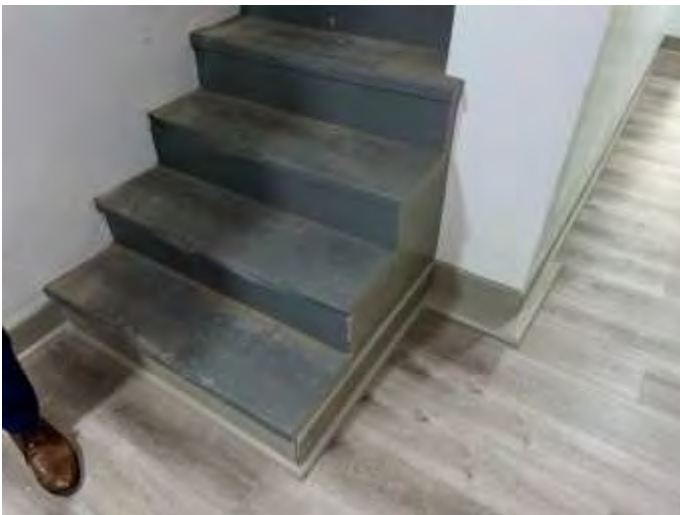
99. Missing guardrails on the basement stairs

4.5	Some stairways lack guardrails on their open sides. Proper installation of guardrails and handrails to meet current safety standards on all stairs or steps within the building for the full length of the stairs or steps is recommended	1	ALLOW	\$20,000	\$20,000		\$20,000

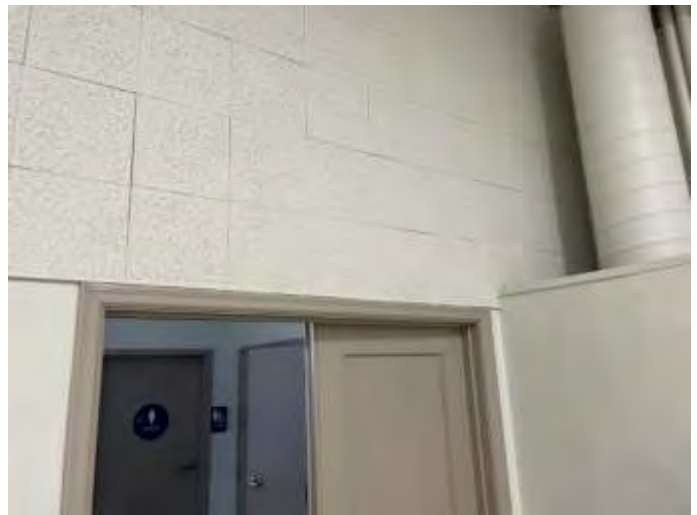
100. 1x1 acoustical tiles at the back room of the ground floor need to be tested for asbestos
