EARLY ASSESSMENT OF WIND TURBINE LAYOUT IN SUMMIT WIND PROJECT

K. Shawn Smallwood

11 August 2014

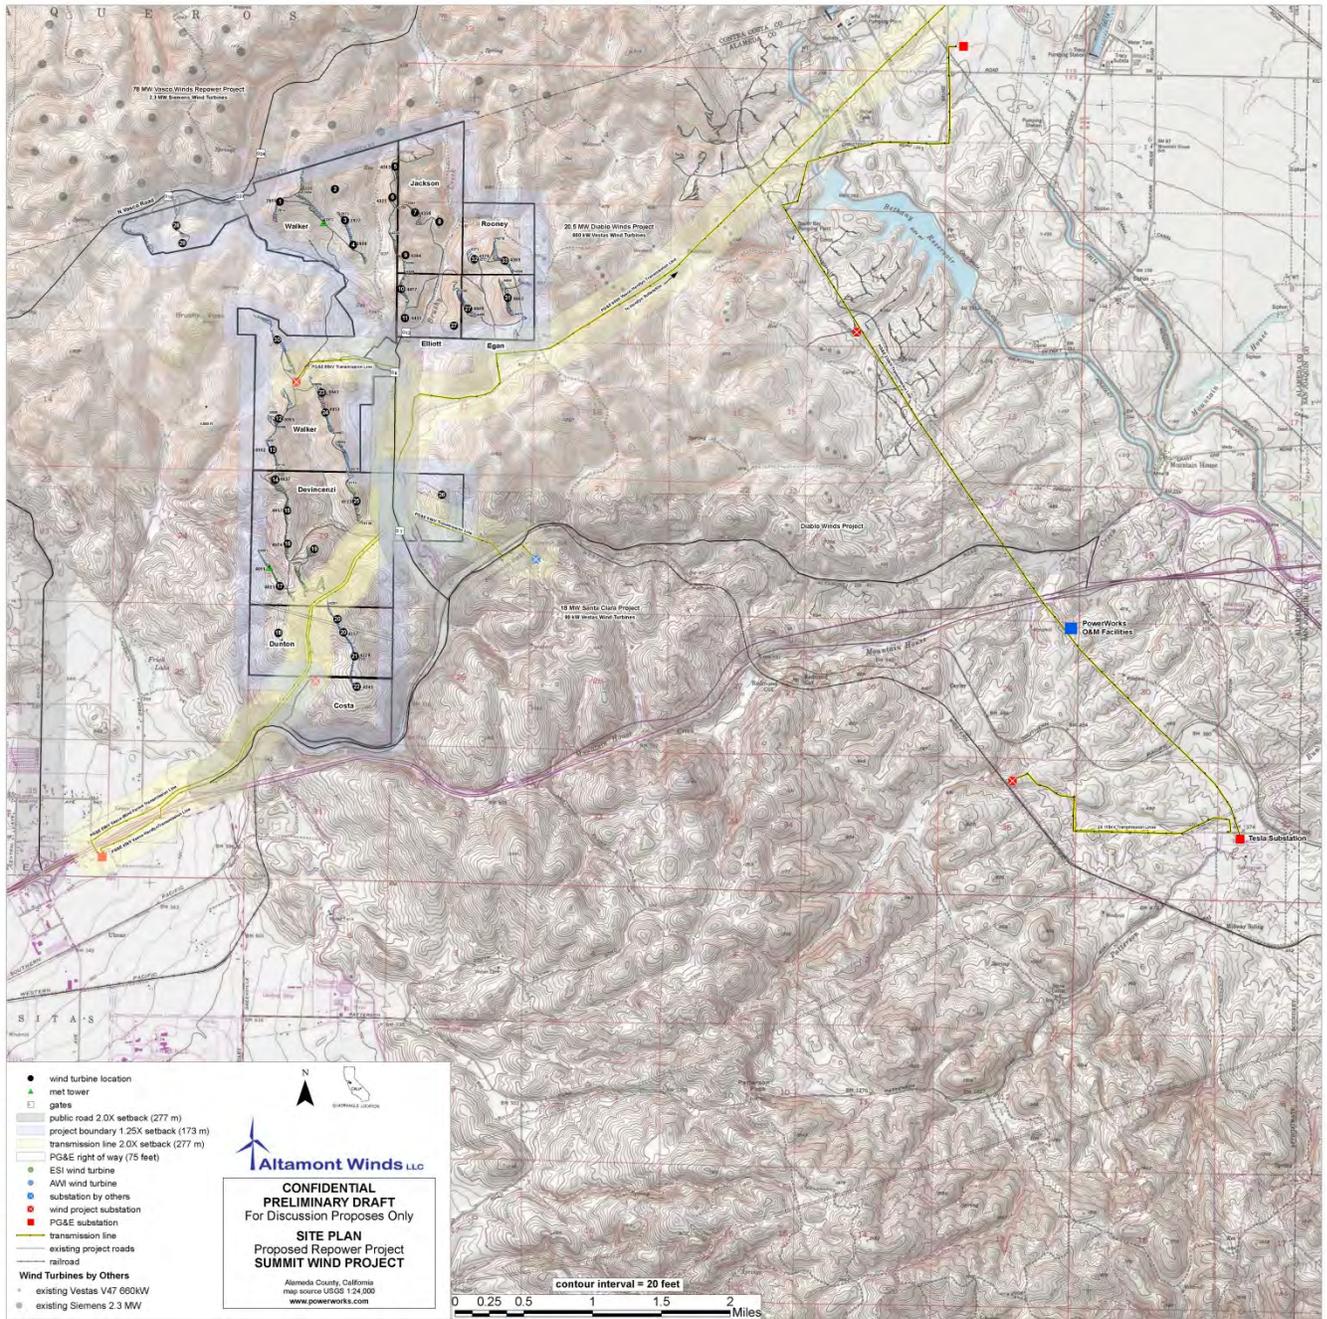
EXHIBIT 1: Site Plan

Table 1. Early assessment of proposed wind turbine locations in the Summit Wind project, including hazard ratings and recommendations and comments on the proposed locations. I worked with several site plans as the project layout evolved, but the addresses below refer specifically to the layout of 7 April 2014, which is attached as an Exhibit below.

Address	Rating	Recommendation/Comment
1	7	Within slight break in slope/d/saddle. Move south 20 m.
2	7	Low on slope on east side of large hill
3	8	Knoll by often-used saddle. Move E-SE to max 30 m.
4	5	Gently declining ridgeline. Minimize cut in slope due grading.
5	7.5	Will cut slope of narrow ridge in between saddle (east) and NW concave slope (west). Move upslope 40 to 60 m.
6	7	Near major saddle, though on local crest
7	8	Catches southwest winds
8	7.5	Lower terrain; heavy eagle traffic through here.
9	7.5	Knoll between saddles at apices of concave slopes. Move to 4343 or 4340
10	5	Knoll, but low terrain
11	7	Low terrain near trees; likely problem for red-tailed hawks
12	8	N side of heavily used saddle. Move N to middle of peak.
13	8.5	N side of saddle. Intense eagle activity. Move N to peak.
14	7	Peak, but intense eagle activity here
15	7	Peak, but intense eagle activity here
16	6.5	Local ridge crest, but near major saddle.

17	9.5	Next to saddle that is intensely used by eagles.
18	7	Low terrain near break in slope
19	8.5	Peak downwind of major saddle. Intense traffic through here. All turbines removed from hill were rated 8.5 by SRC.
20	4	No issue.
Alt 20	7.5	Local peak within complex saddles. Move south to knoll.
21	6.5	Local peak between two saddles
22	4	No issue.
23	6.5	Slight grade; will cut into south side of slope
24	5	No issue.
25	5	No issue.
26	6	On peak, but near saddle. Move 20 m south.
Alt 27	8.5	Saddle. Move north to local ridge crest.
Alt 28	9	Break in slope. Move to bench nearer Vasco Rd.
Alt 29	7.5	Near break in slope. Move 10 m north to old pad.
Alt 30	8.5	Apex of SW concave slope and near rock formations and trees.
27	7	Peak, but intense eagle activity here
31	7	Peak, but intense eagle activity here
32	9.5	Low on declining east-west ridge, immediately west of north-south saddle crossing. Intense eagle use observed here.

33	9	Just west of saddle atop SW slope. Intense eagle traffic here.
