Admin Bldg Roof Replacement

Location: 1221 Oak Street, Oakland

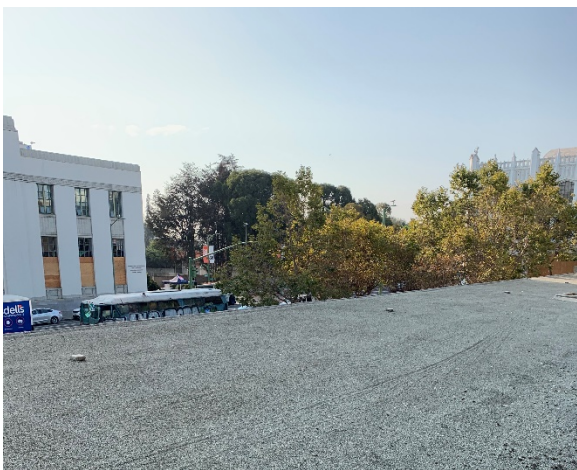
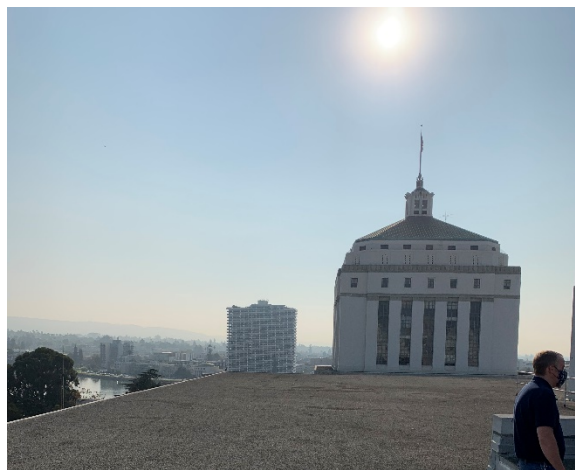
1. Upper and Entryway Gravel Roof

Solution Option: Restore

This is to install a restoration system over the upper roof section (not including skylight area) and lower entryway roof system. **This system comes with a 10 year warranty.**

1. Spud and remove all gravel from roof system.
2. Inspect roof and repair and splits, voids, blisters, etc. per manufacturer's requirements.
3. Power wash roof with TSP and water solution.
4. Prime roof with Garla-Prime VOC.
5. Apply Weatherscreen at 8 gallons per 100 square feet.
6. Immediately embed 400lbs of gravel per 100 square feet.
7. Install new .040 aluminum edge metal and counter flashing.
8. Provide an add alt for Tuff-Coat application along upper penthouse walls and entryway stairwell.
9. Install caulking and silicone emulsion sealant along copingstone and wall connection.

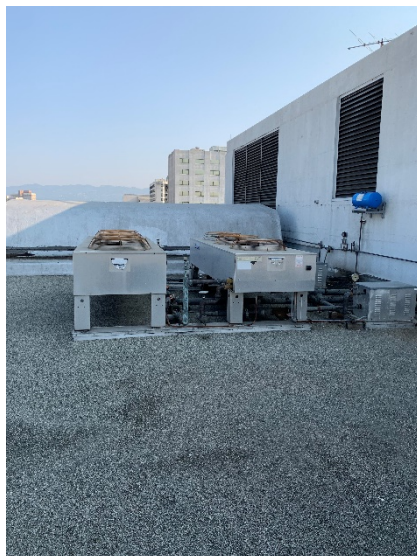
2. Skylight roof section

Solution Option: Replace

1. Remove and dispose of all roofing and edge metal down to structural deck and bare concrete on skylight areas.
2. Inspect deck and perform any repairs as needed.
3. Install insulation and crickets as needed to prevent ponding water and meet energy code requirements. (core testing needed to verify)
4. Install 6 sided 1/2" Asphalt coated wood fiberboard.
5. Install Flexbase 80 in GreenLock Membrane adhesive.
6. Install KEE-STONE FB 60mil membrane in Kee-Lock foam adhesive.
7. Apply Tuff-Coat to all remaining exposed skylight area concrete and roof step up area concrete/stucco.
8. Install new .040 aluminum counter flashing and edge metal.

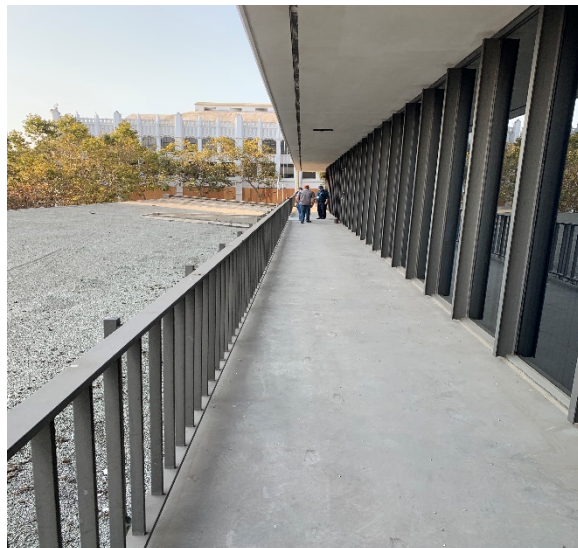
3. Install a new Dura-Walk Pedestrian coating system

- This system has an odor and may need to be performed on weekends due to occupancy odor tolerance.
- **The existing material is hot** or significant measures are required to prevent dust/debris from getting on sidewalk the budget could be significantly higher.

1. Prep walkway by grinding or bead blasting the deck so it is free of existing coating and reaches a CSP 2 or CSP profile. Approximate dimensions are L= 500Ft W=6Ft. **Membrane/Felt – Fire Walk, contains 40% Chrysotile asbestos**
2. Apply Dura-Walk Primer.
3. Apply Dura-Walk Base Coat.
4. Apply Dura-Walk Wear Coat and broadcast desired aggregate.
5. Apply Dura-Walk Top Coat.
6. Follow Dura-Walk application guidelines for all details and installation methods.
