EXHIBIT B - FCA

To whom it may concern:

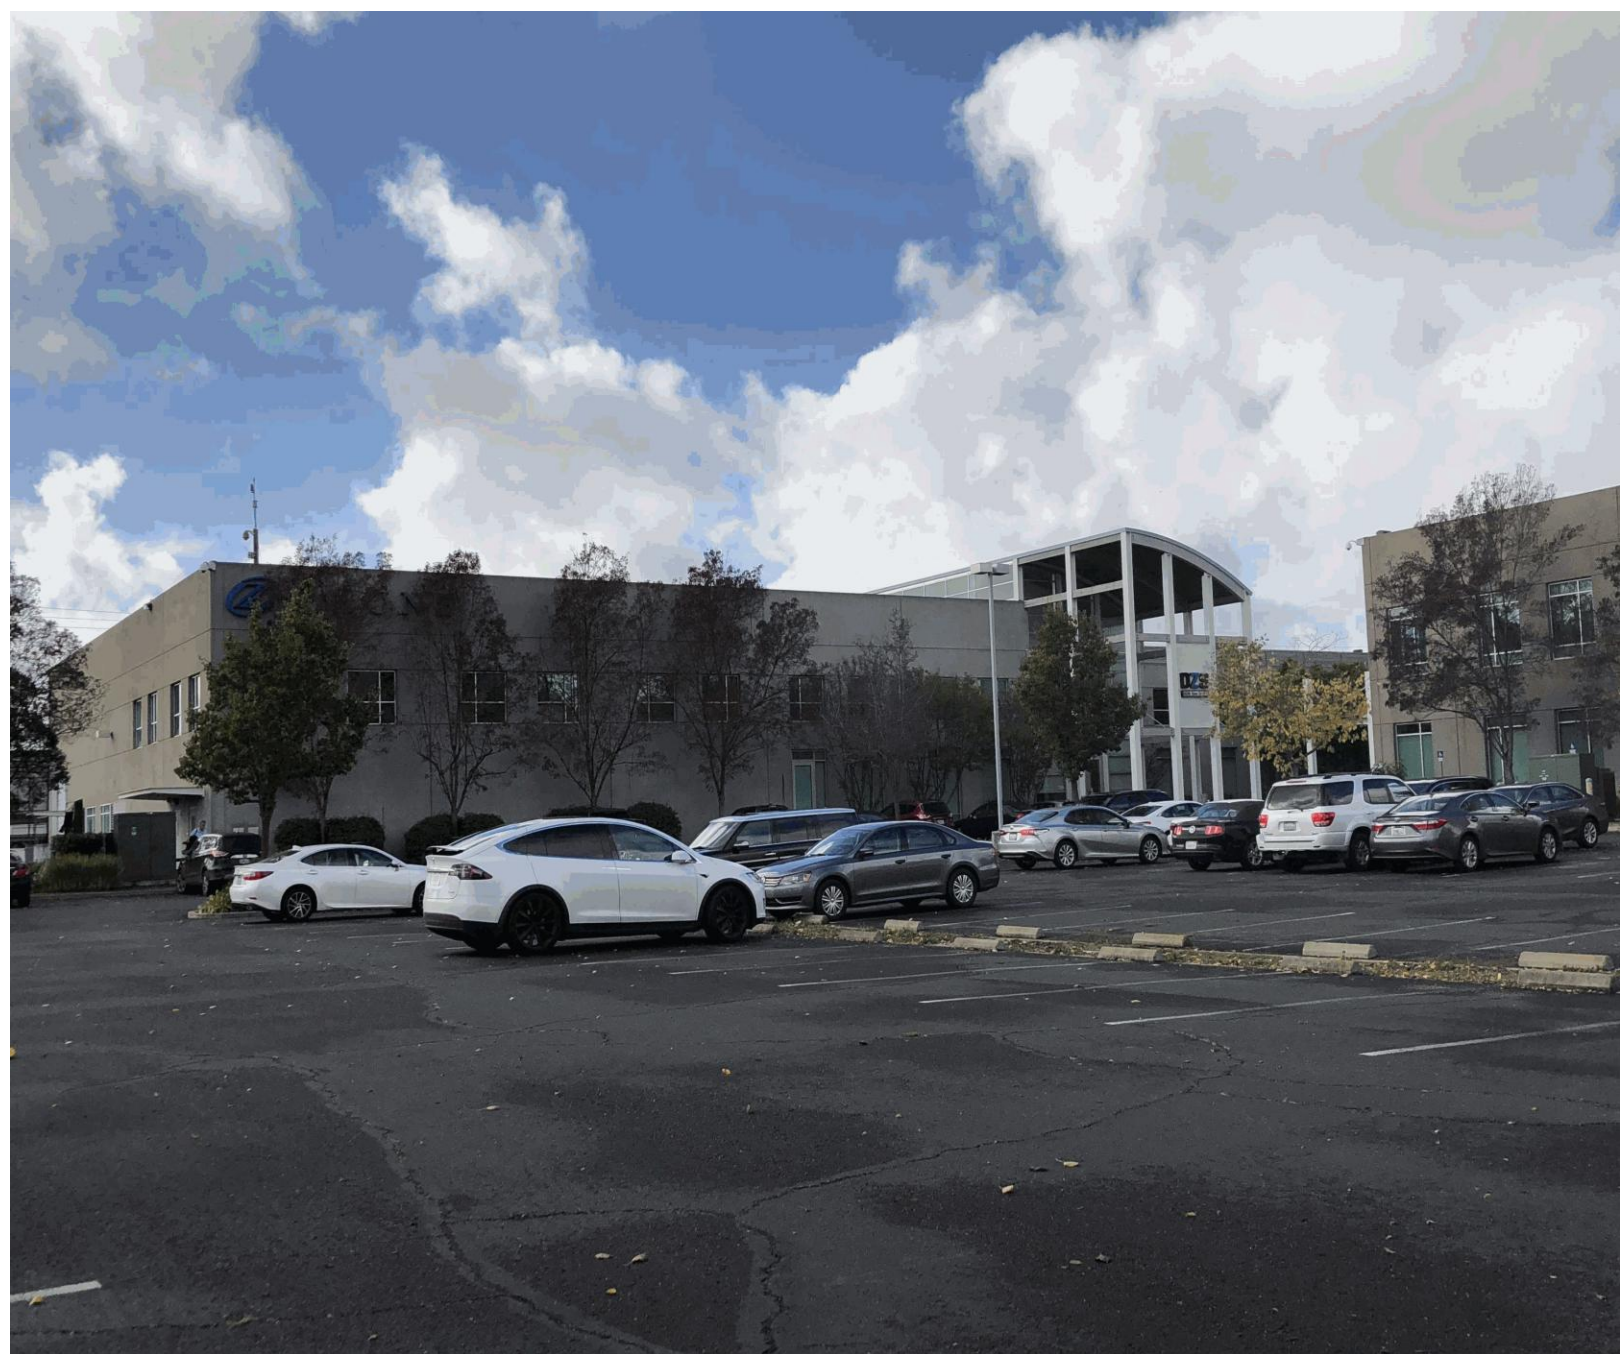
2018 FACILITY CONDITION ASSESSMENT

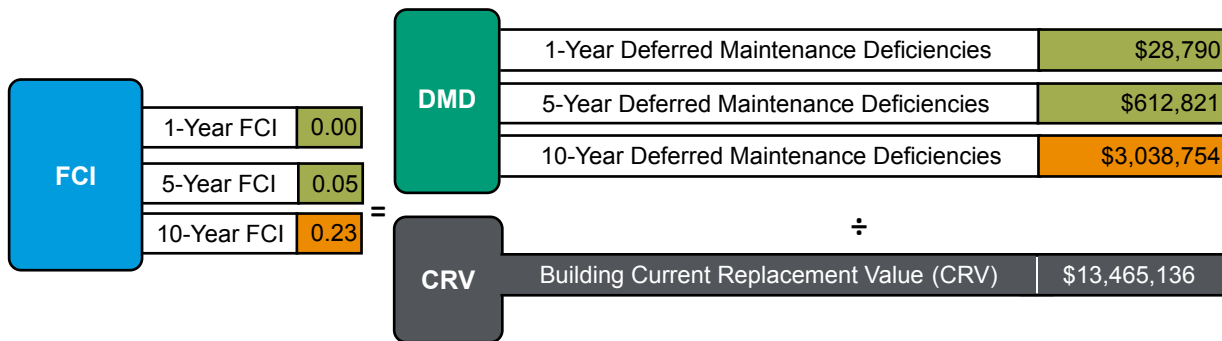
Discipline Condition Index (DCI) and System Condition Index (SCI) Ranking Scales: A similar scale to the Facility Condition Index scale is used in describing SCI and DCI. The two major differences between the FCI scale and the DCI / SCI scale shown below is that the "Divest" ranking has been omitted, and the "Critical" score has been expanded to 1.00. The reason for these changes is to illustrate that an asset's systems or disciplines cannot be divested. They usually require full replacement to enable the asset to function as originally designed and intended.

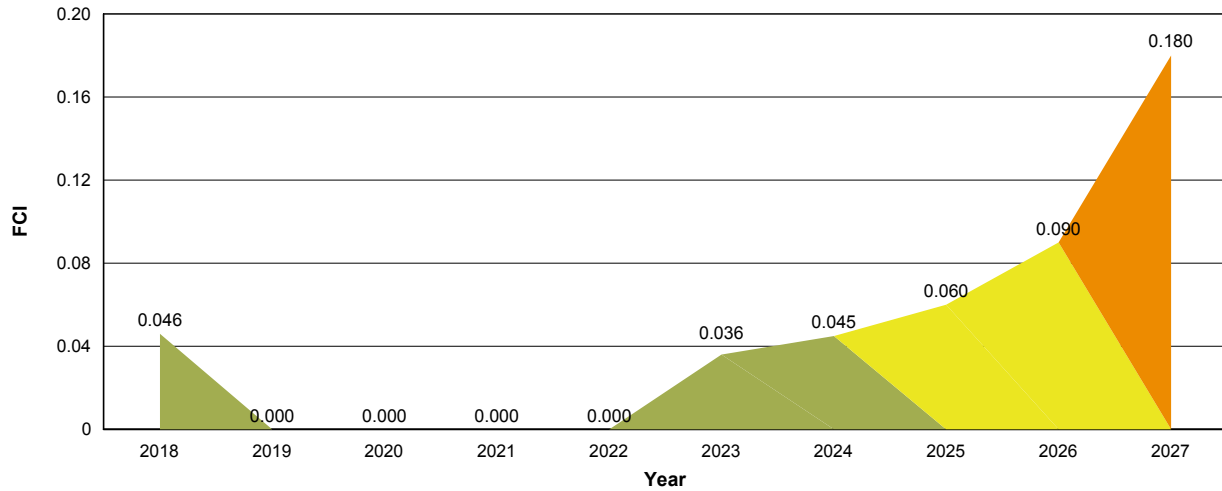
FUTURE STATE - DO NOTHING:

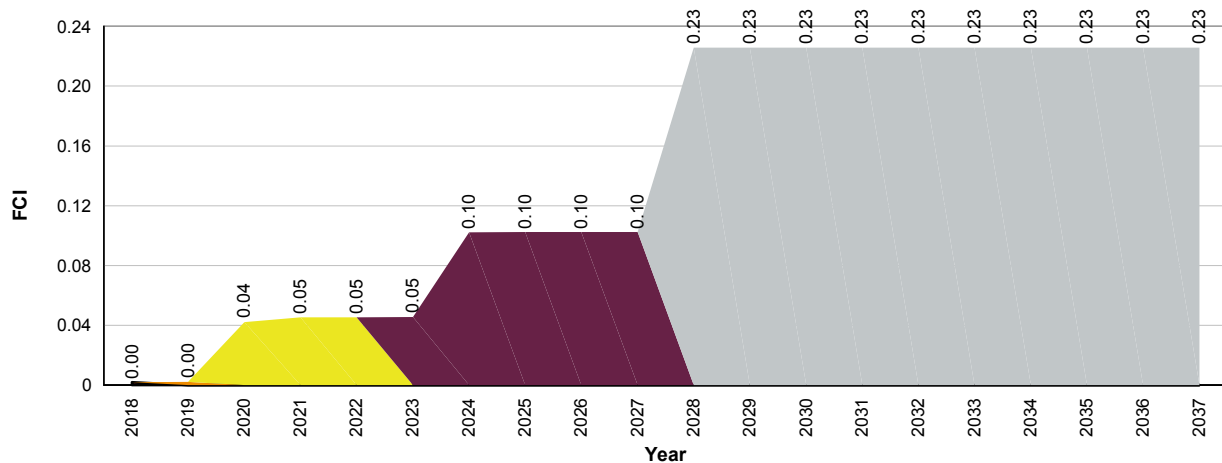
Projected Growth Of Funding Needs Over Time

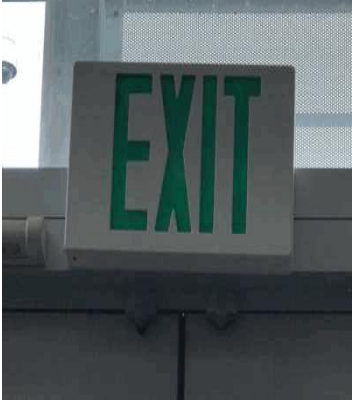
<p>FOScore #: 493495 Uniformat Name: D5040 - Exit Signs Category: Code Compliance - Life Safety Location: Entire Building Area Served: Entire Building Observed Remaining Life: 1 year(s) Act By: 2020 Action Timeframe: 1 year(s) Reference Life (BOMA): 30 year(s)</p>
		<p><u>Description:</u> The building has exit lights with green letters on a white background with battery backup.</p> <p><u>Critical Issues:</u> Some exit signs are inoperable.</p> <p><u>Recommendations:</u> Recommend that a survey be conducted to test all exit sign and replace or repair as needed. Cost is for testing with minimal replacement only.</p> <p><u>Repair Factor:</u> 100%</p> <p style="text-align: right;">Pricing Unit: 5 EA Cost: \$2,763</p>

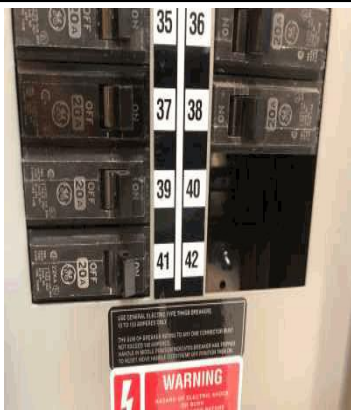
FOScore #: 493498
Uniformat Name: D5020 - Electrical Service And Distribution
Category: Code Compliance - Life Safety
Location: Entire Building
Area Served: Entire Building
Observed Remaining Life: 0 year(s)
Act By: 2020
Action Timeframe: 1 year(s)
Reference Life (BOMA): 30 year(s)

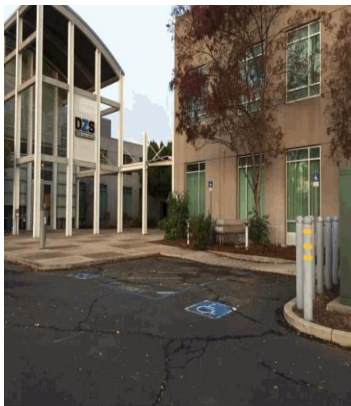
FOScore #: 489144
Uniformat Name: H2010 - ADA Assessments
Category: Code Compliance - ADA/Accessibility
Location: Building Exterior
Area Served: Partial building exterior
Observed Remaining Life: 2 year(s)
Act By: 2021
Action Timeframe: 2 year(s)
Reference Life (BOMA): 75 year(s)

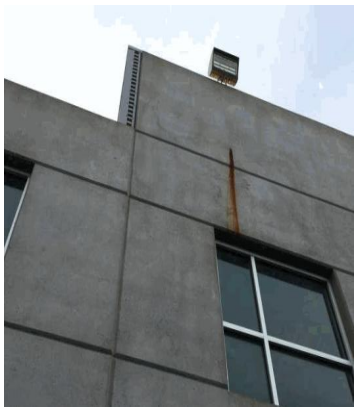
FOScore #: 489155
Uniformat Name: B2010 - Exterior Walls
Category: Building Integrity - Appearance
Location: Building Exterior
Area Served: Partial building exterior
Observed Remaining Life: 2 year(s)
Act By: 2021
Action Timeframe: 2 year(s)
Reference Life (BOMA): 50 year(s)

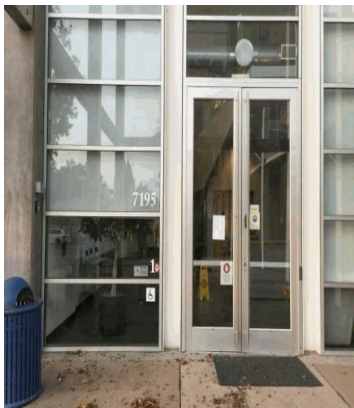
FOScore #: 489208
Uniformat Name: B2020 - Storefronts
Category: Environmental - Energy Conservation Opportunity
Location: Building Exterior
Area Served: Partial exterior shell of building
Observed Remaining Life: 2 year(s)
Act By: 2021
Action Timeframe: 2 year(s)
Reference Life (BOMA): 30 year(s)

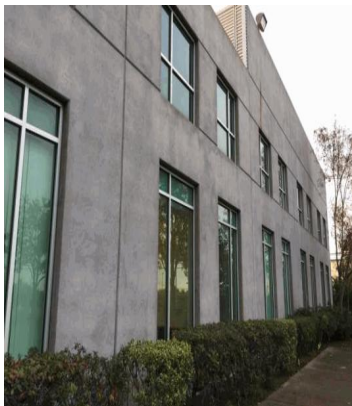
FOScore #: 489210
Uniformat Name: B2020 - Exterior Windows
Category: Environmental - Energy Conservation Opportunity
Location: Building Exterior
Area Served: Partial exterior shell of building
Observed Remaining Life: 2 year(s)
Act By: 2021
Action Timeframe: 2 year(s)
Reference Life (BOMA): 30 year(s)

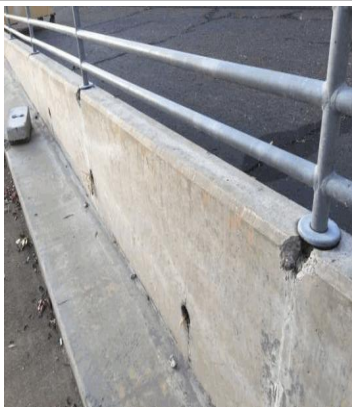
FOScore #: 489215
Uniformat Name: G2030 - Exterior Concrete Ramps
Category: Building Integrity - Construction Deficiency
Location: Building Exterior
Area Served:
Observed Remaining Life: 2 year(s)
Act By: 2021
Action Timeframe: 2 year(s)
Reference Life (BOMA): 75 year(s)

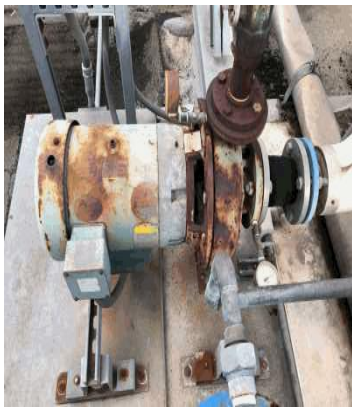
FOScore #: 493845
Uniformat Name: D3050 - Hot Water Pumps- 0 to 10 HP
Category: Building Integrity - Reliability
Location: Roof
Area Served: Entire Building
Observed Remaining Life: 2 year(s)
Act By: 2021
Action Timeframe: 2 year(s)
Reference Life (BOMA): 25 year(s)

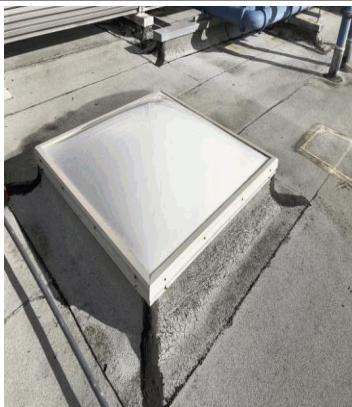
FOScore #: 525400
Uniformat Name: B3060 - Skylights
Category: Building Integrity - Reliability
Location: Roof
Area Served: Roof
Observed Remaining Life: 10 year(s)
Act By: 2021
Action Timeframe: 2 year(s)
Reference Life (BOMA): 25 year(s)

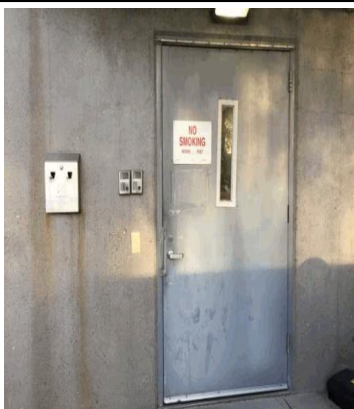
FOScore #: 489170
Uniformat Name: B2050 - Exterior Doors And Grilles
Category: Building Integrity - Appearance
Location: Building Exterior
Area Served: Partial building exterior
Observed Remaining Life: 3 year(s)
Act By: 2022
Action Timeframe: 3 year(s)
Reference Life (BOMA): 15 year(s)

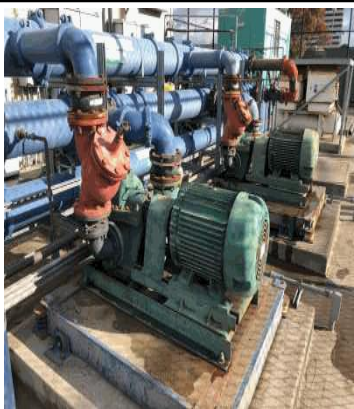
FOScore #: 493849
Uniformat Name: D3050 - Chilled Water Pumps- 11 TO 50 HP
Category: Building Integrity - Reliability
Location: Building Exterior
Area Served: Entire Building
Observed Remaining Life: 11 year(s)
Act By: 2022
Action Timeframe: 3 year(s)
Reference Life (BOMA): 25 year(s)

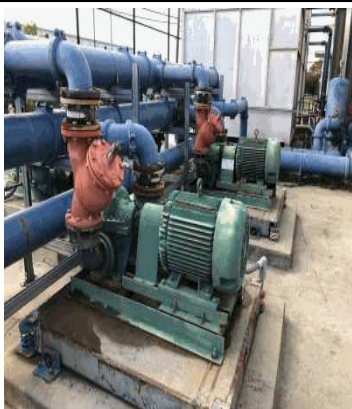
FOScore #: 493851
Uniformat Name: D3050 - Condenser Water Pumps- 11 TO 50 HP
Category: Building Integrity - Reliability
Location: Building Exterior
Area Served: Entire Building
Observed Remaining Life: 11 year(s)
Act By: 2022
Action Timeframe: 3 year(s)
Reference Life (BOMA): 25 year(s)

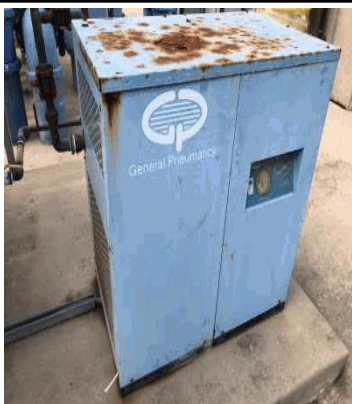
FOScore #: 493853
Uniformat Name: D2060 - Air Compressors - Duplex
Category: Building Integrity - Reliability
Location: Building Exterior
Area Served: Entire Building
Observed Remaining Life: 5 year(s)
Act By: 2022
Action Timeframe: 3 year(s)
Reference Life (BOMA): 15 year(s)

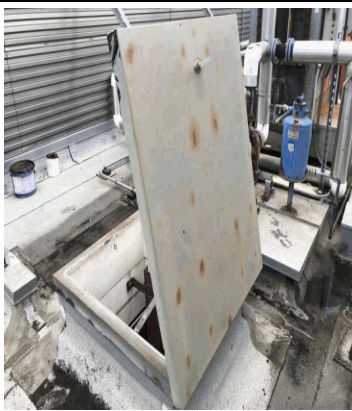
FOScore #: 525345
Uniformat Name: B3060 - Roof Hatches
Category: Building Integrity - Reliability
Location: Roof
Area Served: Roof
Observed Remaining Life: 20 year(s)
Act By: 2024
Action Timeframe: 5 year(s)
Reference Life (BOMA): 75 year(s)

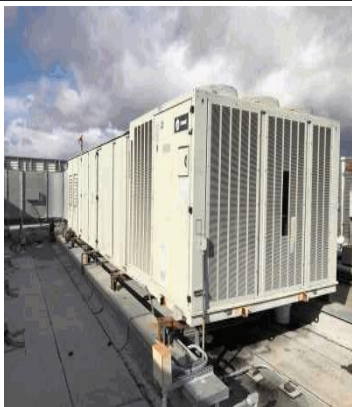
FOScore #: 493838
Uniformat Name: D3060 - Packaged DX Air-Conditioning Units- 6 to 50 TON
Category: Building Integrity - Reliability
Location: Roof
Area Served: Entire Building
Observed Remaining Life: 6 year(s)
Act By: 2025
Action Timeframe: 6 year(s)
Reference Life (BOMA): 15 year(s)

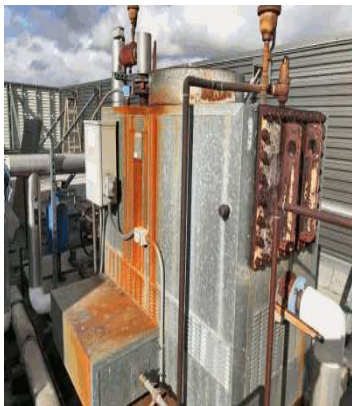
FOScore #: 493846
Uniformat Name: D3020 - Fuel-Fired Heating Boilers - 501 to 1750 MBH
Category: Building Integrity - Reliability
Location: Roof
Area Served: Entire Building
Observed Remaining Life: 16 year(s)
Act By: 2025
Action Timeframe: 6 year(s)
Reference Life (BOMA): 30 year(s)

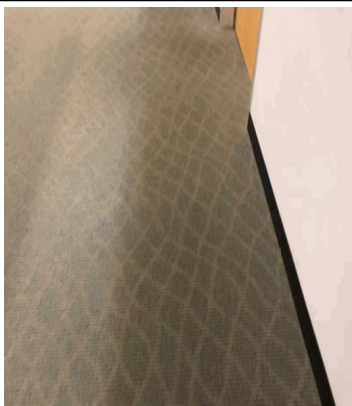
FOScore #: 525211
Uniformat Name: C2030 - Sheet Carpeting
Category: Building Integrity - Appearance
Location: 1st Floor
Area Served: Open office areas, office spaces, training space
Observed Remaining Life: 6 year(s)
Act By: 2025
Action Timeframe: 6 year(s)
Reference Life (BOMA): 5 year(s)

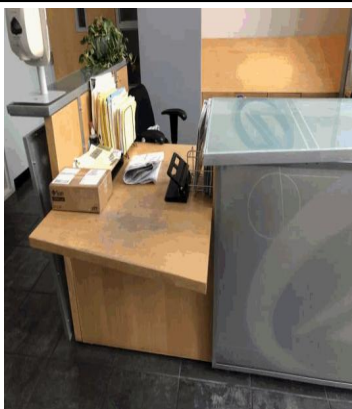
FOScore #: 525276
Uniformat Name: E2010 - Wood Veneer Countertops
Category: Building Integrity - Appearance
Location: 1st Floor
Area Served: Receptionist Desk
Observed Remaining Life: 7 year(s)
Act By: 2026
Action Timeframe: 7 year(s)
Reference Life (BOMA): 10 year(s)

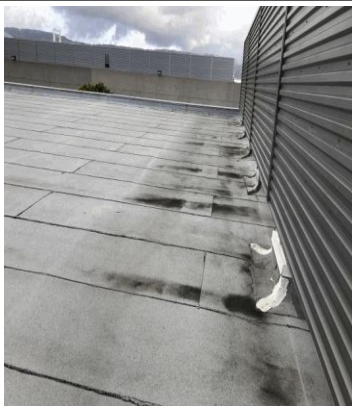
FOScore #: 525287
Uniformat Name: B3010 - Roofing - Unprotected Membrane
Category: Building Integrity - Reliability
Location: Roof
Area Served: Roof
Observed Remaining Life: 10 year(s)
Act By: 2029
Action Timeframe: 10 year(s)
Reference Life (BOMA): 20 year(s)

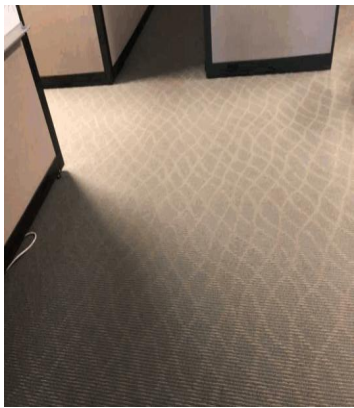
FOScore #: 525367
Uniformat Name: C2030 - Sheet Carpeting
Category: Building Integrity - Appearance
Location: Mezzanine
Area Served: Open office areas, office spaces
Observed Remaining Life: 6 year(s)
Act By: 2025
Action Timeframe: 6 year(s)
Reference Life (BOMA): 5 year(s)

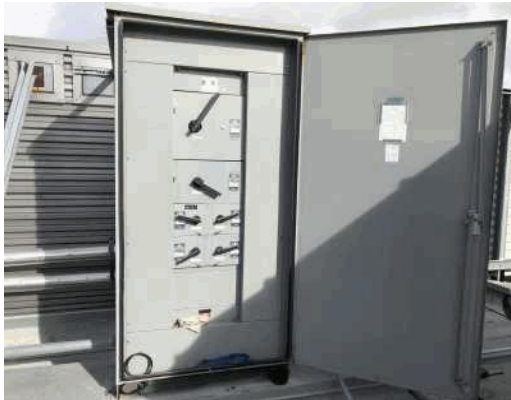
Item #: 493479
Uniformat Number: D5020
Item Title: Electrical Arc Flash Hazard Analysis and Short Circuit Coordination
Caption: Equipment not labeled with required safety information
Priority: 1 - Currently Critical

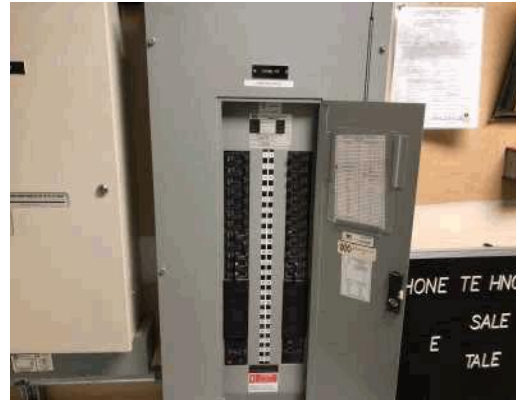
Item #: 493479
Uniformat Number: D5020
Item Title: Electrical Arc Flash Hazard Analysis and Short Circuit Coordination
Caption: Equipment not labeled with required safety information
Priority: 1 - Currently Critical

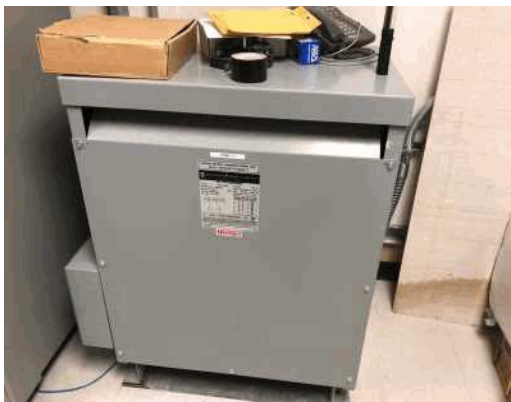
Item #: 493479
Uniformat Number: D5020
Item Title: Electrical Arc Flash Hazard Analysis and Short Circuit Coordination
Caption: Equipment not labeled with required safety information
Priority: 1 - Currently Critical

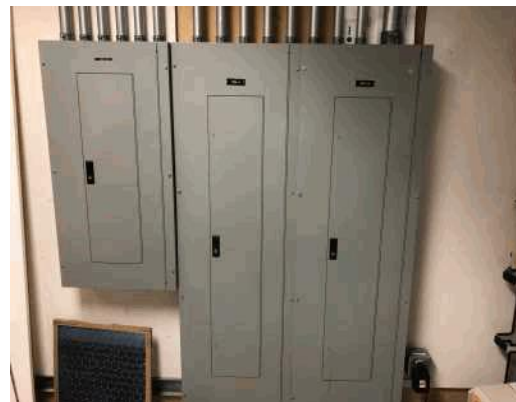
Item #: 493479
Uniformat Number: D5020
Item Title: Electrical Arc Flash Hazard Analysis and Short Circuit Coordination
Caption: Equipment not labeled with required safety information
Priority: 1 - Currently Critical

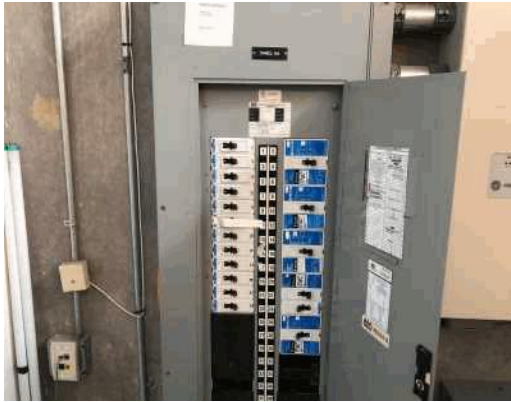
Item #: 493479
 Uniformat Number: D5020
 Item Title: Electrical Arc Flash Hazard Analysis and Short Circuit Coordination
 Caption: Equipment not labeled with required safety information
 Priority: 1 - Currently Critical

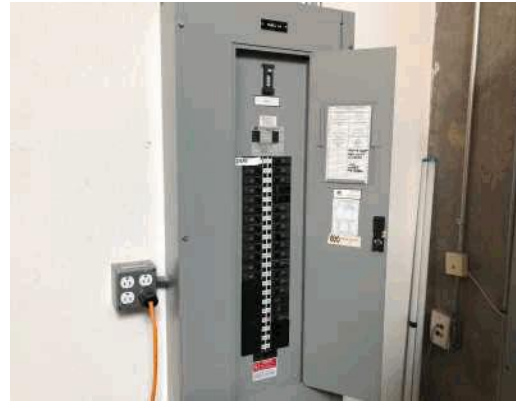
Item #: 493479
 Uniformat Number: D5020
 Item Title: Electrical Arc Flash Hazard Analysis and Short Circuit Coordination
 Caption: Equipment not labeled with required safety information
 Priority: 1 - Currently Critical

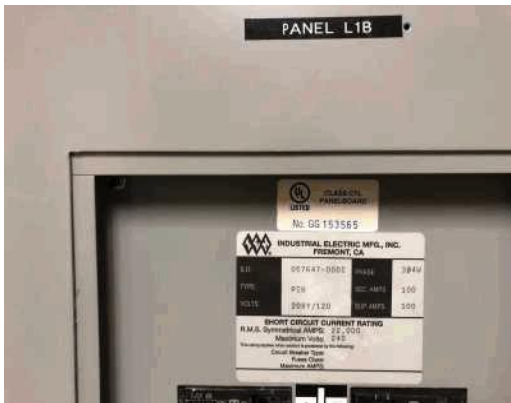
Item #: 493498
 Uniformat Number: D5020
 Item Title: Electrical Service And Distribution
 Caption: Panel L1B
 Priority: 1 - Currently Critical

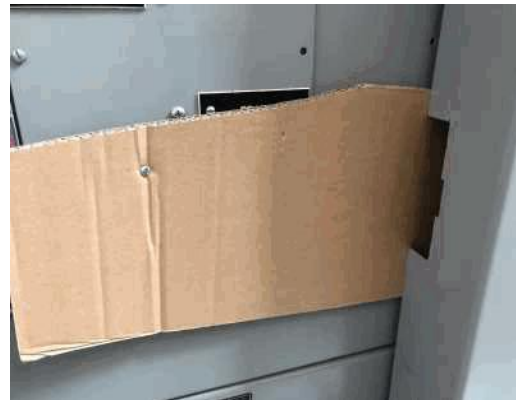
Item #: 493498
Uniformat Number: D5020
Item Title: Electrical Service And Distribution
Caption: Missing dead front
Priority: 1 - Currently Critical

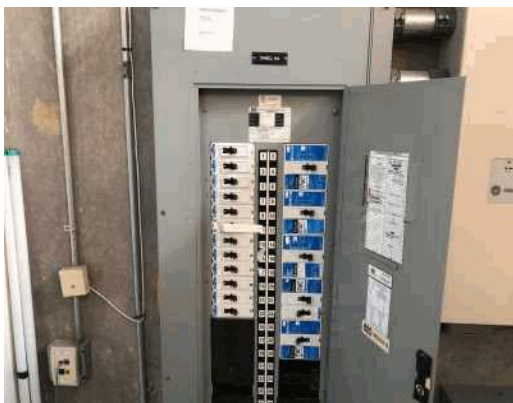
Item #: 493498
Uniformat Number: D5020
Item Title: Electrical Service And Distribution
Caption: Panel HA
Priority: 1 - Currently Critical

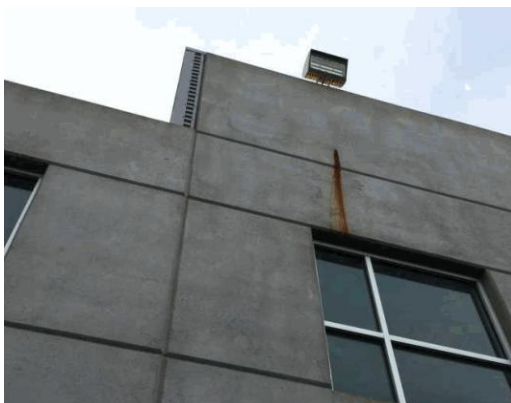
Item #: 489155
Uniformat Number: B2010
Item Title: Exterior Walls
Caption: Corrosion at exterior wall
Priority: 2 - Potentially Critical

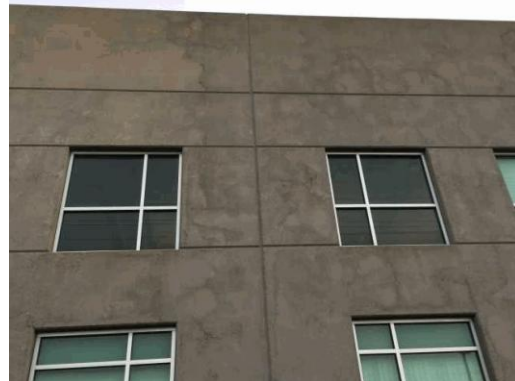
Item #: 489155
Uniformat Number: B2010
Item Title: Exterior Walls
Caption: Cracking in concrete walls
Priority: 2 - Potentially Critical

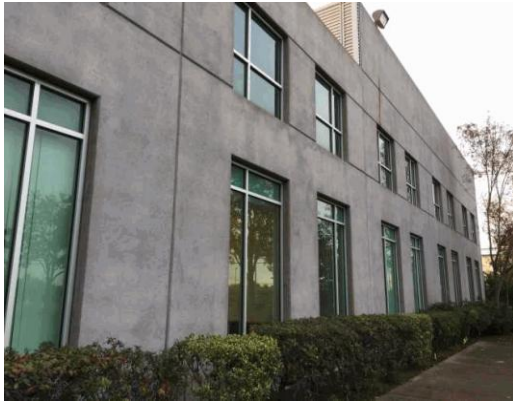
Item #: 489210
Uniformat Number: B2020
Item Title: Exterior Windows
Caption: Energy inefficient single pane glazing assemblies observed
Priority: 2 - Potentially Critical

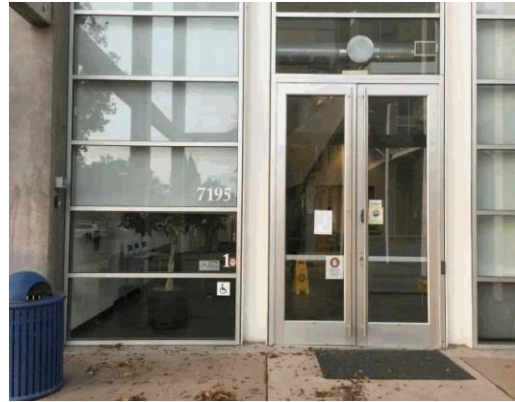
Item #: 489208
Uniformat Number: B2020
Item Title: Storefronts
Caption: Energy inefficient single pane glazing assemblies observed
Priority: 2 - Potentially Critical

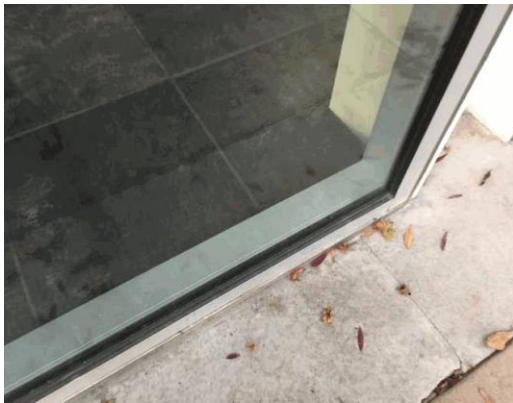
Item #: 489208
Uniformat Number: B2020
Item Title: Storefronts
Caption: Energy inefficient single pane glazing assemblies observed
Priority: 2 - Potentially Critical

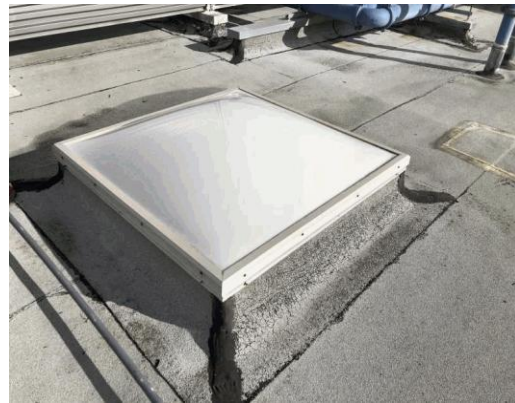
Item #: 525400
Uniformat Number: B3060
Item Title: Skylights
Caption: Skylights do not have fall protection
Priority: 2 - Potentially Critical

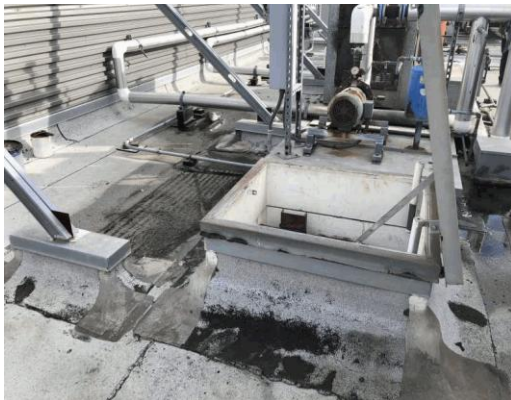
Item #: 525345
Uniformat Number: B3060
Item Title: Roof Hatches
Caption: Roof hatch finish is deteriorating. Surface rust was observed. Roof hatch is missing railing
Priority: 3 - Necessary - Not Yet Critical

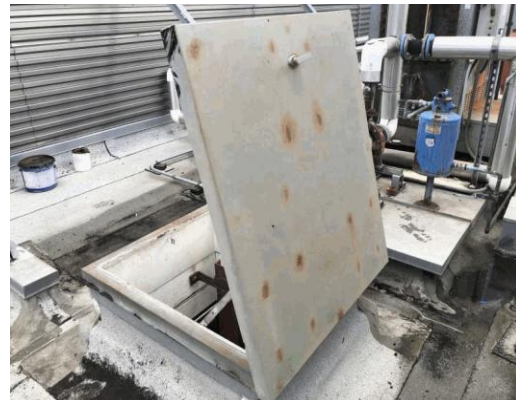
Item #: 525345
Uniformat Number: B3060
Item Title: Roof Hatches
Caption: Roof hatch finish is deteriorating. Surface rust was observed. Roof hatch is missing railing
Priority: 3 - Necessary - Not Yet Critical

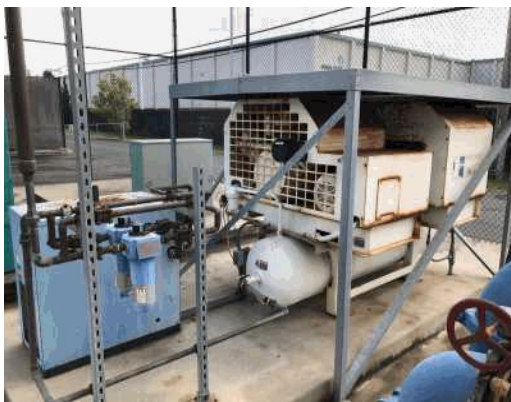
Item #: 493853
Uniformat Number: D2060
Item Title: Air Compressors - Duplex
Caption: Air compressor & air dryer
Priority: 3 - Necessary - Not Yet Critical

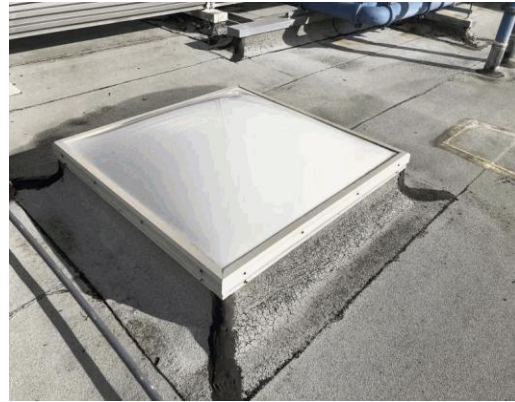
Item #: 525287
Uniformat Number: B3010
Item Title: Roofing - Unprotected Membrane
Caption: Roof membrane at roof curbs and parapets are beginning to crack & deteriorate.
Priority: 4 - Recommended

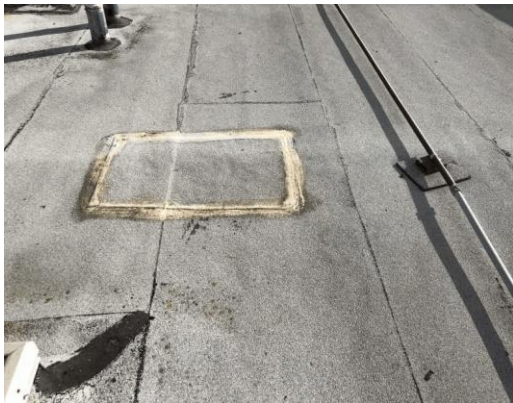
Item #: 525287
Uniformat Number: B3010
Item Title: Roofing - Unprotected Membrane
Caption: Numerous roof patches were observed
Priority: 4 - Recommended

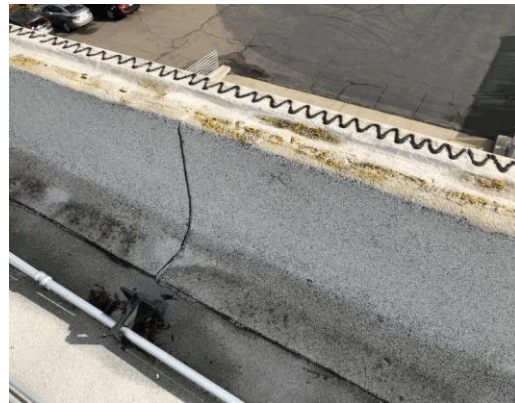
Item #: 525287
Uniformat Number: B3010
Item Title: Roofing - Unprotected Membrane
Caption: Roof membrane at roof curbs and parapets are beginning to crack & deteriorat
Priority: 4 - Recommended

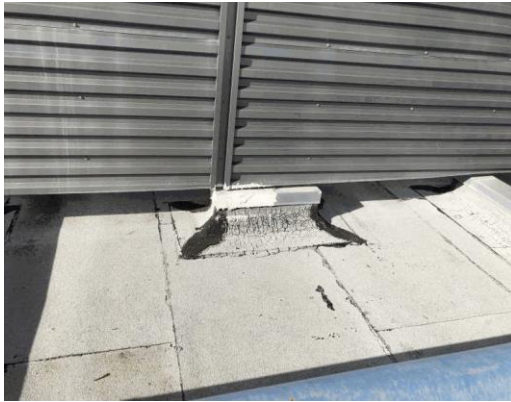
Item #: 525287
Uniformat Number: B3010
Item Title: Roofing - Unprotected Membrane
Caption: Roof membrane at roof curbs and parapets are beginning to crack & deteriorat
Priority: 4 - Recommended

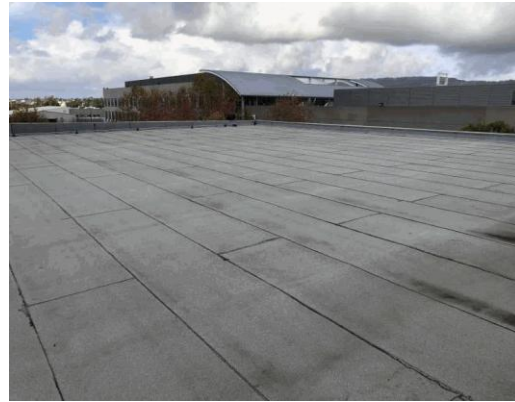
Item #: 525287
Uniformat Number: B3010
Item Title: Roofing - Unprotected Membrane
Caption: View of aging roof system
Priority: 4 - Recommended

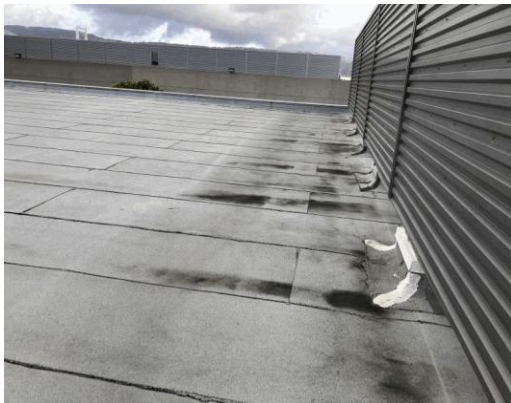
Item #: 525287
Uniformat Number: B3010
Item Title: Roofing - Unprotected Membrane
Caption: View of aging roof system
Priority: 4 - Recommended

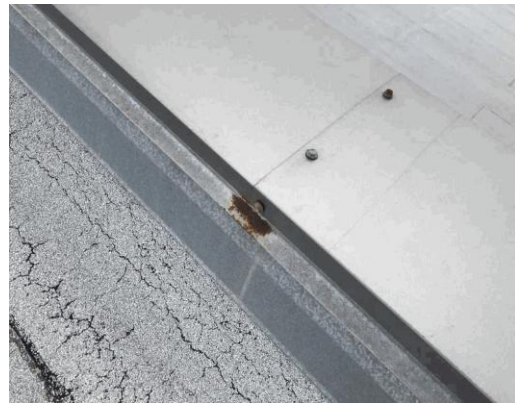
Item #: 525287
Uniformat Number: B3010
Item Title: Roofing - Unprotected Membrane
Caption: Galvanized caps and flashing is beginning to rust
Priority: 4 - Recommended

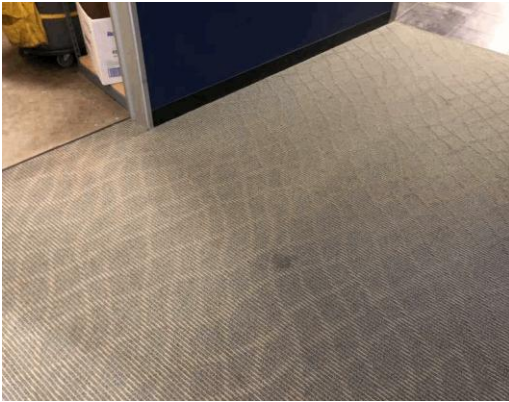
Item #: 525211
Uniformat Number: C2030
Item Title: Sheet Carpeting
Caption: Flooring is stained and showing signs of wear
Priority: 4 - Recommended

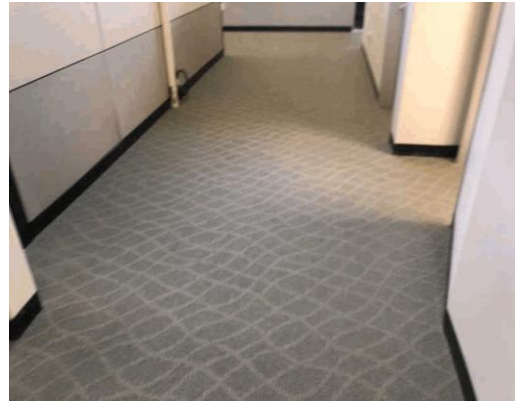
Item #: 525211
Uniformat Number: C2030
Item Title: Sheet Carpeting
Caption: Flooring is stained and showing signs of wear
Priority: 4 - Recommended

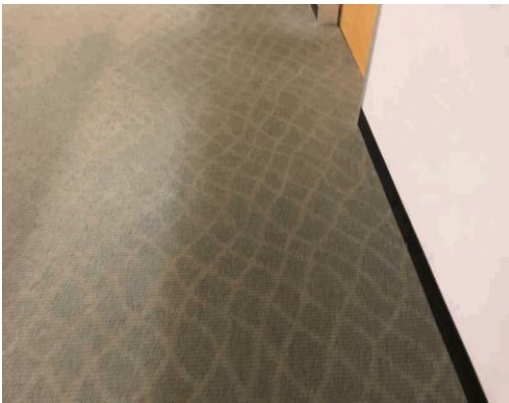
Item #: 525211
Uniformat Number: C2030
Item Title: Sheet Carpeting
Caption: Flooring is stained and showing signs of wear
Priority: 4 - Recommended

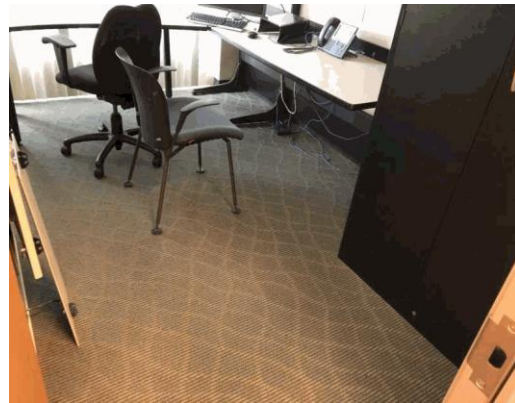
Item #: 525211
Uniformat Number: C2030
Item Title: Sheet Carpeting
Caption: Flooring is stained and showing signs of wear
Priority: 4 - Recommended

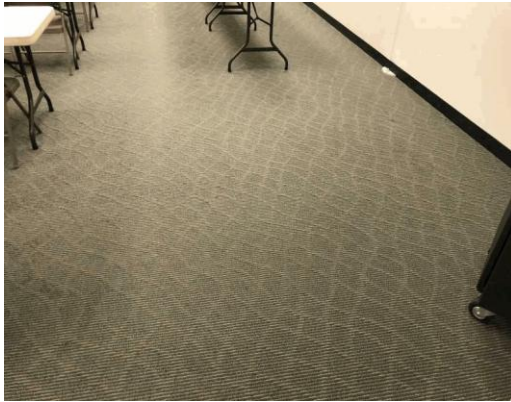
Item #: 525211
Uniformat Number: C2030
Item Title: Sheet Carpeting
Caption: Flooring is stained and showing signs of wear
Priority: 4 - Recommended

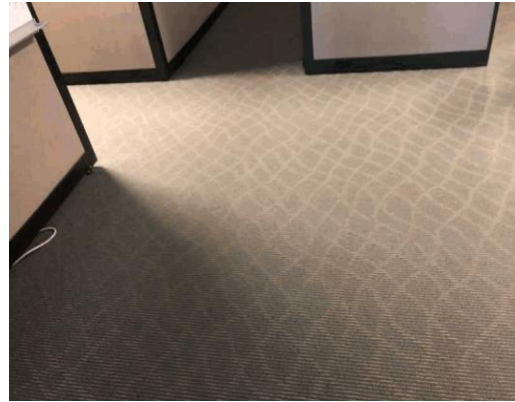
Item #: 525367
Uniformat Number: C2030
Item Title: Sheet Carpeting
Caption: Flooring is stained and showing signs of wear.
Priority: 4 - Recommended

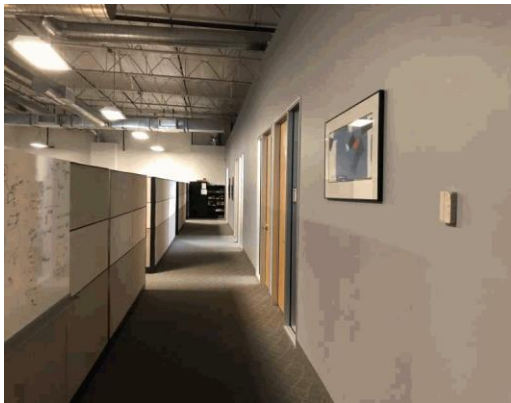
Item #: 525367
Uniformat Number: C2030
Item Title: Sheet Carpeting
Caption: Flooring is stained and showing signs of wear.
Priority: 4 - Recommended

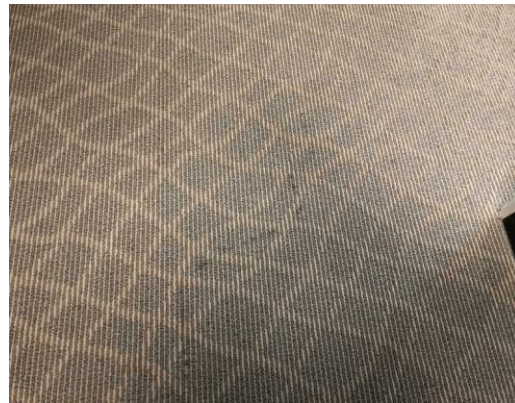
Item #: 525367
Uniformat Number: C2030
Item Title: Sheet Carpeting
Caption: Flooring is stained and showing signs of wear.
Priority: 4 - Recommended

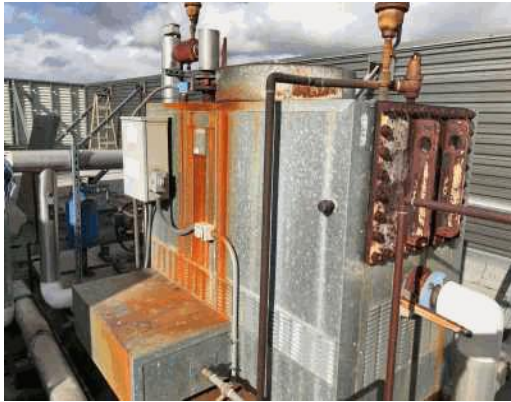
Item #: 493846
 Uniformat Number: D3020
 Item Title: Fuel-Fired Heating Boilers - 501 to 1750 MBH
 Caption: Hot water boiler
 Priority: 4 - Recommended

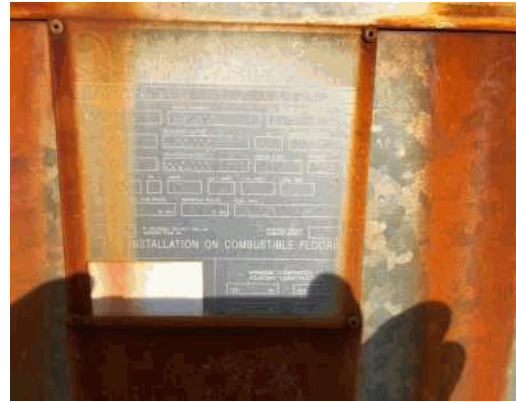
Item #: 493846
 Uniformat Number: D3020
 Item Title: Fuel-Fired Heating Boilers - 501 to 1750 MBH
 Caption: Hot water boiler nameplate
 Priority: 4 - Recommended

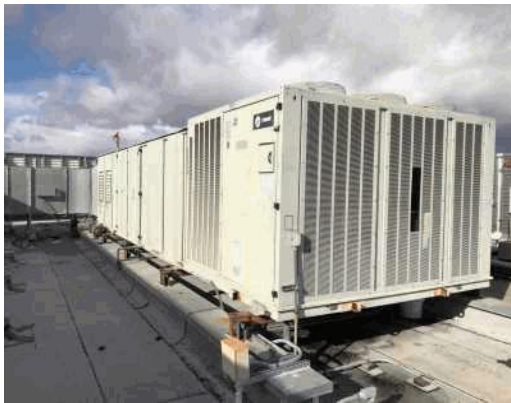
Item #: 493838
 Uniformat Number: D3060
 Item Title: Packaged DX Air-Conditioning Units- 6 to 50 TON
 Caption: 60 Ton A/C unit
 Priority: 4 - Recommended

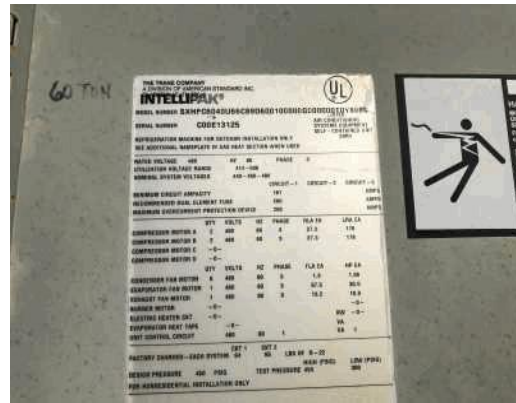
Item #: 493838
 Uniformat Number: D3060
 Item Title: Packaged DX Air-Conditioning Units- 6 to 50 TON
 Caption: 60 Ton A/C unit Nameplate
 Priority: 4 - Recommended

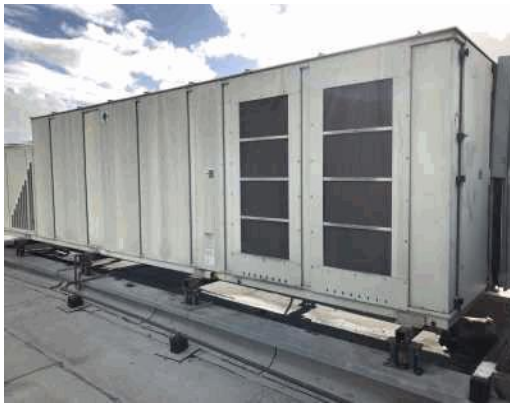
Item #: 493838
Uniformat Number: D3060
Item Title: Packaged DX Air-Conditioning Units- 6 to 50 TON
Caption: 50 Ton A/C unit
Priority: 4 - Recommended

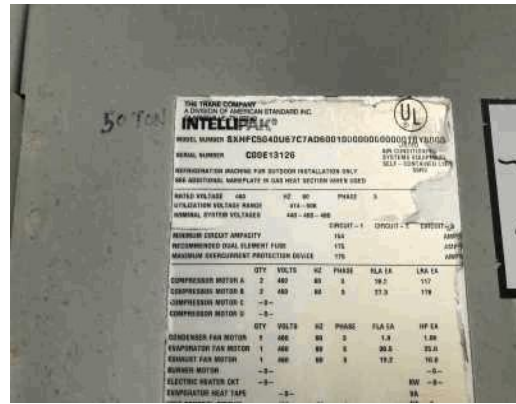
Item #: 493838
Uniformat Number: D3060
Item Title: Packaged DX Air-Conditioning Units- 6 to 50 TON
Caption: 50 Ton A/C unit Nameplate
Priority: 4 - Recommended

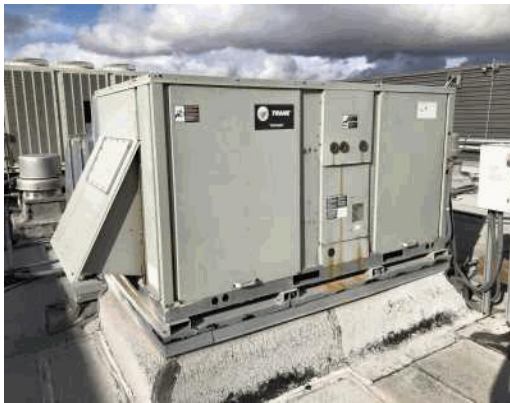
Item #: 493838
Uniformat Number: D3060
Item Title: Packaged DX Air-Conditioning Units- 6 to 50 TON
Caption: 10 Ton A/C unit
Priority: 4 - Recommended

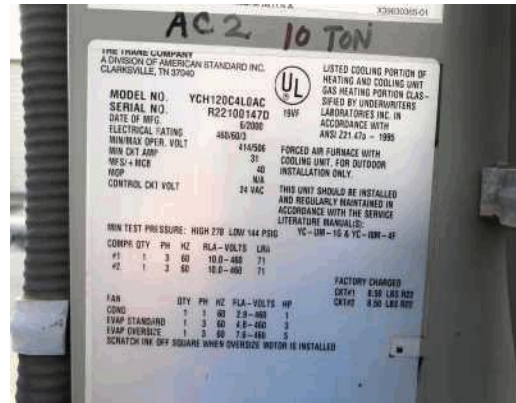
Item #: 493838
Uniformat Number: D3060
Item Title: Packaged DX Air-Conditioning Units- 6 to 50 TON
Caption: 10 Ton A/C unit Nameplate
Priority: 4 - Recommended

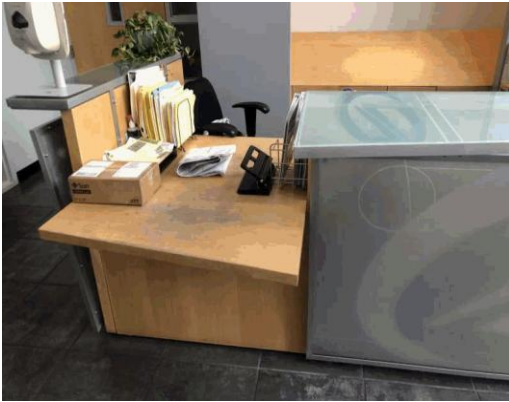
Item #: 525276
Uniformat Number: E2010
Item Title: Wood Veneer Countertops
Caption: Countertop is worn and scratched
Priority: 4 - Recommended

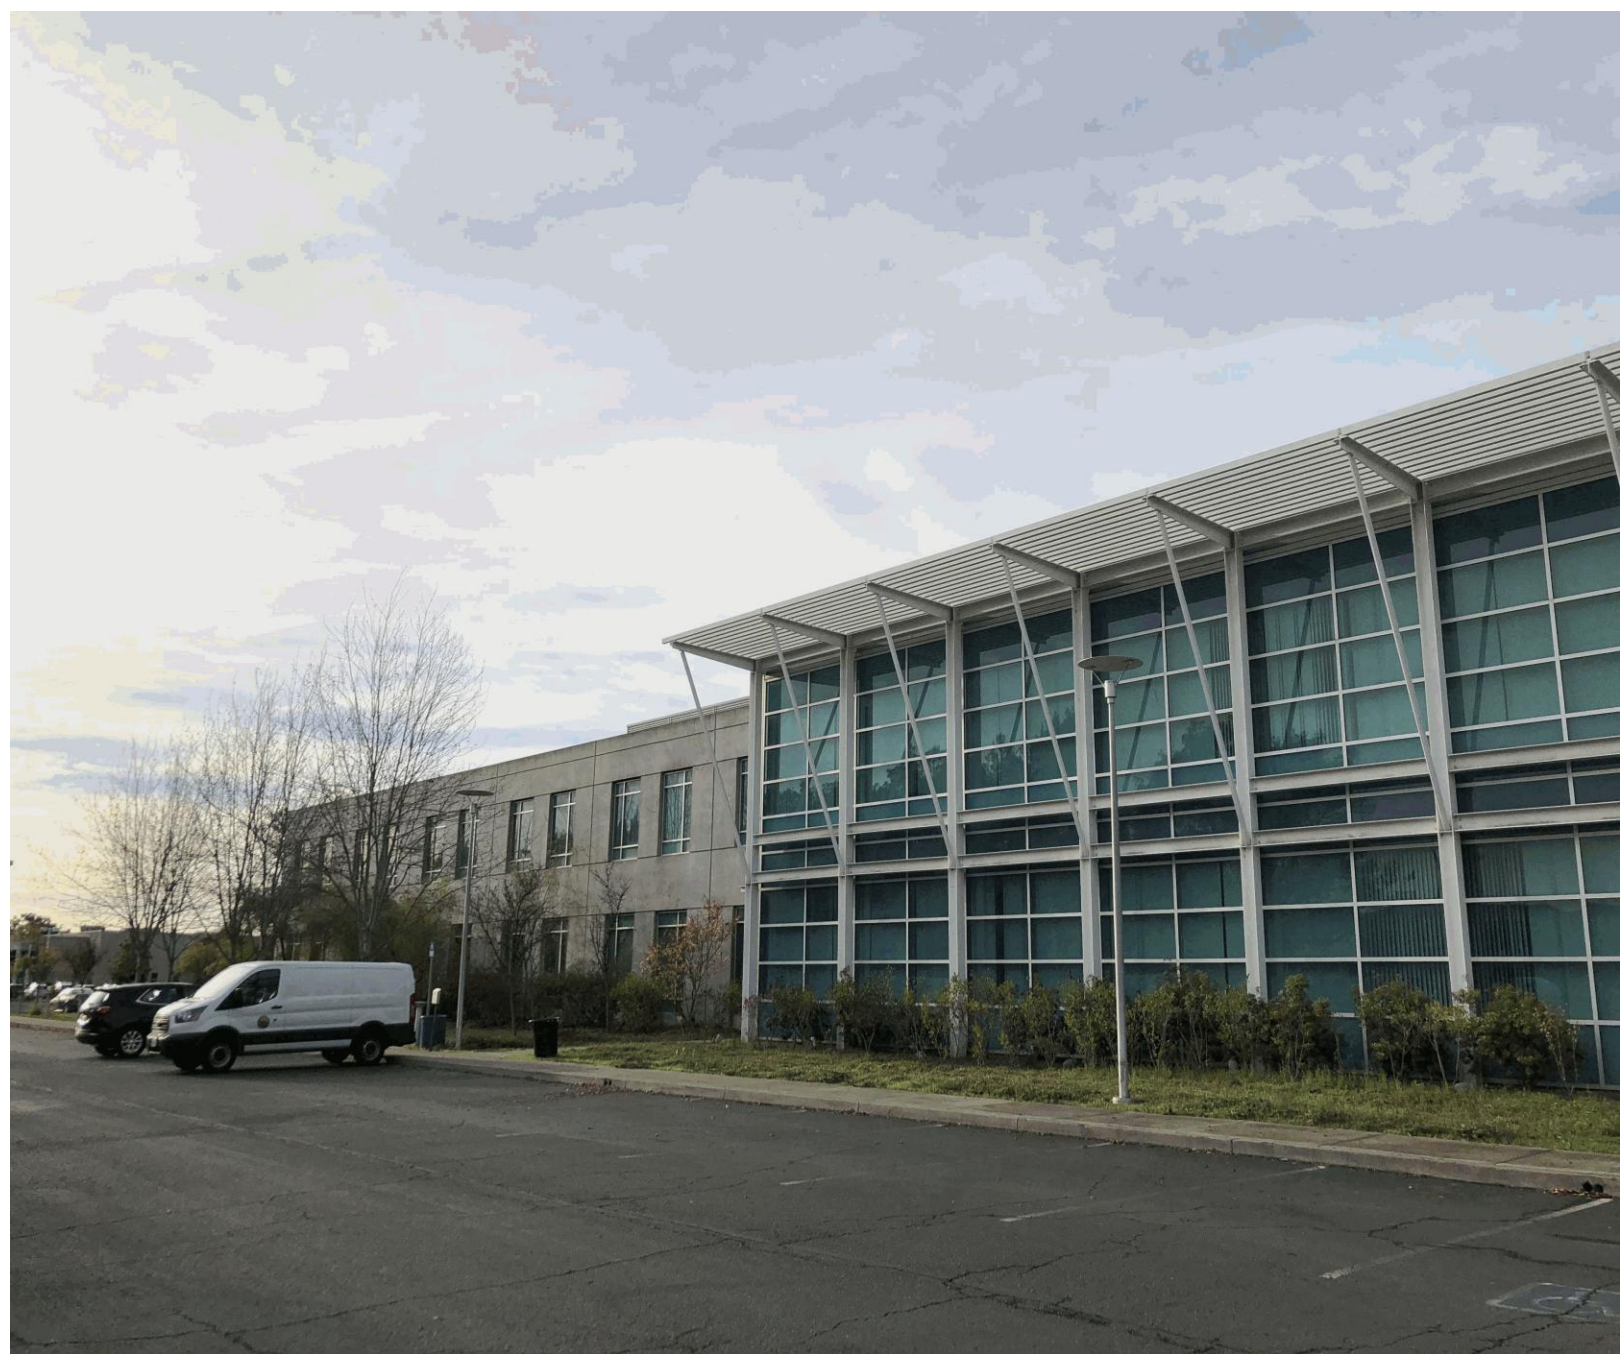
2018 FACILITY CONDITION ASSESSMENT

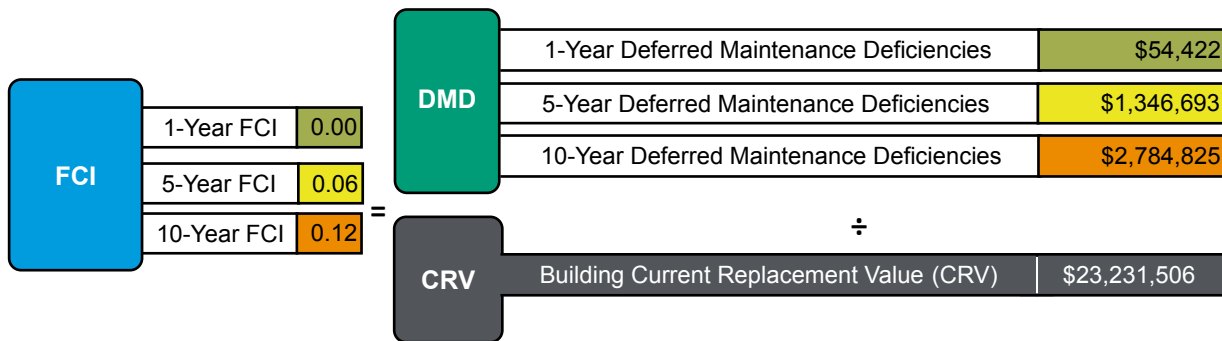
Discipline Condition Index (DCI) and System Condition Index (SCI) Ranking Scales: A similar scale to the Facility Condition Index scale is used in describing SCI and DCI. The two major differences between the FCI scale and the DCI / SCI scale shown below is that the "Divest" ranking has been omitted, and the "Critical" score has been expanded to 1.00. The reason for these changes is to illustrate that an asset's systems or disciplines cannot be divested. They usually require full replacement to enable the asset to function as originally designed and intended.

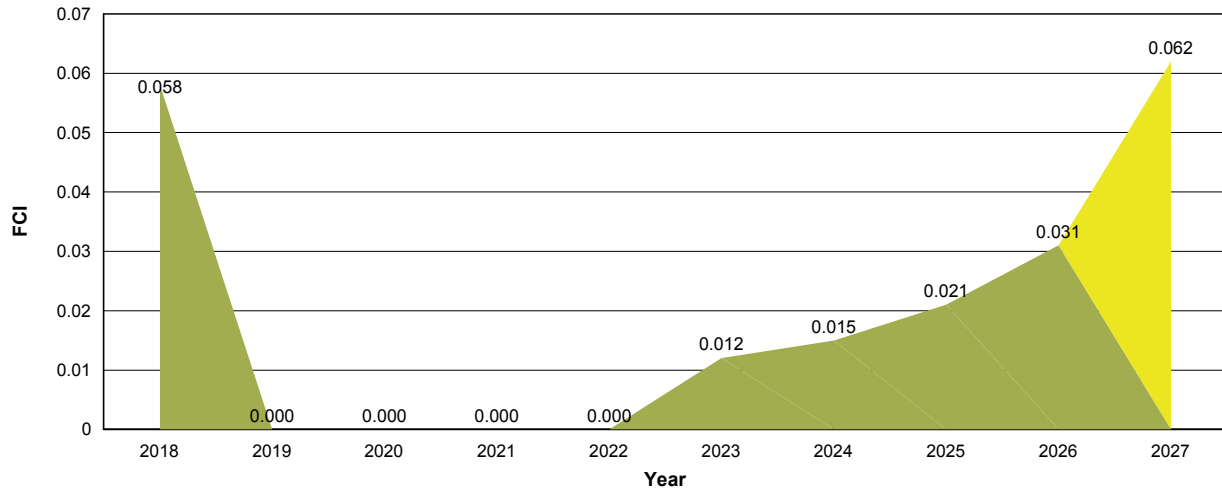
FUTURE STATE - DO NOTHING:
