EXHIBIT B - FCA

To whom it may concern:

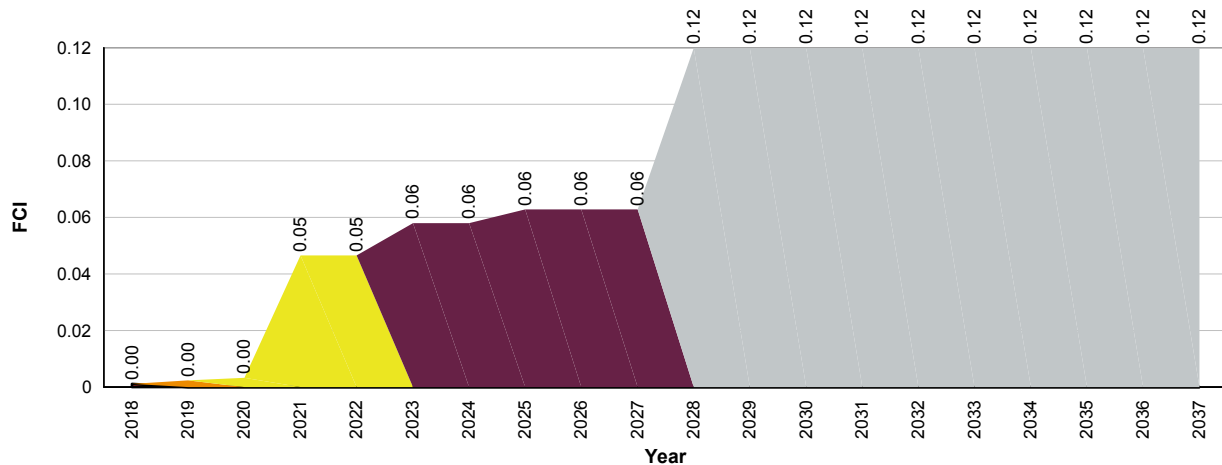
Projected Growth Of Funding Needs Over Time

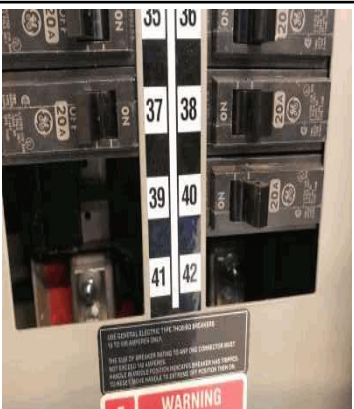
<p>FOScore #: 493625 Uniformat Name: D5020 - Panelboard Deficiencies Category: Code Compliance - Life Safety Location: Entire Building Area Served: Entire building Observed Remaining Life: 0 year(s) Act By: 2019 Action Timeframe: 0 year(s) Reference Life (BOMA): 30 year(s)</p>
	<p><u>Description:</u> Panel ZX3A and Panel ZX5</p> <p><u>Critical Issues:</u> Circuit breaker locations were observed empty in these 2 panelboards causing energized components to be exposed.</p> <p><u>Recommendations:</u> Install manufacturer approved breakers seals to eliminated the hazards associated with exposed energized components.</p> <p><u>Repair Factor:</u> 100%</p> <p style="text-align: right;">Pricing Unit: 60,733 BGSF Cost: \$1,119</p>

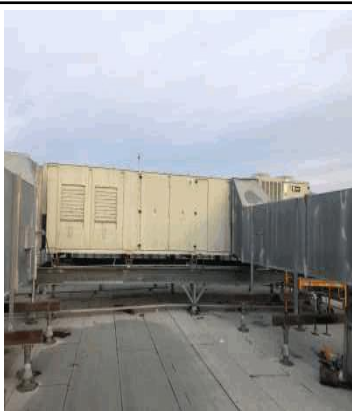
FOScore #: 493862
Uniformat Name: D3060 - Packaged DX Air-Conditioning Units- 6 to 50 TON
Category: Building Integrity - Reliability
Location: Roof
Area Served: Entire Building
Observed Remaining Life: 15 year(s)
Act By: 2020
Action Timeframe: 1 year(s)
Reference Life (BOMA): 15 year(s)

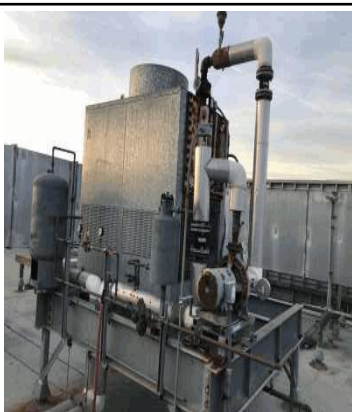
FOScore #: 493863
Uniformat Name: D3020 - Fuel-Fired Heating Boilers - 501 to 1750 MBH
Category: Building Integrity - Reliability
Location: Roof
Area Served: Entire Building
Observed Remaining Life: 16 year(s)
Act By: 2020
Action Timeframe: 1 year(s)
Reference Life (BOMA): 30 year(s)

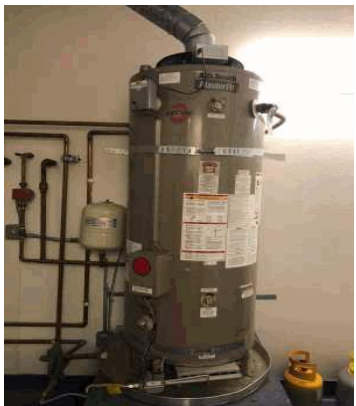
FOScore #: 493864
Uniformat Name: D2010 - Domestic Water Heaters
Category: Building Integrity - Reliability
Location: 1st Floor
Area Served: Entire Building
Observed Remaining Life: 11 year(s)
Act By: 2020
Action Timeframe: 1 year(s)
Reference Life (BOMA): 15 year(s)

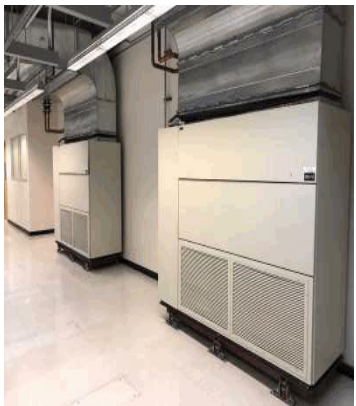
FOScore #: 493865
Uniformat Name: D3040 - Computer-Room Air-Conditioners
Category: Building Integrity - Reliability
Location: 1st Floor
Area Served: Entire Building
Observed Remaining Life: 15 year(s)
Act By: 2020
Action Timeframe: 1 year(s)
Reference Life (BOMA): 15 year(s)

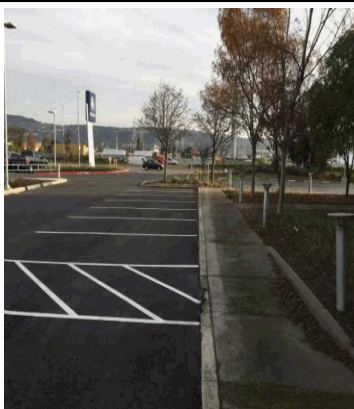
FOScore #: 489217
Uniformat Name: H2010 - ADA Assessments
Category: Code Compliance - ADA/Accessibility
Location: Partial Building
Area Served:
Observed Remaining Life: 2 year(s)
Act By: 2021
Action Timeframe: 2 year(s)
Reference Life (BOMA): 75 year(s)

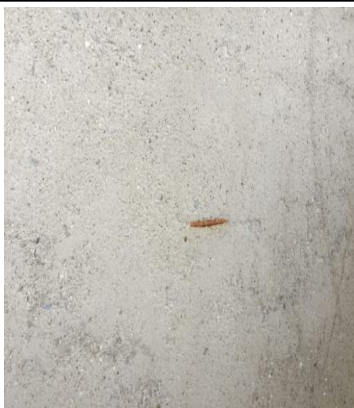
FOScore #: 489222
Uniformat Name: B2010 - Exterior Walls
Category: Building Integrity - Construction Deficiency
Location: Building Exterior
Area Served: Partial exterior shell of building
Observed Remaining Life: 2 year(s)
Act By: 2021
Action Timeframe: 2 year(s)
Reference Life (BOMA): 50 year(s)

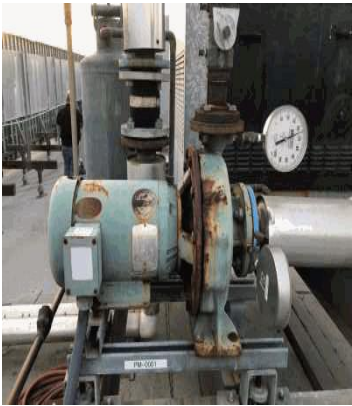
<p>FOScore #: 493861 Uniformat Name: D3050 - Hot Water Pumps- 0 to 10 HP Category: Building Integrity - Reliability Location: Roof Area Served: Entire Building Observed Remaining Life: 2 year(s) Act By: 2021 Action Timeframe: 2 year(s) Reference Life (BOMA): 25 year(s)</p>
		<p>Description: 5 HP End suction pump Critical Issues: Pump is severally corroding due to exposure to the elements. Recommendations: Budget near term for replacement. Repair Factor: 40%</p> <p style="text-align: right;">Pricing Unit: 5 HP Cost: \$5,305</p>
P R I O R I T Y 3

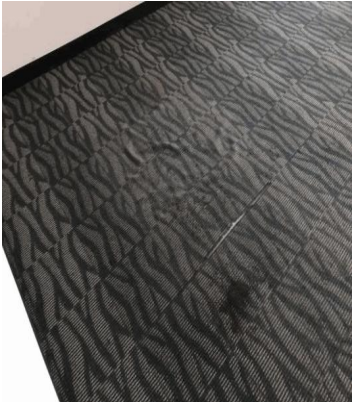
<p>FOScore #: 525379 Uniformat Name: C2030 - Sheet Carpeting Category: Building Integrity - Appearance Location: 1st Floor Area Served: Hallways, enclosed and open office spaces Observed Remaining Life: 5 year(s) Act By: 2024 Action Timeframe: 5 year(s) Reference Life (BOMA): 5 year(s)</p>
		<p>Description: Broadloom interior floor carpeting Critical Issues: Flooring is stained and showing signs of wear in some areas. In other areas, the flooring is functional, but has exceeded the expected life cycle. Recommendations: Age and condition warrants replacement of flooring during prescribed action time frames. Areas observed that warrant consideration include: Hallways, enclosed and open office spaces Repair Factor: 100%</p> <p style="text-align: right;">Pricing Unit: 17,453 SF Cost: \$119,592</p>

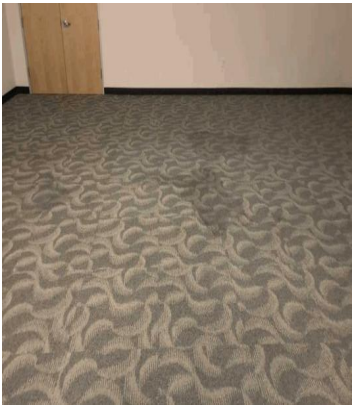
<p> FOScore #: 525382 Uniformat Name: C2030 - Sheet Carpeting Category: Building Integrity - Appearance Location: 2nd floor Area Served: Hallways, enclosed and open office spaces Observed Remaining Life: 5 year(s) Act By: 2024 Action Timeframe: 5 year(s) Reference Life (BOMA): 5 year(s) </p>
	<p> Description: Broadloom interior floor carpeting Critical Issues: Flooring is stained and showing signs of wear in some areas. In other areas, the flooring is functional, but has exceeded the expected life cycle. Recommendations: Age and condition warrants replacement of flooring during prescribed action time frames. Areas observed that warrant consideration include: Hallways, enclosed and open office spaces Repair Factor: 100% </p> <p style="text-align: right;">Pricing Unit: 21,440 SF Cost: \$146,912</p>	
P R I O R I T Y 3

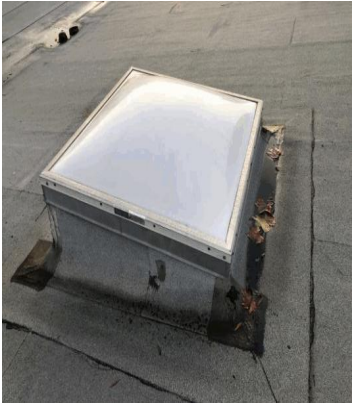
<p> FOScore #: 525387 Uniformat Name: B3060 - Skylights Category: Building Integrity - Reliability Location: Roof Area Served: Roof Observed Remaining Life: 10 year(s) Act By: 2022 Action Timeframe: 3 year(s) Reference Life (BOMA): 25 year(s) </p>

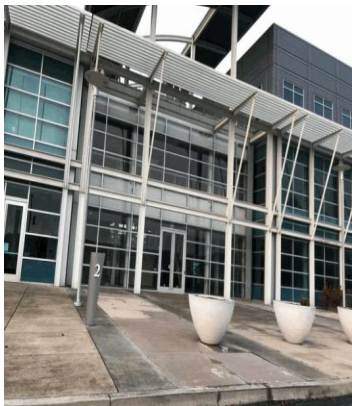
FOScore #: 525408
Uniformat Name: B2010 - Exterior Curtain Wall Assemblies
Category: Environmental - Energy Conservation Opportunity
Location: Building Exterior
Area Served: Partial exterior shell of building
Observed Remaining Life: 35 year(s)
Act By: 2022
Action Timeframe: 3 year(s)
Reference Life (BOMA): 50 year(s)

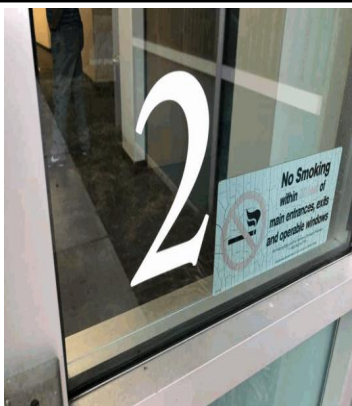
FOScore #: 525410
Uniformat Name: B2020 - Aluminum Windows (fixed)
Category: Environmental - Energy Conservation Opportunity
Location: Partial Building
Area Served: Partial building exterior
Observed Remaining Life: 15 year(s)
Act By: 2022
Action Timeframe: 3 year(s)
Reference Life (BOMA): 30 year(s)

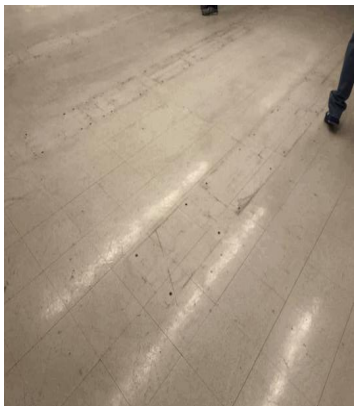
FOScore #: 525381
Uniformat Name: C2030 - Vinyl Composite Tile Flooring
Category: Building Integrity - Appearance
Location: 1st Floor
Area Served: Vacant areas within the 1st floor
Observed Remaining Life: 7 year(s)
Act By: 2026
Action Timeframe: 7 year(s)
Reference Life (BOMA): 12 year(s)

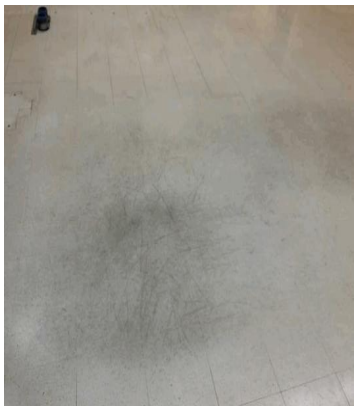
FOScore #: 525383
Uniformat Name: C2030 - Vinyl Composite Tile Flooring
Category: Building Integrity - Appearance
Location: 2nd floor
Area Served: Vacant areas within the 2nd floor
Observed Remaining Life: 7 year(s)
Act By: 2026
Action Timeframe: 7 year(s)
Reference Life (BOMA): 12 year(s)

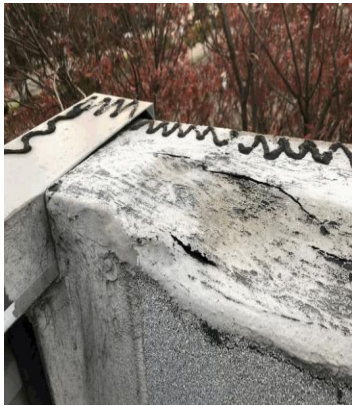
FOScore #: 525384
Uniformat Name: B3010 - Roofing - Unprotected Membrane
Category: Building Integrity - Reliability
Location: Roof
Area Served: Roof
Observed Remaining Life: 10 year(s)
Act By: 2029
Action Timeframe: 10 year(s)
Reference Life (BOMA): 20 year(s)

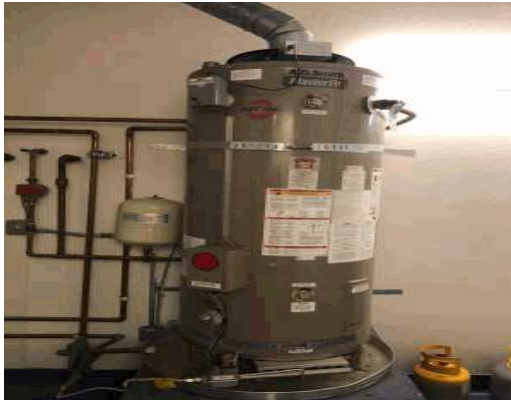
Item #: 493864
Uniformat Number: D2010
Item Title: Domestic Water Heaters
Caption: Gas hot water heater
Priority: 1 - Currently Critical

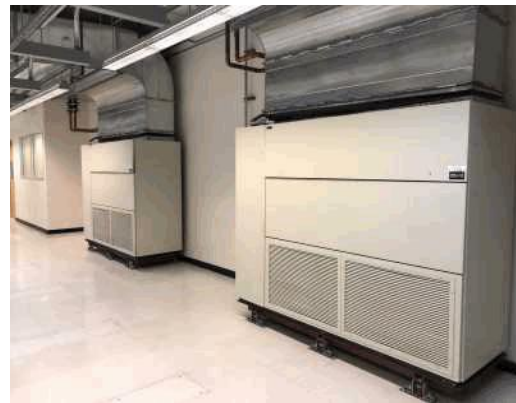
Item #: 493865
Uniformat Number: D3040
Item Title: Computer-Room Air-Conditioners
Caption: Water cooled Computer room A/C units
Priority: 1 - Currently Critical

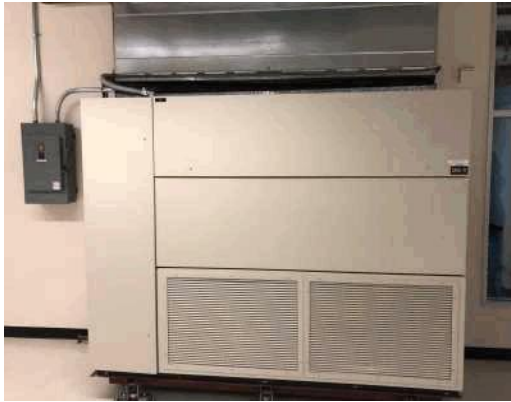
Item #: 493865
 Uniformat Number: D3040
 Item Title: Computer-Room Air-Conditioners
 Caption: Typical Computer room A/C unit
 Priority: 1 - Currently Critical

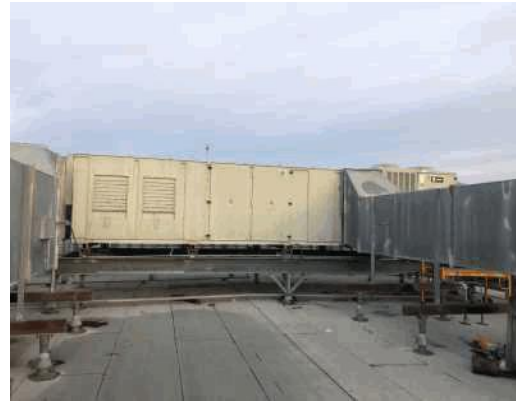
Item #: 493862
 Uniformat Number: D3060
 Item Title: Packaged DX Air-Conditioning Units- 6 to 50 TON
 Caption: Packaged DX Rooftop unit
 Priority: 1 - Currently Critical

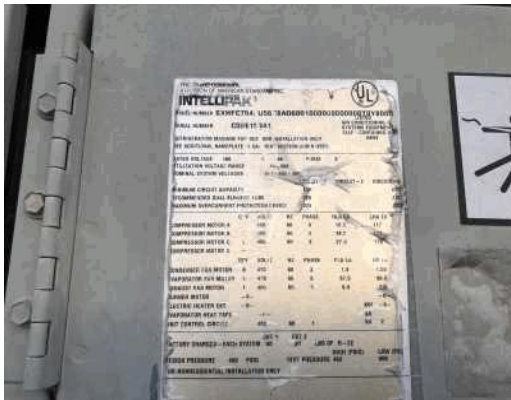
Item #: 493862
 Uniformat Number: D3060
 Item Title: Packaged DX Air-Conditioning Units- 6 to 50 TON
 Caption: RTU Nameplate
 Priority: 1 - Currently Critical

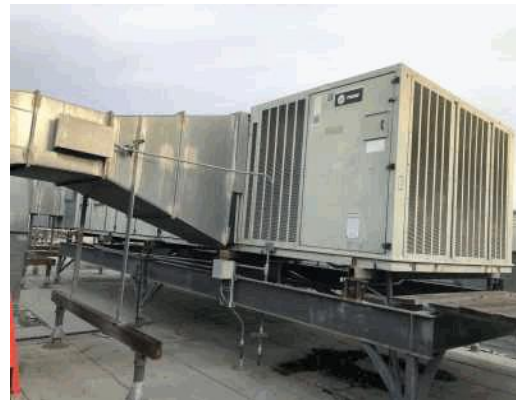
Item #: 493862
 Uniformat Number: D3060
 Item Title: Packaged DX Air-Conditioning Units- 6 to 50 TON
 Caption: Packaged DX Rooftop unit
 Priority: 1 - Currently Critical

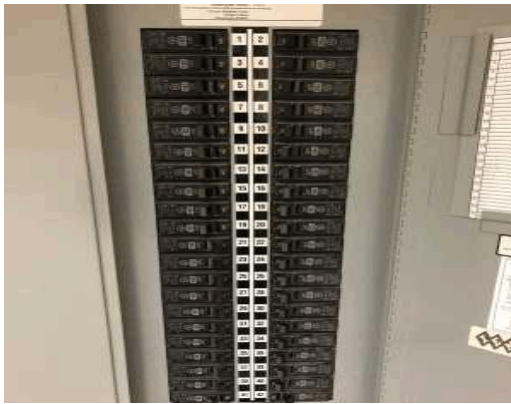
Item #: 493474
 Uniformat Number: D5020
 Item Title: Electrical Arc Flash Hazard Analysis and Short Circuit Coordination
 Caption: Equipment not labeled with hazards
 Priority: 1 - Currently Critical

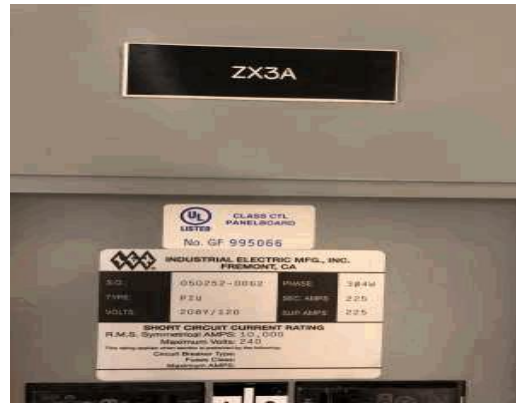
Item #: 493625
 Uniformat Number: D5020
 Item Title: Panelboard Deficiencies
 Caption: ZX3A
 Priority: 1 - Currently Critical

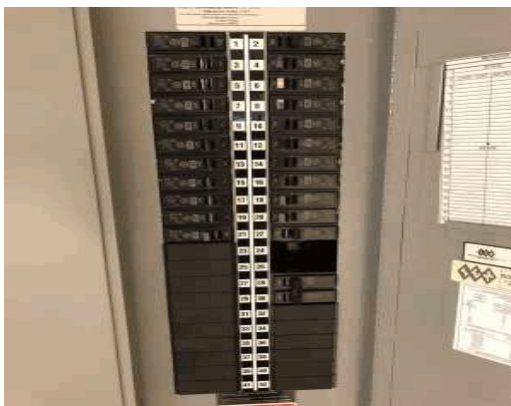
Item #: 493625
 Uniformat Number: D5020
 Item Title: Panelboard Deficiencies
 Caption: ZX3A
 Priority: 1 - Currently Critical

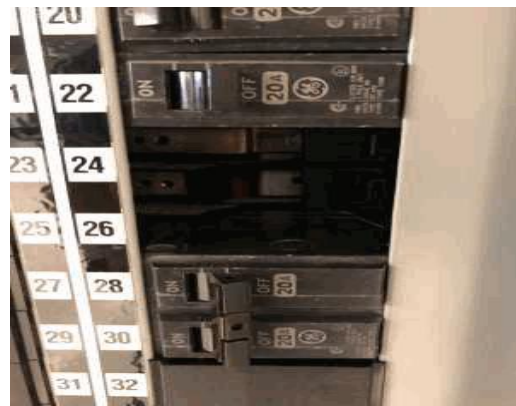
Item #: 493625
 Uniformat Number: D5020
 Item Title: Panelboard Deficiencies
 Caption: ZX3A
 Priority: 1 - Currently Critical

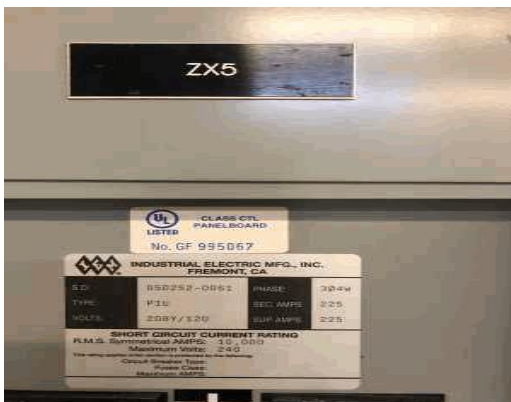
Item #: 493625
 Uniformat Number: D5020
 Item Title: Panelboard Deficiencies
 Caption: ZX5
 Priority: 1 - Currently Critical

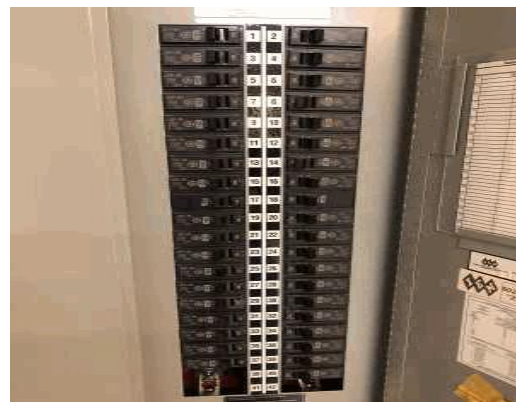
Item #: 493625
 Uniformat Number: D5020
 Item Title: Panelboard Deficiencies
 Caption: ZX5
 Priority: 1 - Currently Critical

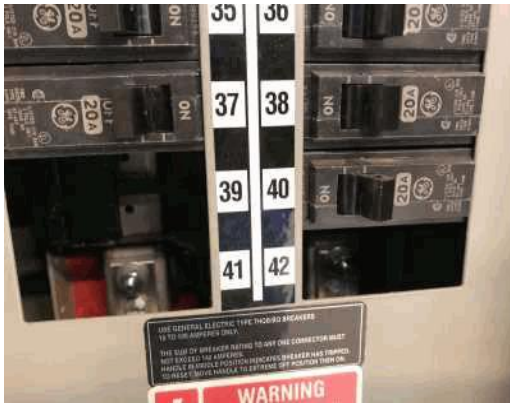
Item #: 493625
Uniformat Number: D5020
Item Title: Panelboard Deficiencies
Caption: ZX5
Priority: 1 - Currently Critical

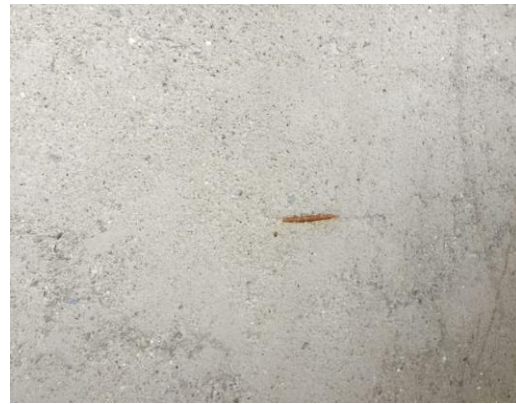
Item #: 489222
Uniformat Number: B2010
Item Title: Exterior Walls
Caption: Exposed rebar on exterior wall
Priority: 2 - Potentially Critical

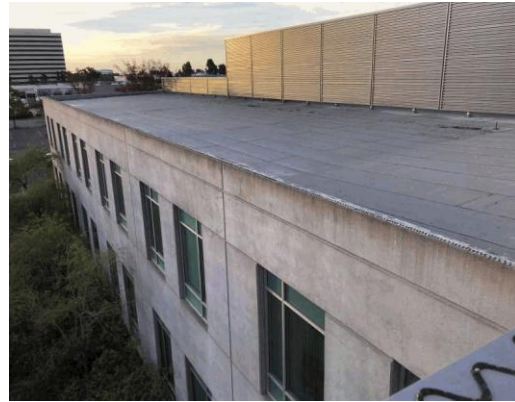
Item #: 525410
Uniformat Number: B2020
Item Title: Aluminum Windows (fixed)
Caption: Energy inefficient single pane glazing assemblies observed
Priority: 3 - Necessary - Not Yet Critical

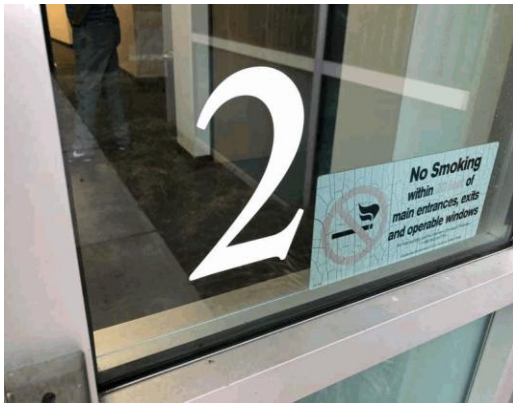
Item #: 525410
Uniformat Number: B2020
Item Title: Aluminum Windows (fixed)
Caption: Energy inefficient single pane glazing assemblies observed
Priority: 3 - Necessary - Not Yet Critical

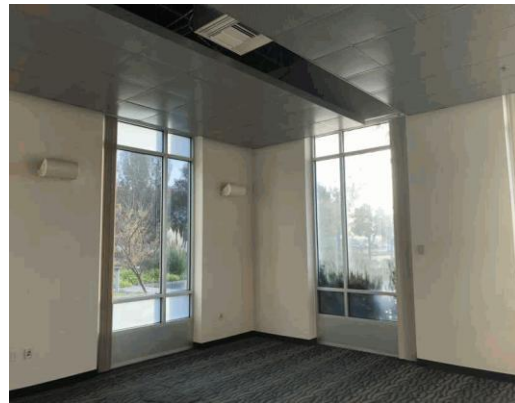
Item #: 525410
Uniformat Number: B2020
Item Title: Aluminum Windows (fixed)
Caption: Energy inefficient single pane glazing assemblies observed
Priority: 3 - Necessary - Not Yet Critical

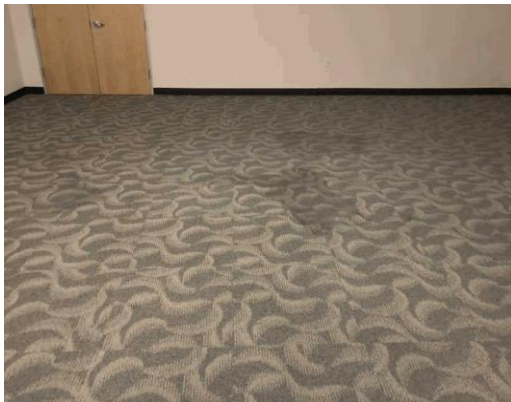
Item #: 525379
Uniformat Number: C2030
Item Title: Sheet Carpeting
Caption: Flooring is stained and showing signs of wear in some areas
Priority: 3 - Necessary - Not Yet Critical

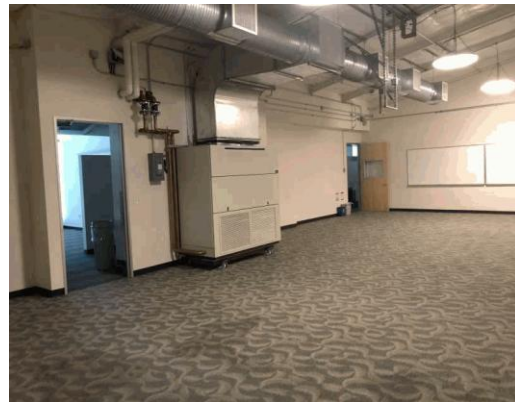
Item #: 525379
Uniformat Number: C2030
Item Title: Sheet Carpeting
Caption: Flooring is stained and showing signs of wear in some areas
Priority: 3 - Necessary - Not Yet Critical

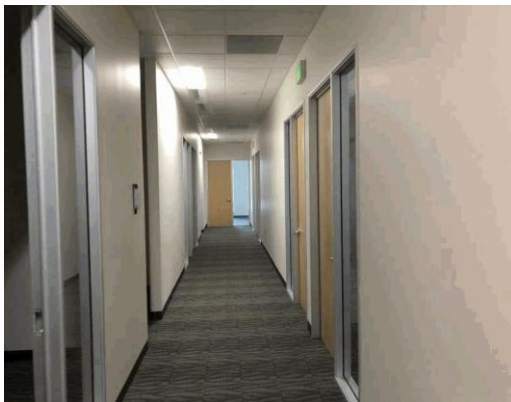
Item #: 525379
Uniformat Number: C2030
Item Title: Sheet Carpeting
Caption: In other areas, the flooring is functional, but has exceeded the expected lifecycle.
Priority: 3 - Necessary - Not Yet Critical

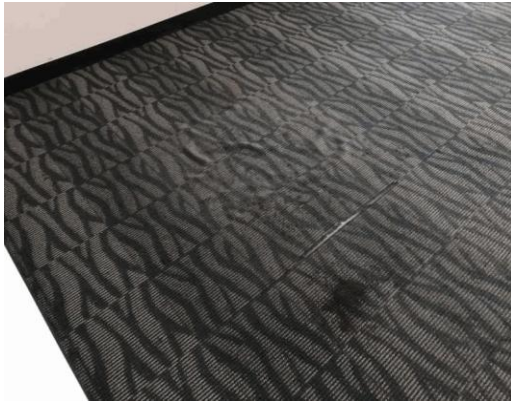
Item #: 525379
Uniformat Number: C2030
Item Title: Sheet Carpeting
Caption: Flooring is stained and showing signs of wear in some areas
Priority: 3 - Necessary - Not Yet Critical

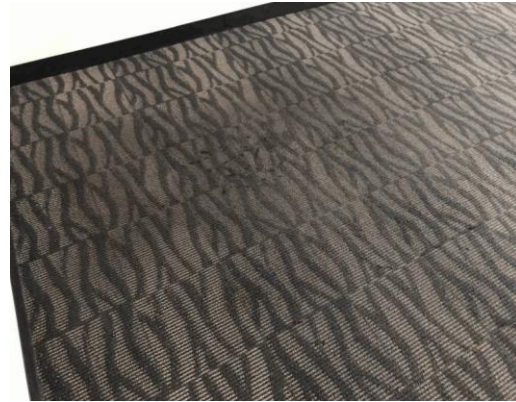
Item #: 525379
Uniformat Number: C2030
Item Title: Sheet Carpeting
Caption: Flooring is stained and showing signs of wear in some areas
Priority: 3 - Necessary - Not Yet Critical

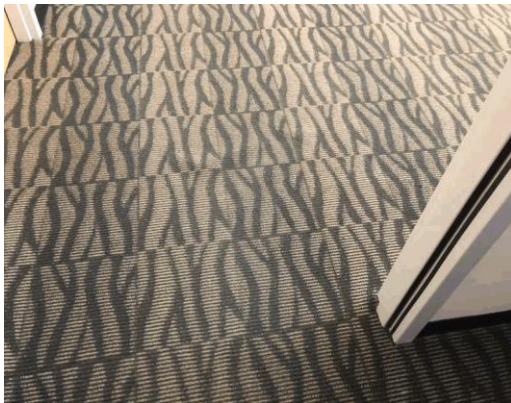
Item #: 525382
Uniformat Number: C2030
Item Title: Sheet Carpeting
Caption: Flooring is stained and showing signs of wear
Priority: 3 - Necessary - Not Yet Critical

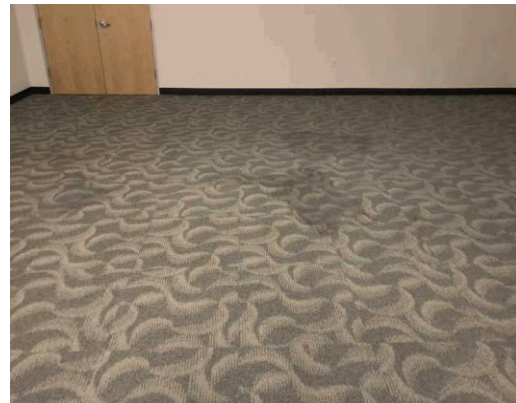
Item #: 525382
Uniformat Number: C2030
Item Title: Sheet Carpeting
Caption: Flooring is stained and showing signs of wear
Priority: 3 - Necessary - Not Yet Critical

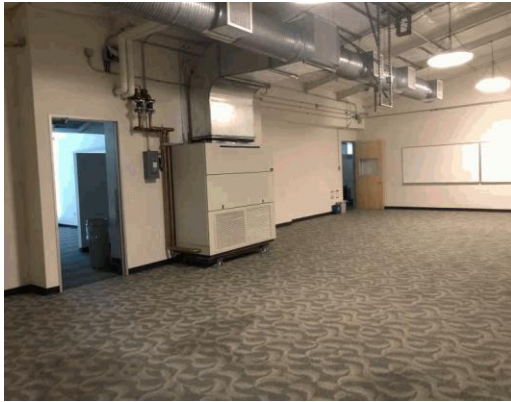
Item #: 525382
Uniformat Number: C2030
Item Title: Sheet Carpeting
Caption: Flooring is stained and showing signs of wear
Priority: 3 - Necessary - Not Yet Critical

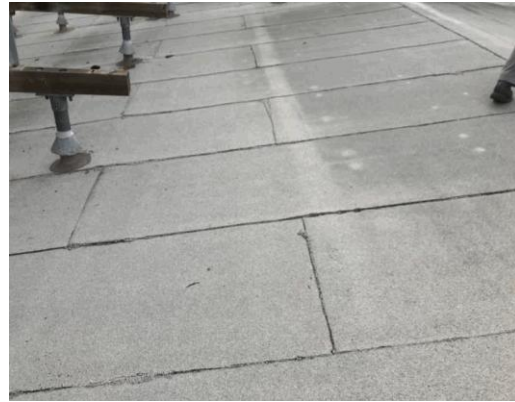
Item #: 525384
Uniformat Number: B3010
Item Title: Roofing - Unprotected Membrane
Caption: Roof is approaching the the end of the expected life cycle
Priority: 4 - Recommended

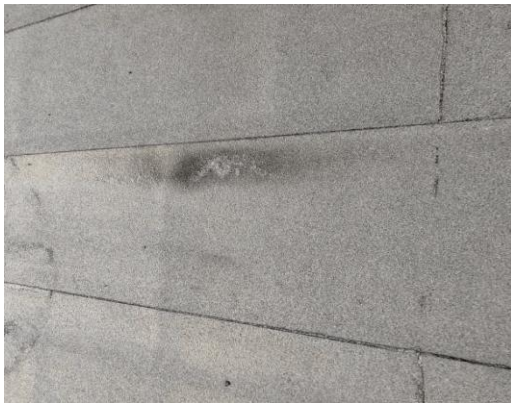
Item #: 525384
Uniformat Number: B3010
Item Title: Roofing - Unprotected Membrane
Caption: Roof is approaching the the end of the expected life cycle
Priority: 4 - Recommended

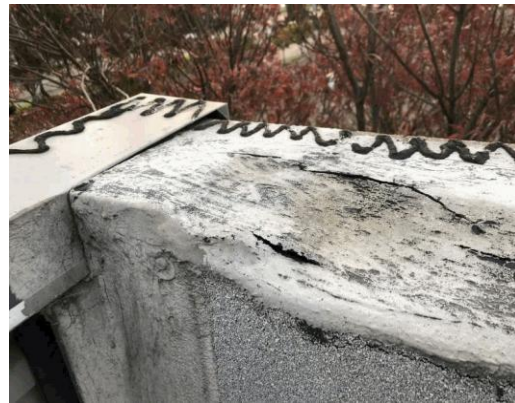
Item #: 525384
Uniformat Number: B3010
Item Title: Roofing - Unprotected Membrane
Caption: Roof is approaching the the end of the expected life cycle
Priority: 4 - Recommended

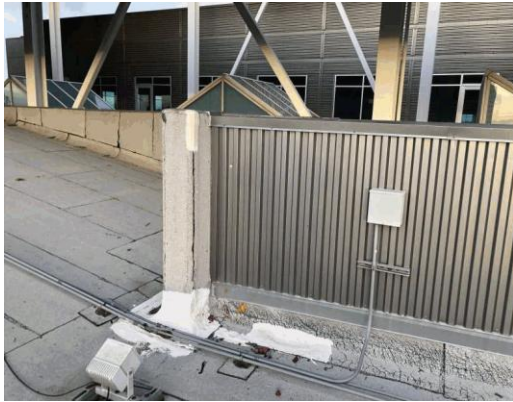
Item #: 525384
Uniformat Number: B3010
Item Title: Roofing - Unprotected Membrane
Caption: Roof is approaching the the end of the expected life cycle
Priority: 4 - Recommended

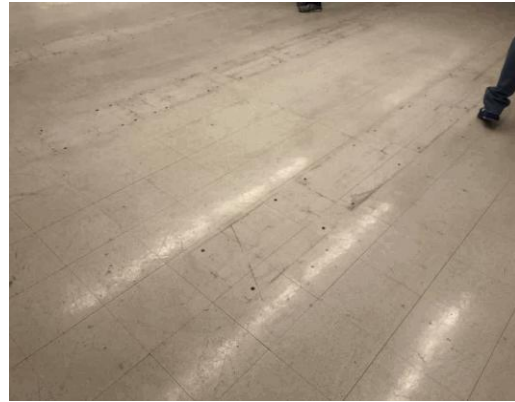
Item #: 525381
Uniformat Number: C2030
Item Title: Vinyl Composite Tile Flooring
Caption: Flooring is damaged in some areas. Flooring has exceeded the lifecycle expectancy.
Priority: 4 - Recommended

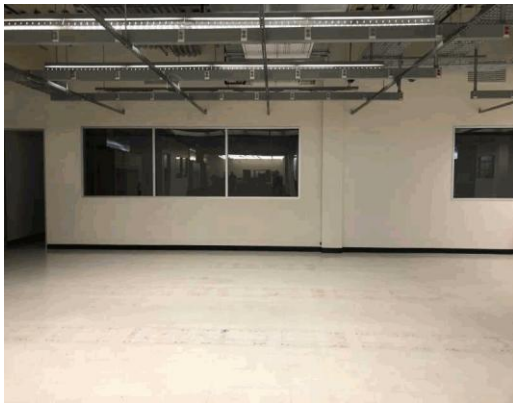
Item #: 525381
Uniformat Number: C2030
Item Title: Vinyl Composite Tile Flooring
Caption: Flooring is damaged in some areas. Flooring has exceeded the lifecycle expectancy.
Priority: 4 - Recommended

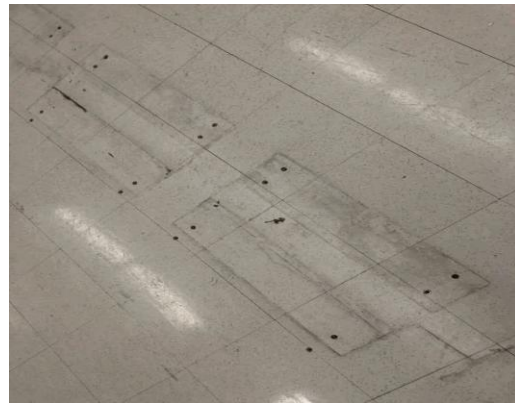
Item #: 525381
Uniformat Number: C2030
Item Title: Vinyl Composite Tile Flooring
Caption: Flooring is damaged in some areas. Flooring has exceeded the lifecycle expectancy.
Priority: 4 - Recommended

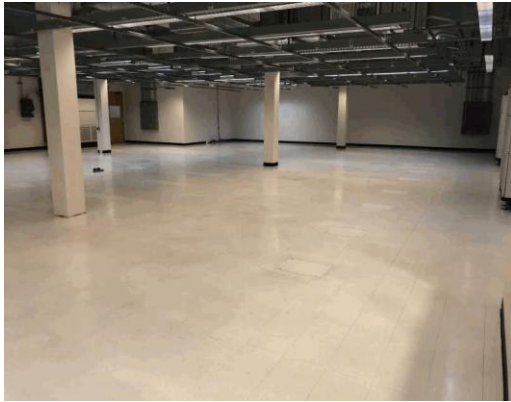
Item #: 525383
Uniformat Number: C2030
Item Title: Vinyl Composite Tile Flooring
Caption: Flooring is damaged in some areas. Flooring has exceeded the lifecycle expectancy.
Priority: 4 - Recommended

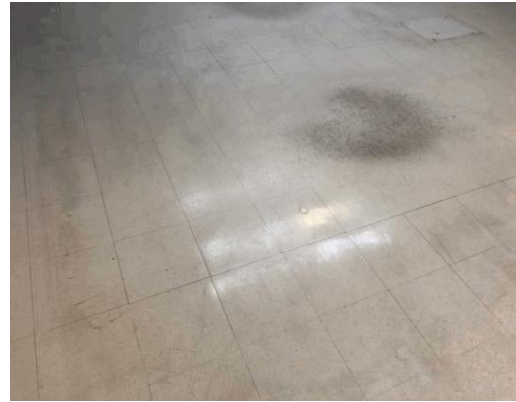
Item #: 525383
Uniformat Number: C2030
Item Title: Vinyl Composite Tile Flooring
Caption: Flooring is damaged in some areas. Flooring has exceeded the lifecycle expectancy.
Priority: 4 - Recommended

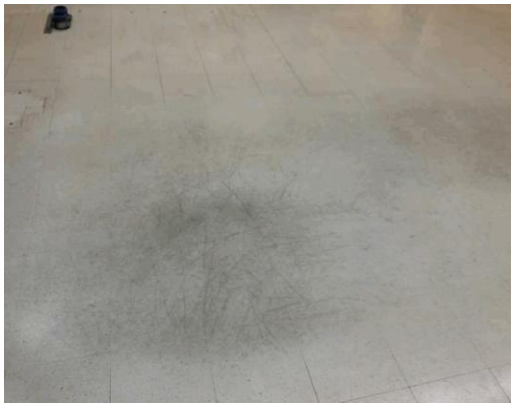
Item #: 525383
Uniformat Number: C2030
Item Title: Vinyl Composite Tile Flooring
Caption: Flooring is damaged in some areas. Flooring has exceeded the lifecycle expectancy.
Priority: 4 - Recommended

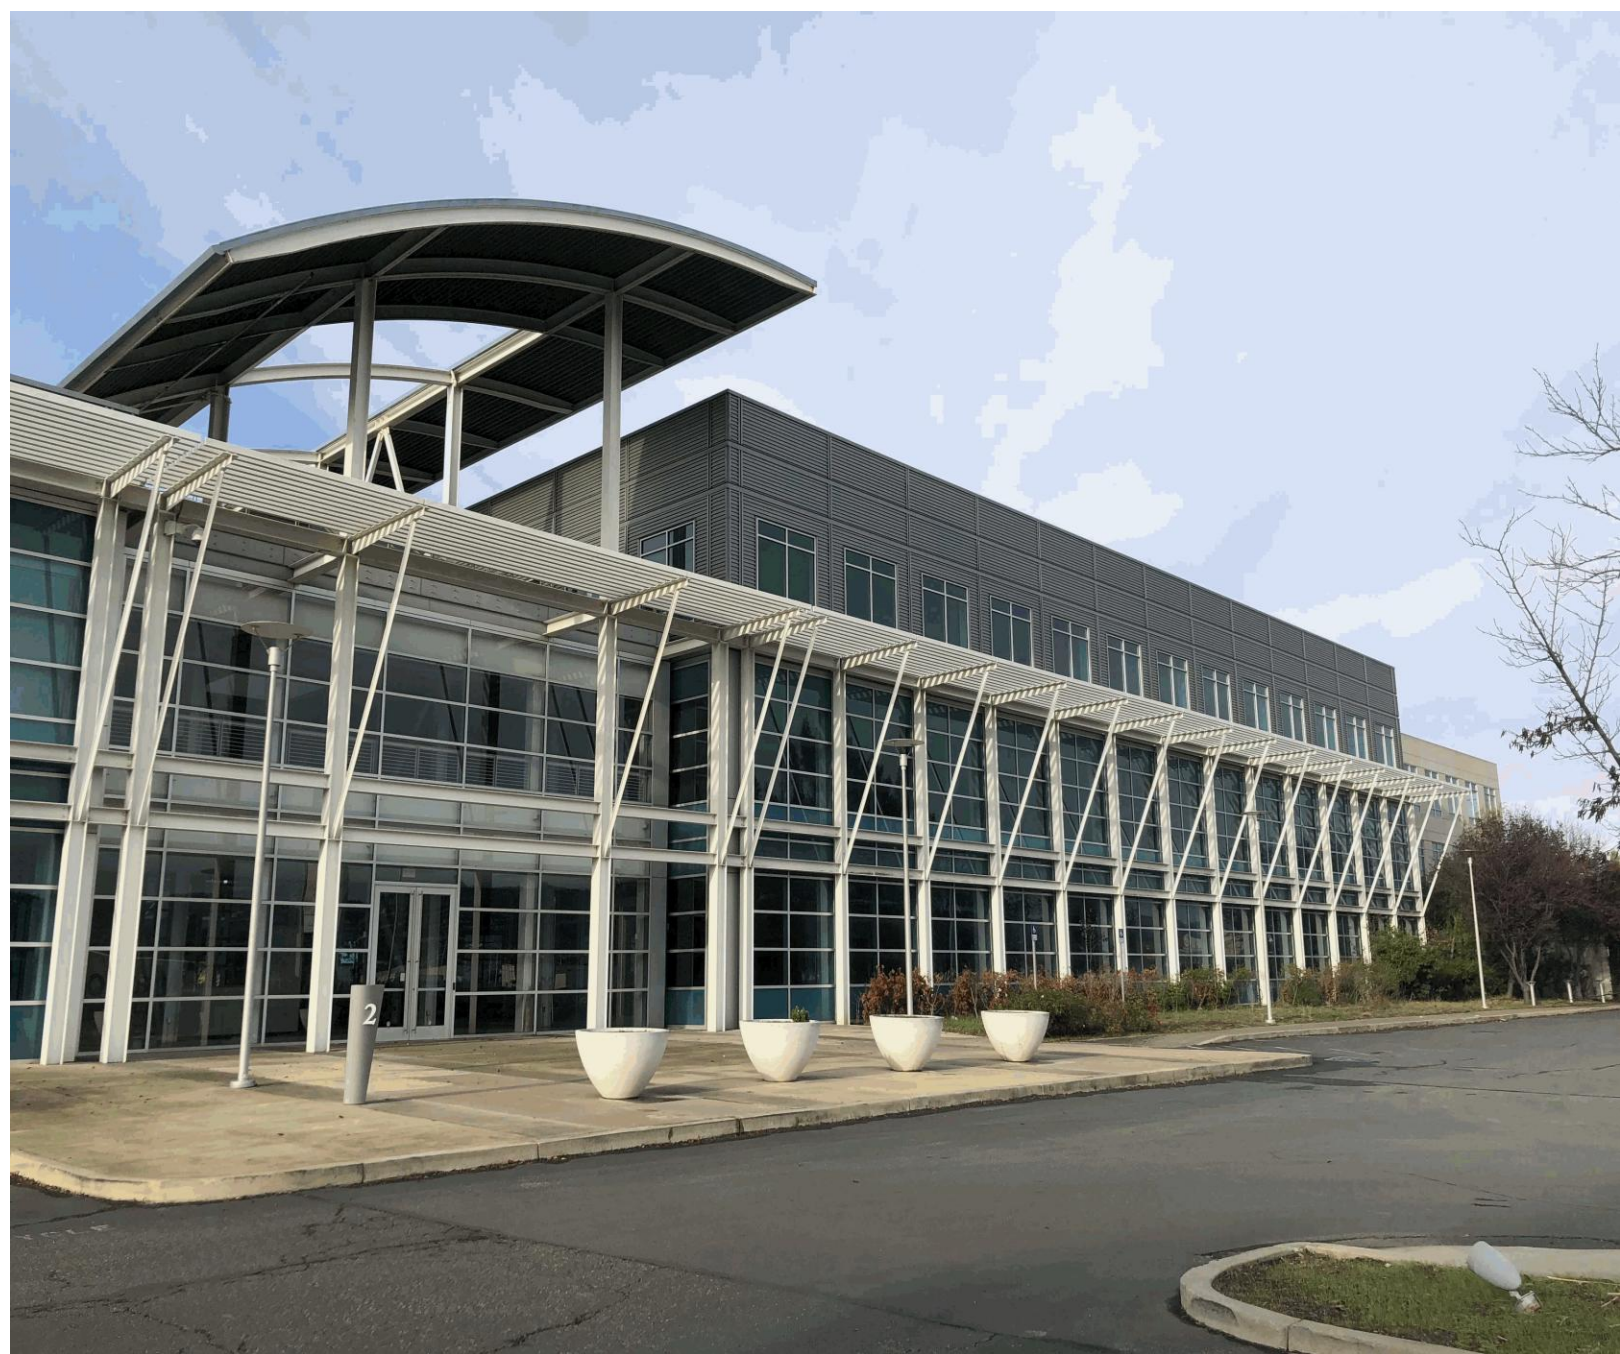
2018 FACILITY CONDITION ASSESSMENT

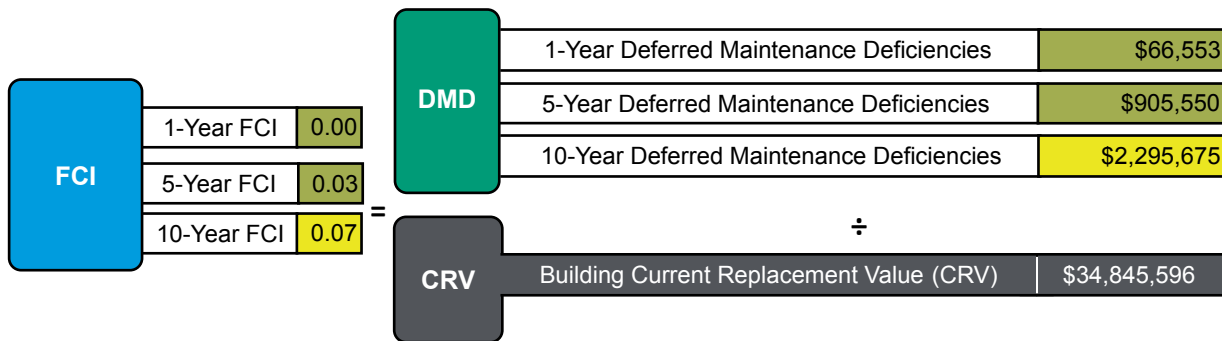
Discipline Condition Index (DCI) and System Condition Index (SCI) Ranking Scales: A similar scale to the Facility Condition Index scale is used in describing SCI and DCI. The two major differences between the FCI scale and the DCI / SCI scale shown below is that the "Divest" ranking has been omitted, and the "Critical" score has been expanded to 1.00. The reason for these changes is to illustrate that an asset's systems or disciplines cannot be divested. They usually require full replacement to enable the asset to function as originally designed and intended.

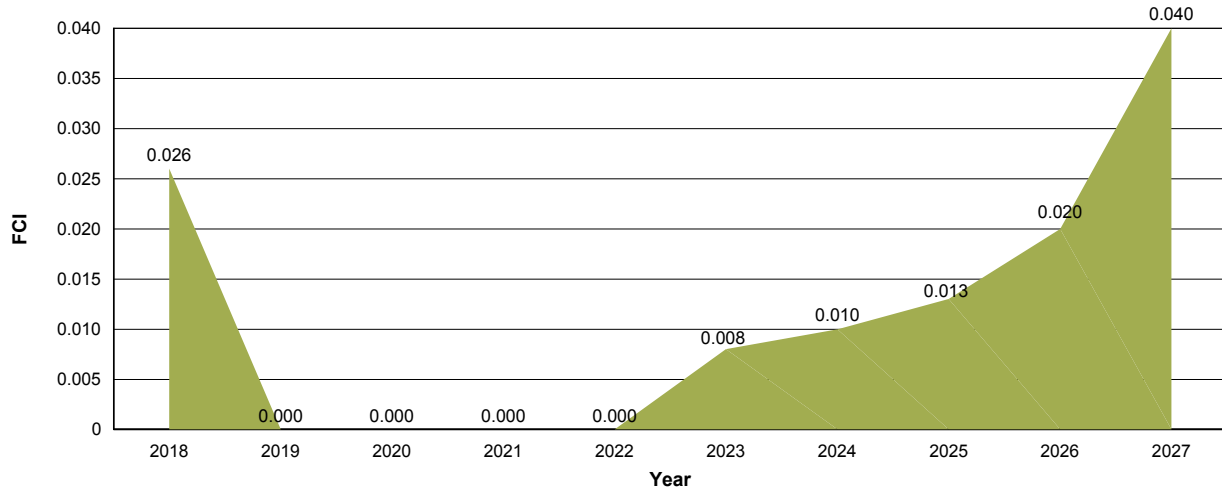
FUTURE STATE - DO NOTHING:

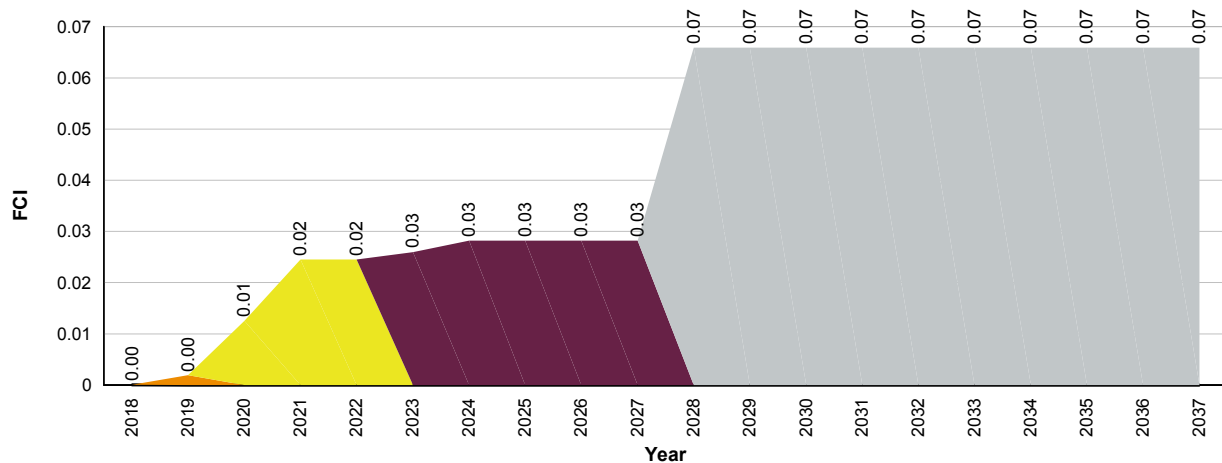
Projected Growth Of Funding Needs Over Time

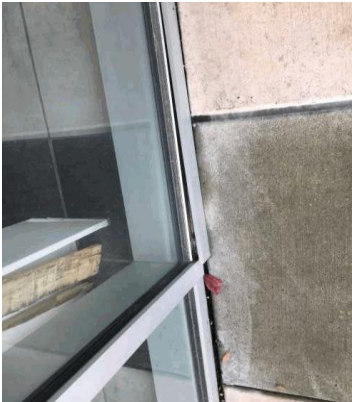
<p> FOScore #: 491194 Uniformat Name: B2020 - Storefronts Category: Building Integrity - Construction Deficiency Location: Partial Building Area Served: Partial building exterior Observed Remaining Life: 1 year(s) Act By: 2020 Action Timeframe: 1 year(s) Reference Life (BOMA): 30 year(s) </p> <hr/> <p> Description: Aluminum Sill Critical Issues: Sill is detaching from the building envelope. Recommendations: Repair aluminum sill. Repair Factor: 100% </p> <p style="text-align: right;">Pricing Unit: 24 SF Cost: \$2,418</p>

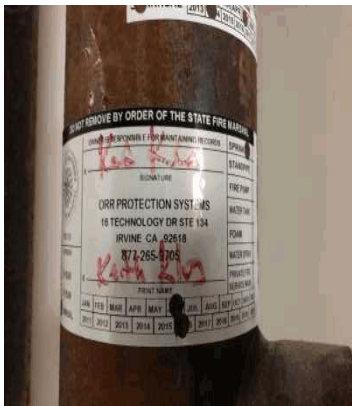
FOScore #: 493872
Uniformat Name: D4010 - Fire Suppression - Wet System
Category: Code Compliance - Life Safety
Location: 1st Floor
Area Served: Entire Building
Observed Remaining Life: 6 year(s)
Act By: 2019
Action Timeframe: 0 year(s)
Reference Life (BOMA): 20 year(s)

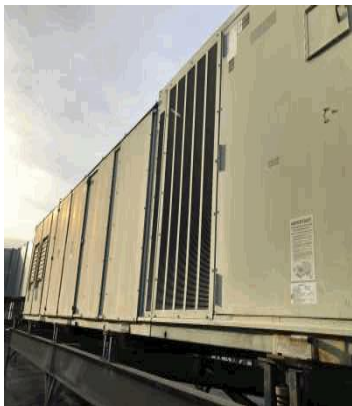
FOScore #: 493875
Uniformat Name: D3060 - Packaged DX Air-Conditioning Units- 6 to 50 TON
Category: Building Integrity - Reliability
Location: Roof
Area Served: Entire Building
Observed Remaining Life: 15 year(s)
Act By: 2020
Action Timeframe: 1 year(s)
Reference Life (BOMA): 15 year(s)

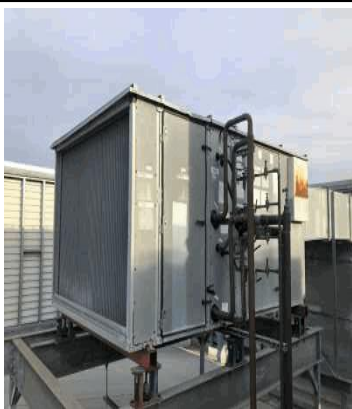
FOScore #: 493888
Uniformat Name: D3040 - Split-System Air-Conditioners
Category: Building Integrity - Reliability
Location: Roof
Area Served: Entire Building
Observed Remaining Life: 15 year(s)
Act By: 2020
Action Timeframe: 1 year(s)
Reference Life (BOMA): 15 year(s)

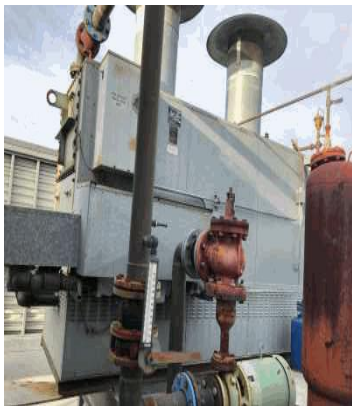
FOScore #: 493889
Uniformat Name: D3020 - Fuel-Fired Heating Boilers - 3751 to 7500 MBH
Category: Building Integrity - Reliability
Location: Roof
Area Served: Entire Building
Observed Remaining Life: 30 year(s)
Act By: 2020
Action Timeframe: 1 year(s)
Reference Life (BOMA): 30 year(s)

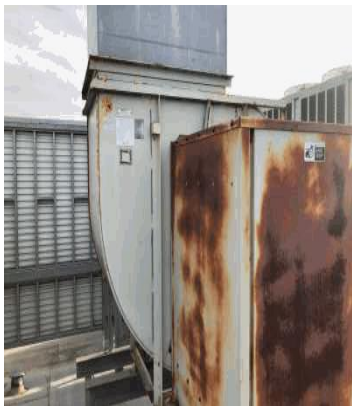
FOScore #: 493890
Uniformat Name: D3060 - Exhaust Air HVAC Fans- General
Category: Building Integrity - Reliability
Location: Roof
Area Served: Entire Building
Observed Remaining Life: 15 year(s)
Act By: 2020
Action Timeframe: 1 year(s)
Reference Life (BOMA): 15 year(s)

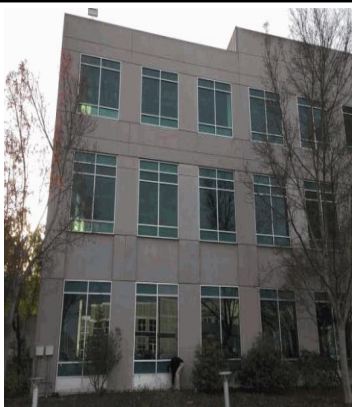
FOScore #: 490022
Uniformat Name: B2020 - Exterior Windows
Category: Building Integrity - Construction Deficiency
Location: Building Exterior
Area Served: Partial exterior elevation
Observed Remaining Life: 2 year(s)
Act By: 2021
Action Timeframe: 2 year(s)
Reference Life (BOMA): 30 year(s)

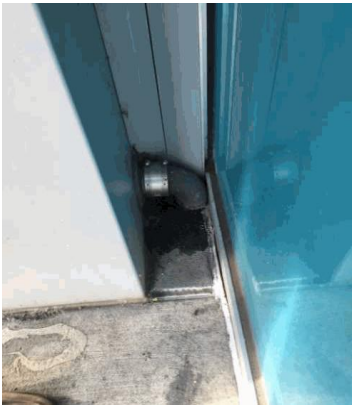
<p>FOScore #: 491219 Uniformat Name: B3020 - Downspouts Category: Building Integrity - Construction Deficiency Location: Building Exterior Area Served: Partial building exterior Observed Remaining Life: 2 year(s) Act By: 2021 Action Timeframe: 2 year(s) Reference Life (BOMA): 30 year(s)</p>
		<p>Description: Downspouts Critical Issues: Lack of drainage at downspout. Recommendations: Provide proper drainage for downspout. Repair Factor: 100%</p> <p style="text-align: right;">Pricing Unit: 1 LF Cost: \$770</p>
P R I O R I T Y 3

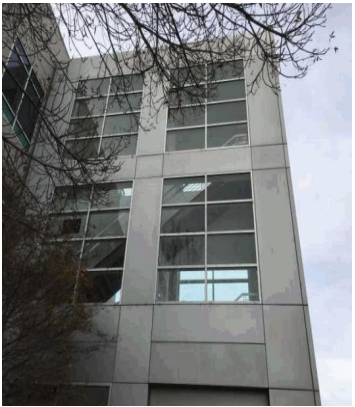
<p>FOScore #: 490815 Uniformat Name: B2010 - Exterior Walls Category: Building Integrity - Appearance Location: Building Exterior Area Served: Partial exterior elevation Observed Remaining Life: 3 year(s) Act By: 2022 Action Timeframe: 3 year(s) Reference Life (BOMA): 50 year(s)</p>
		<p>Description: Exterior wall panels Critical Issues: Staining observed on exterior walls. Recommendations: Powerwash to clean exterior walls. Repair Factor: 100%</p> <p style="text-align: right;">Pricing Unit: 13,284 WSF Cost: \$34,257</p>

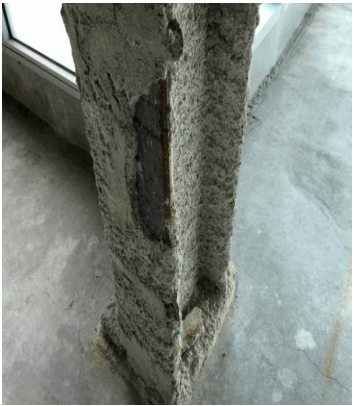
<p> FOScore #: 525465 Uniformat Name: B1030 - Steel Building Structure Category: Building Integrity - Latent Deficiency Location: Partial Building Area Served: Partial building Observed Remaining Life: 85 year(s) Act By: 2022 Action Timeframe: 3 year(s) Reference Life (BOMA): 100 year(s) </p>
	<p> Description: Steel column & beam building structure Critical Issues: Some fireproofing on steel columns is missing. Recommendations: Provide fireproofing where missing on steel columns. Repair Factor: 1% </p> <p style="text-align: right;">Pricing Unit: 94,154 BGSF Cost: \$40,467</p>	
P R I O R I T Y 3

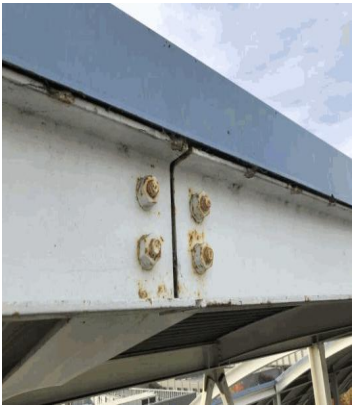
<p> FOScore #: 525529 Uniformat Name: B1030 - Steel Building Structure Category: Building Integrity - Appearance Location: Partial Building Area Served: Exterior canopy on the roof Observed Remaining Life: 5 year(s) Act By: 2024 Action Timeframe: 5 year(s) Reference Life (BOMA): 100 year(s) </p>
		<p> Description: Steel column & beam building structure Critical Issues: Some areas of the steel canopy frame above the 3rd floor plaza is beginning to rust. Recommendations: Scrape, prime and repaint steel frame to prevent further damage. Repair Factor: 100% </p> <p style="text-align: right;">Pricing Unit: 4,000 BGSF Cost: \$49,120</p>
P R I O R I T Y 3

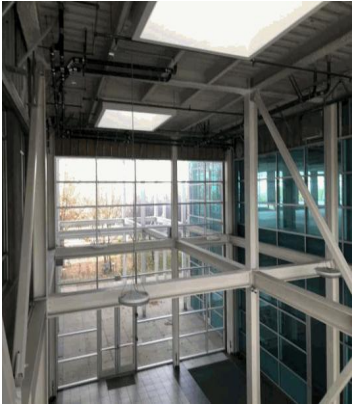
<p> FOScore #: 525530 Uniformat Name: B2010 - Exterior Curtain Wall Assemblies Category: Environmental - Energy Conservation Opportunity Location: Building Exterior Area Served: Partial exterior shell of building Observed Remaining Life: 3 year(s) Act By: 2022 Action Timeframe: 3 year(s) Reference Life (BOMA): 50 year(s) </p>

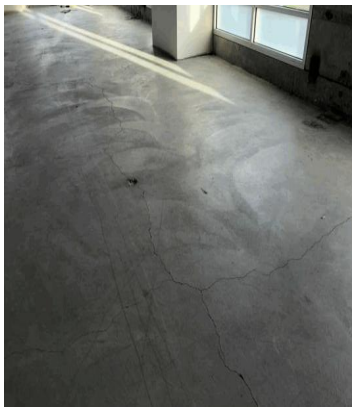
FOScore #: 525449
Uniformat Name: B1010 - Composite Floor Decking
Category: Building Integrity - Latent Deficiency
Location: 3rd Floor
Area Served: Portions of the building
Observed Remaining Life: 85 year(s)
Act By: 2025
Action Timeframe: 6 year(s)
Reference Life (BOMA): 100 year(s)

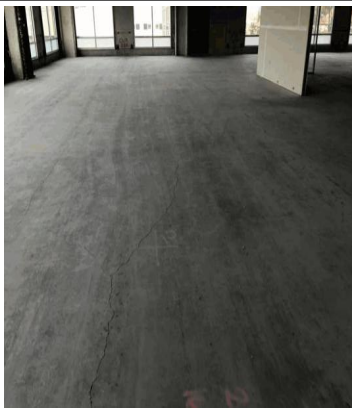
FOScore #: 525456
Uniformat Name: B1010 - Composite Floor Decking
Category: Building Integrity - Latent Deficiency
Location: 2nd floor
Area Served: Portions of the building
Observed Remaining Life: 85 year(s)
Act By: 2025
Action Timeframe: 6 year(s)
Reference Life (BOMA): 100 year(s)

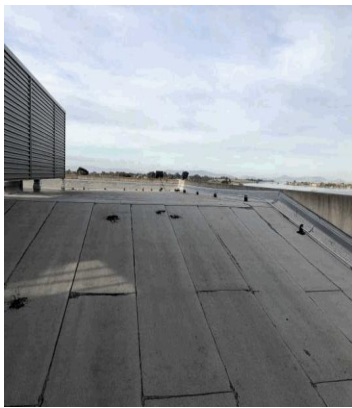
FOScore #: 525488
Uniformat Name: B3010 - Roofing - Unprotected Membrane
Category: Building Integrity - Reliability
Location: Roof
Area Served: Roof
Observed Remaining Life: 10 year(s)
Act By: 2029
Action Timeframe: 10 year(s)
Reference Life (BOMA): 20 year(s)

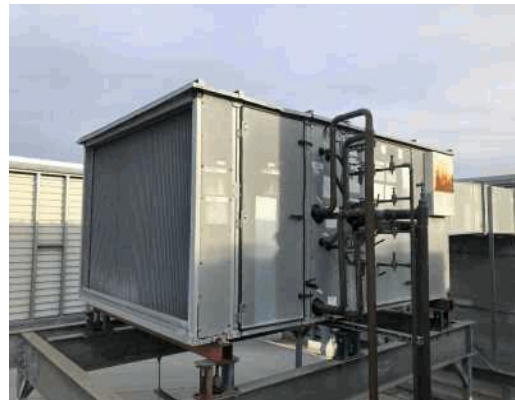
Item #: 493888
Uniformat Number: D3040
Item Title: Split-System Air-Conditioners
Caption: Evaporator section
Priority: 1 - Currently Critical

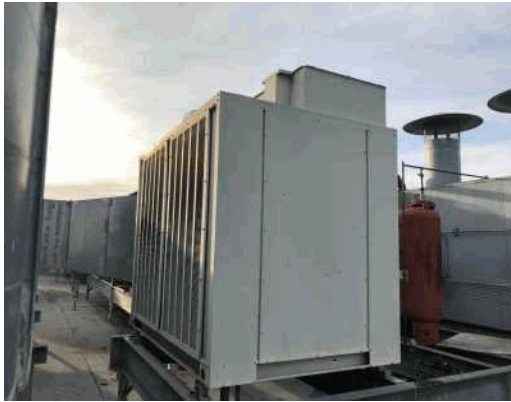
Item #: 493888
 Uniformat Number: D3040
 Item Title: Split-System Air-Conditioners
 Caption: Air cooled condenser section
 Priority: 1 - Currently Critical

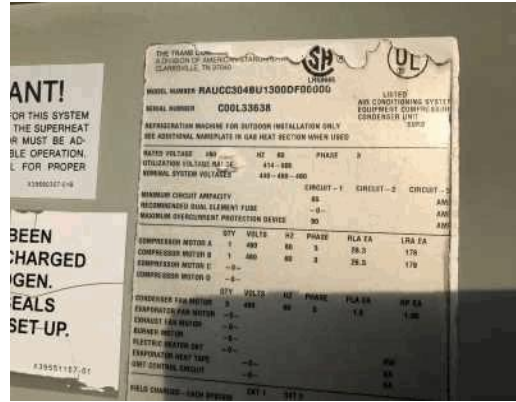
Item #: 493888
 Uniformat Number: D3040
 Item Title: Split-System Air-Conditioners
 Caption: Air cooled condenser section nameplate
 Priority: 1 - Currently Critical

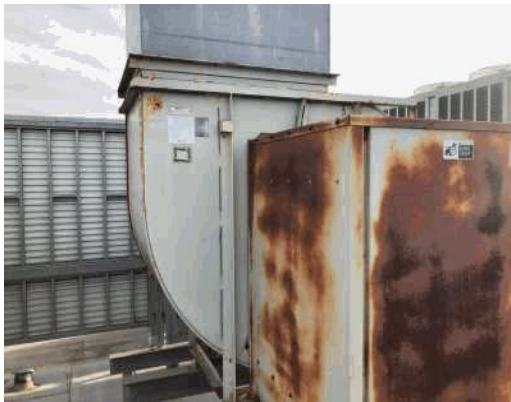
Item #: 493890
 Uniformat Number: D3060
 Item Title: Exhaust Air HVAC Fans- General
 Caption: EF-2
 Priority: 1 - Currently Critical

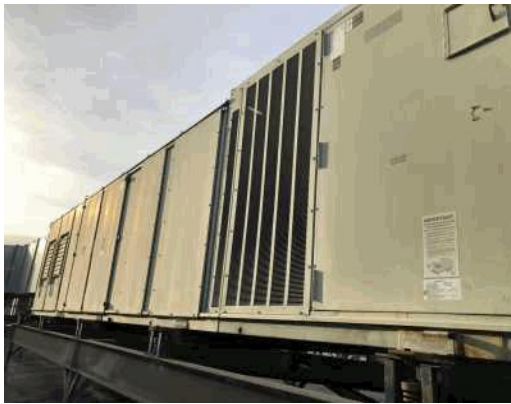
Item #: 493875
 Uniformat Number: D3060
 Item Title: Packaged DX Air-Conditioning Units- 6 to 50 TON
 Caption: Packaged DX Rooftop unit
 Priority: 1 - Currently Critical

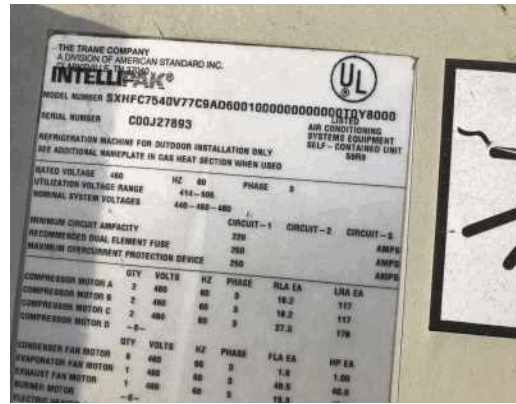
Item #: 493875
 Uniformat Number: D3060
 Item Title: Packaged DX Air-Conditioning Units- 6 to 50 TON
 Caption: Packaged DX Rooftop unit nameplate
 Priority: 1 - Currently Critical
