EXHIBIT B - FCA

To whom it may concern:

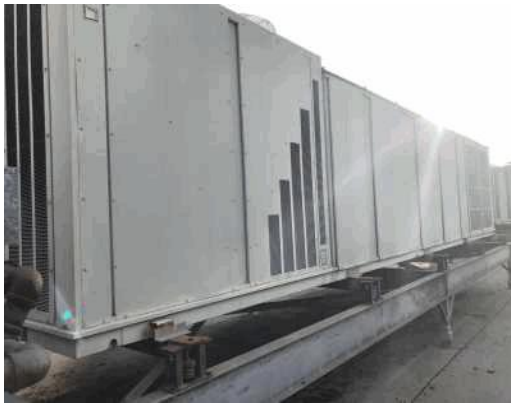
Item #: 493875
 Uniformat Number: D3060
 Item Title: Packaged DX Air-Conditioning Units- 6 to 50 TON
 Caption: Packaged DX Rooftop unit
 Priority: 1 - Currently Critical

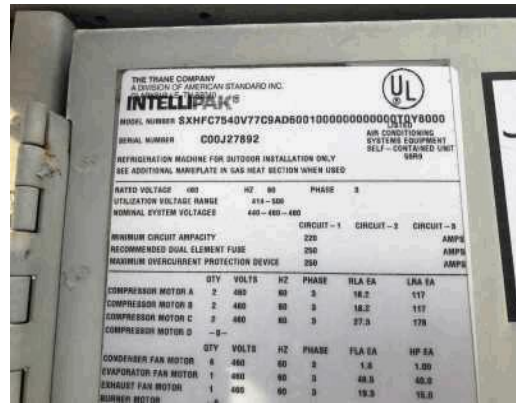
Item #: 493875
 Uniformat Number: D3060
 Item Title: Packaged DX Air-Conditioning Units- 6 to 50 TON
 Caption: Packaged DX Rooftop unit nameplate
 Priority: 1 - Currently Critical

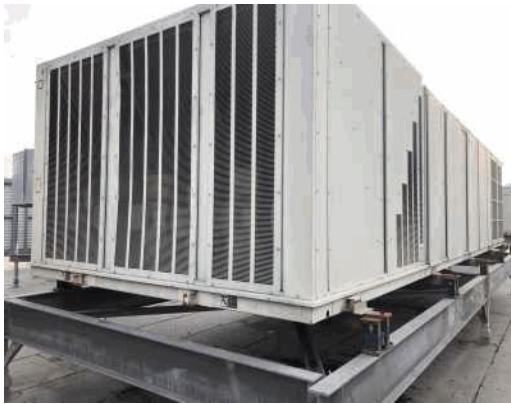
Item #: 493875
 Uniformat Number: D3060
 Item Title: Packaged DX Air-Conditioning Units- 6 to 50 TON
 Caption: Packaged DX Rooftop unit
 Priority: 1 - Currently Critical

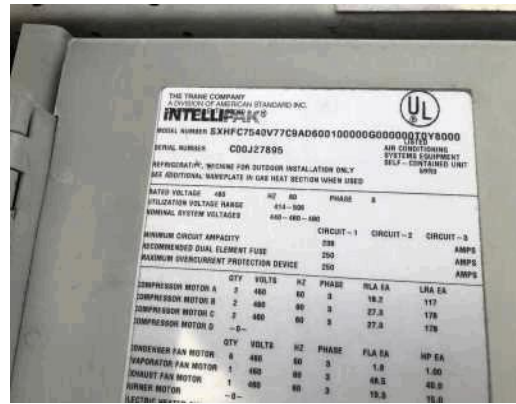
Item #: 493875
 Uniformat Number: D3060
 Item Title: Packaged DX Air-Conditioning Units- 6 to 50 TON
 Caption: Packaged DX Rooftop unit nameplate
 Priority: 1 - Currently Critical

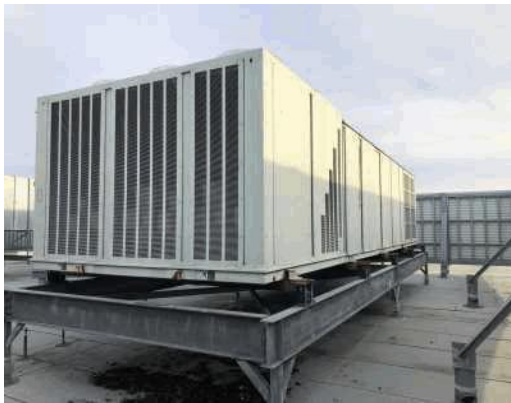
Item #: 493875
 Uniformat Number: D3060
 Item Title: Packaged DX Air-Conditioning Units- 6 to 50 TON
 Caption: Packaged DX Rooftop unit
 Priority: 1 - Currently Critical

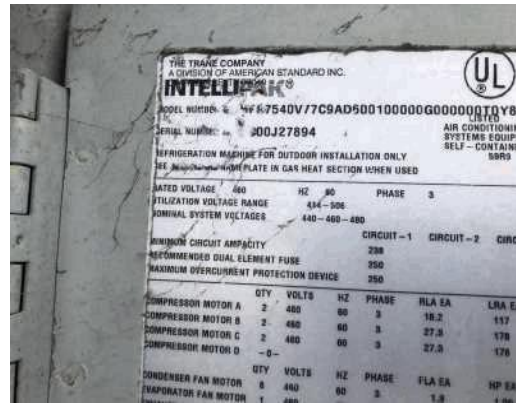
Item #: 493875
 Uniformat Number: D3060
 Item Title: Packaged DX Air-Conditioning Units- 6 to 50 TON
 Caption: Packaged DX Rooftop unit nameplate
 Priority: 1 - Currently Critical

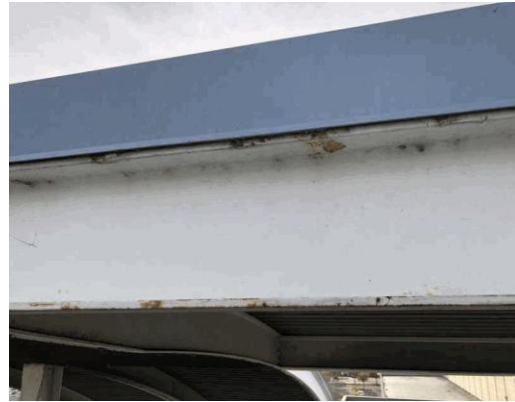
Item #: 525529
Uniformat Number: B1030
Item Title: Steel Building Structure
Caption: Areas of the steel canopy frame is beginning to rust
Priority: 3 - Necessary - Not Yet Critical

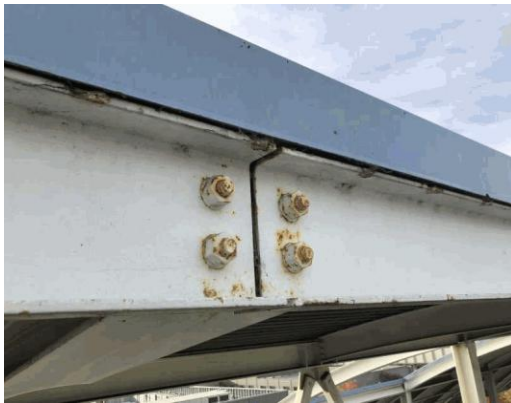
Item #: 525529
Uniformat Number: B1030
Item Title: Steel Building Structure
Caption: Areas of the steel canopy frame is beginning to rust
Priority: 3 - Necessary - Not Yet Critical

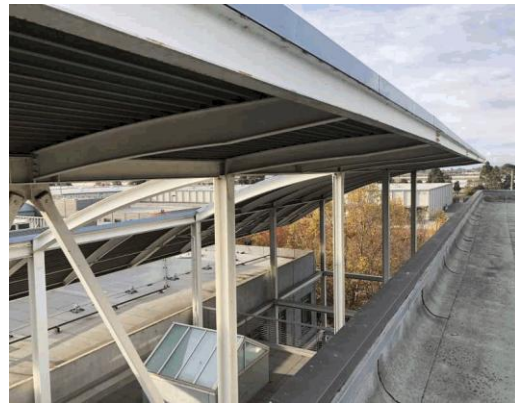
Item #: 525529
Uniformat Number: B1030
Item Title: Steel Building Structure
Caption: Areas of the steel canopy frame is beginning to rust
Priority: 3 - Necessary - Not Yet Critical

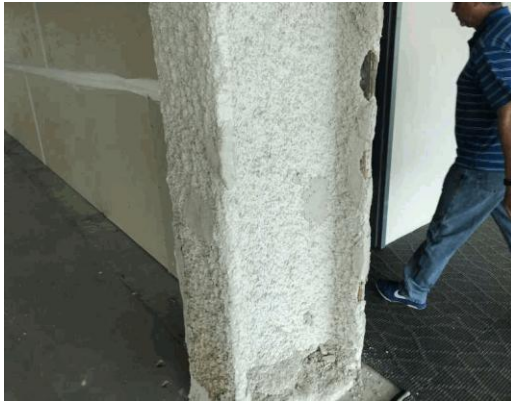
Item #: 525465
Uniformat Number: B1030
Item Title: Steel Building Structure
Caption: Some fireproofing on steel columns is missing
Priority: 3 - Necessary - Not Yet Critical

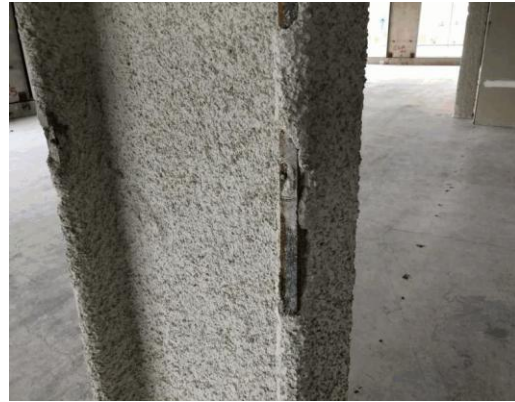
Item #: 525465
Uniformat Number: B1030
Item Title: Steel Building Structure
Caption: Some fireproofing on steel columns is missing
Priority: 3 - Necessary - Not Yet Critical

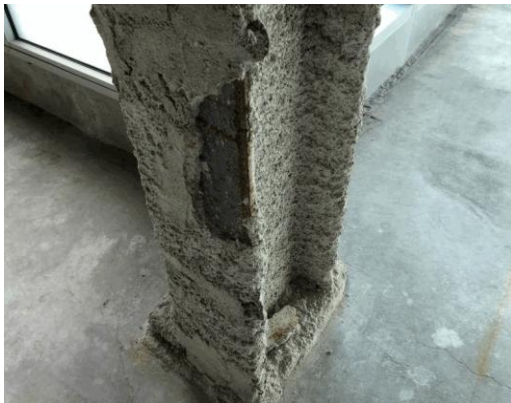
Item #: 525465
Uniformat Number: B1030
Item Title: Steel Building Structure
Caption: Some fireproofing on steel columns is missing
Priority: 3 - Necessary - Not Yet Critical

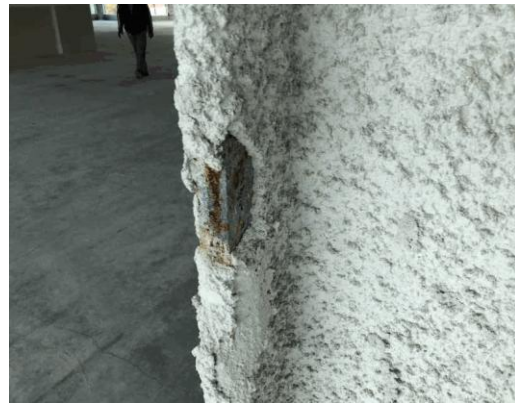
Item #: 525465
Uniformat Number: B1030
Item Title: Steel Building Structure
Caption: Some fireproofing on steel columns is missing
Priority: 3 - Necessary - Not Yet Critical

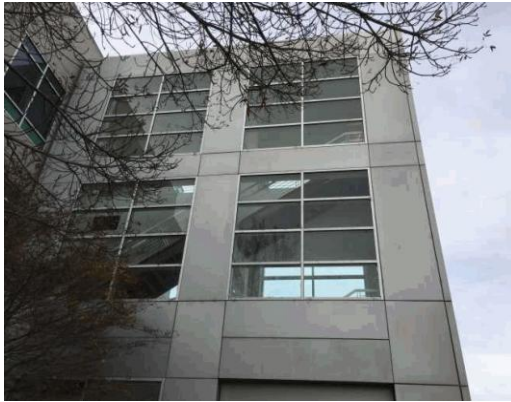
Item #: 490815
Uniformat Number: B2010
Item Title: Exterior Walls
Caption: Staining observed on exterior walls
Priority: 3 - Necessary - Not Yet Critical

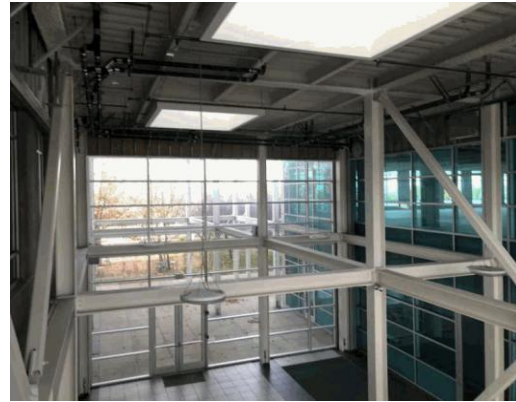
Item #: 525530
Uniformat Number: B2010
Item Title: Exterior Curtain Wall Assemblies
Caption: Energy inefficient single-pane glazed curtain wall assemblies
Priority: 3 - Necessary - Not Yet Critical

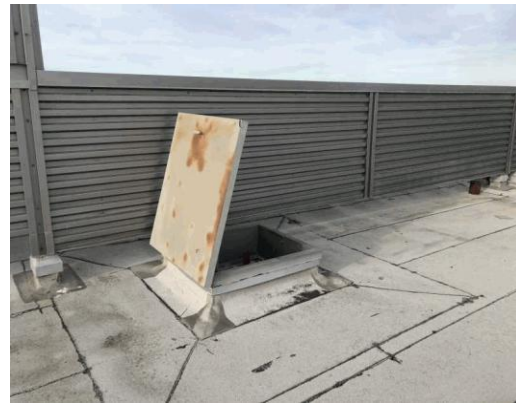
Item #: 525491
Uniformat Number: B3060
Item Title: Roof Hatches
Caption: Roof hatch finish is deteriorating. Surface rust was observed. Roof hatch is missing railing
Priority: 3 - Necessary - Not Yet Critical

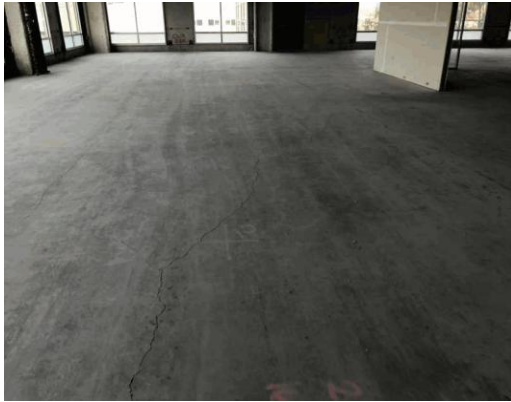
Item #: 525456
Uniformat Number: B1010
Item Title: Composite Floor Decking
Caption: Surface cracking in concrete topping was observed.
Priority: 4 - Recommended

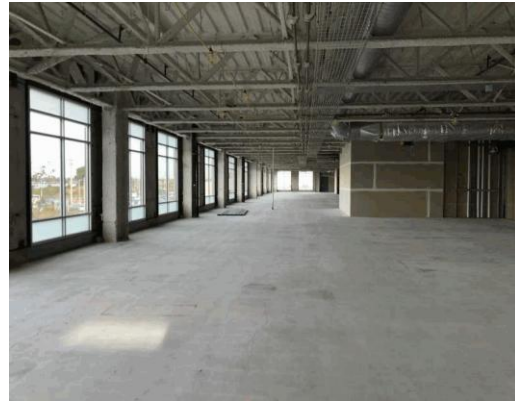
Item #: 525456
Uniformat Number: B1010
Item Title: Composite Floor Decking
Caption: Surface cracking in concrete topping was observed.
Priority: 4 - Recommended

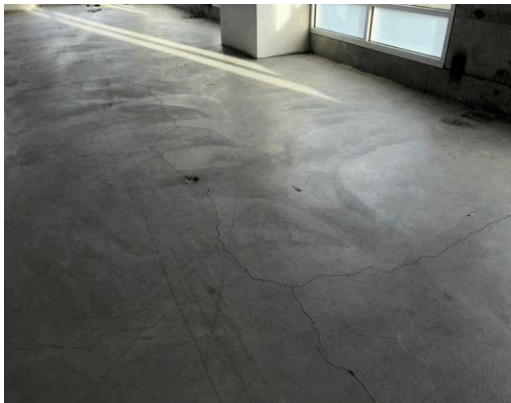
Item #: 525449
Uniformat Number: B1010
Item Title: Composite Floor Decking
Caption: Surface cracking in concrete topping was observed.
Priority: 4 - Recommended

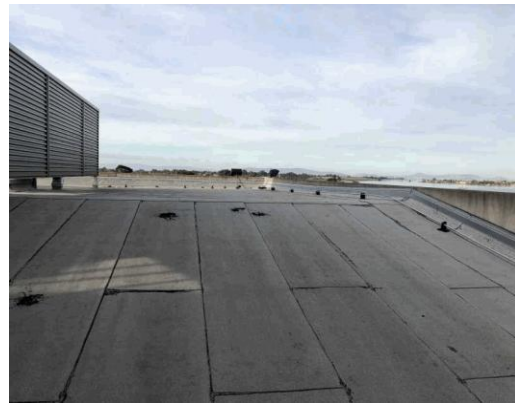
Item #: 525488
Uniformat Number: B3010
Item Title: Roofing - Unprotected Membrane
Caption: Roof is approaching the the end of the expected life cycle
Priority: 4 - Recommended

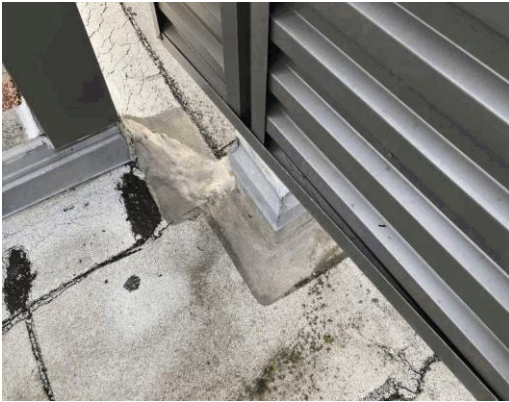
Item #: 525488
Uniformat Number: B3010
Item Title: Roofing - Unprotected Membrane
Caption: Roof is approaching the the end of the expected life cycle
Priority: 4 - Recommended

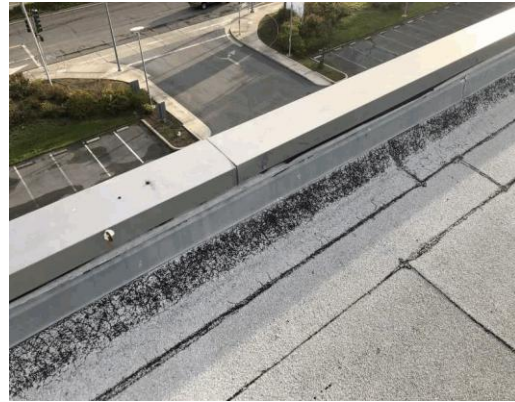
Item #: 525488
Uniformat Number: B3010
Item Title: Roofing - Unprotected Membrane
Caption: Roof is approaching the the end of the expected life cycle
Priority: 4 - Recommended
