Re: Record search results for the proposed Cherryland Fire Station 23 Project.

In accordance with your request, we have prepared this geotechnical evaluation for the proposed Fire Station to be located at 19745 Meekland Avenue in Hayward, California. This report presents our geotechnical findings, conclusions, and recommendations regarding the proposed project.

In accordance with your request, we have performed a geotechnical evaluation for the proposed Fire Station to be located at 19745 Meekland Avenue in Hayward, California (Figure 1). The purpose of our study was to assess potential geologic hazards and evaluate geotechnical conditions for the proposed improvements, and provide our recommendations for the design and construction of this project.

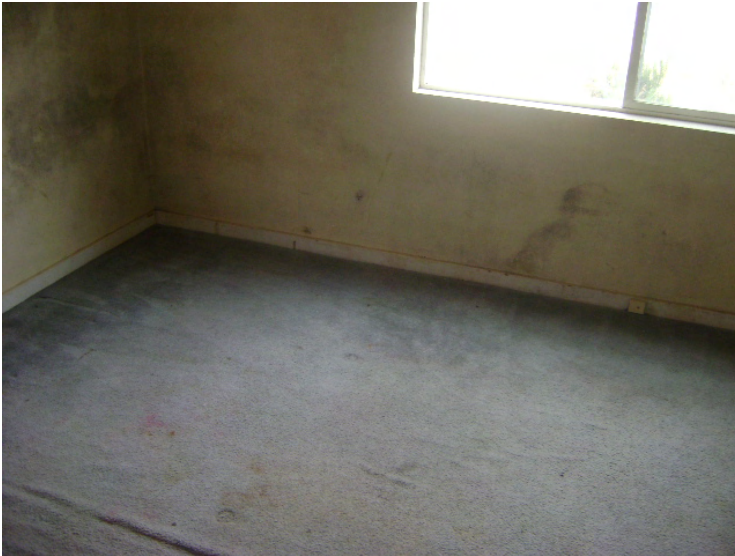
22. View of a bedroom area showing mold growth in the 19755 Meekland Avenue building.

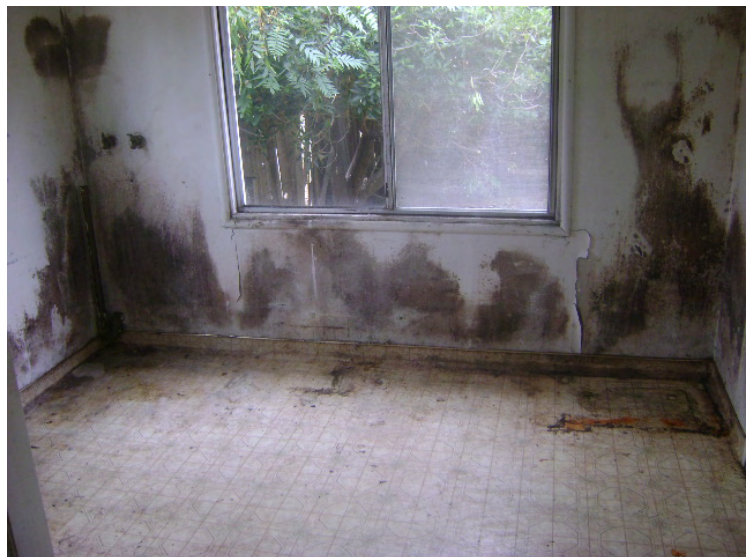
23. View of drywall mold growth in the 19745 Meekland Avenue building.

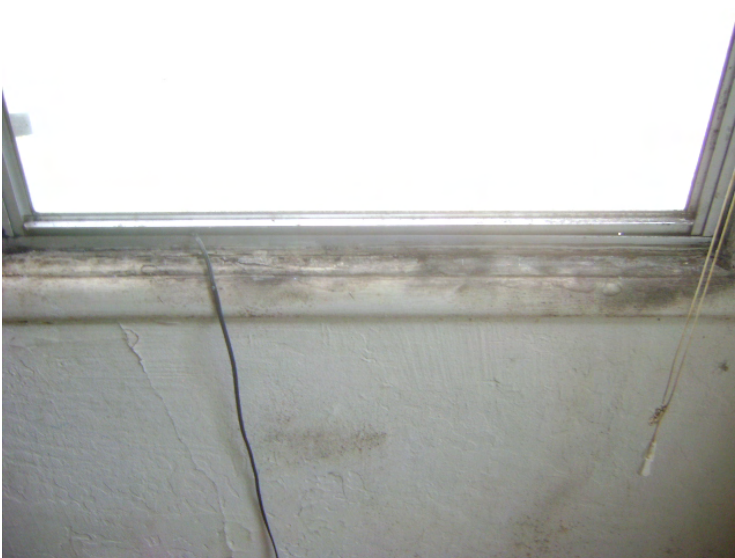
24. View of window frame mold in the 19745 Meekland Avenue building.

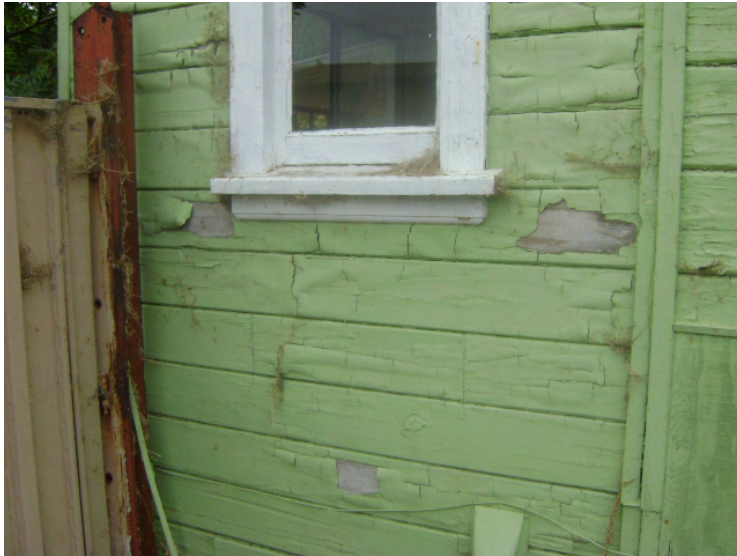
25. View of damaged exterior paint of the 19745 Meekland Avenue building.

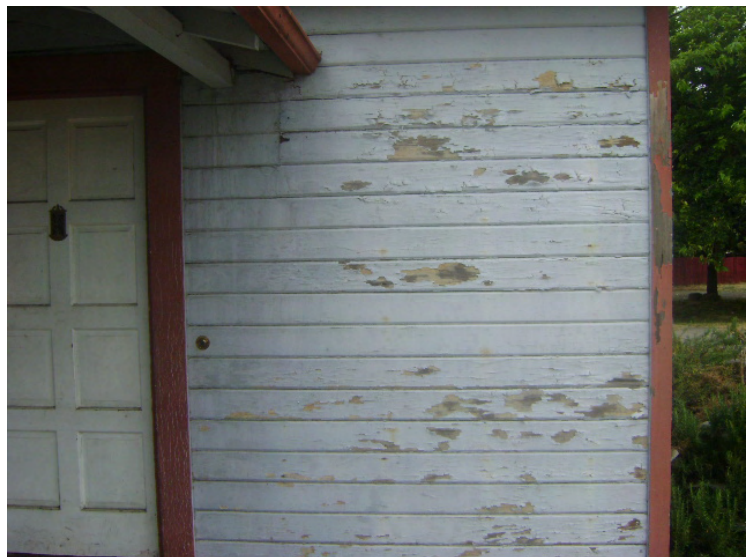
26. View of damaged exterior paint of the 19755 Meekland Avenue building.

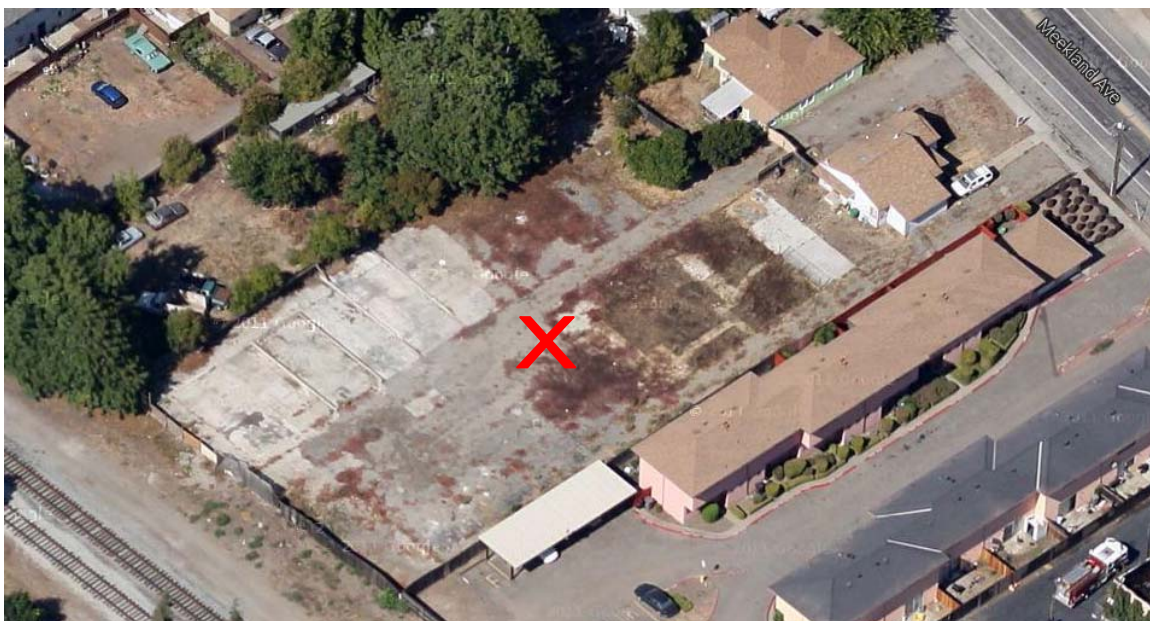
The measurement location was on the property, approximately 100 feet away from the southwest fence that runs parallel to the railroad tracks. Figure 1 below shows the measurement location from an aerial view.

Figure 1 - Aerial photograph of project site. Sound measurement location illustrated in red.  
Image courtesy of Google Maps.
