Tree Risk Assessment

**San Leandro Creek
Location 1 – Huff Ave.
Alameda County Flood Control**

June, 2010

Tree Risk Assessment
San Leandro Creek
Location 1, Huff Ave.
Alameda County Flood Control

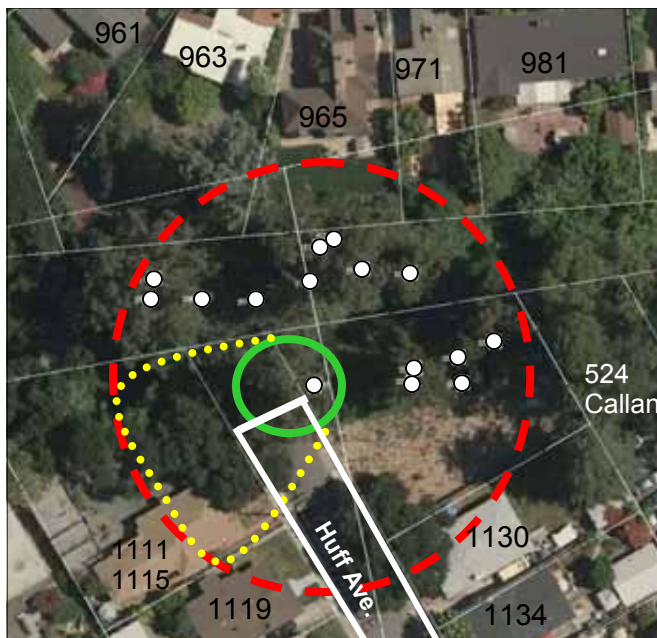
Potential Impact Zone

Potential targets	Private property (1111, 1115, 1119, 1130 Huff Ave., 963, 965, 971 Lee); parking on Huff Ave., creek, bank
Most likely failure mode	Whole tree failure during storm: tall, leaning tree exposed to strong winds on steep slope with wet soil.
Most likely targets	Lean and heavy weight on W will likely direct failure towards 1111, 1115 Huff and parking on Huff., bank
Failure potential	3
Size of part	3
Target rating	4
Risk rating	10
Risk reduction options	To reduce risk, remove SW branch; to eliminate risk, remove tree.

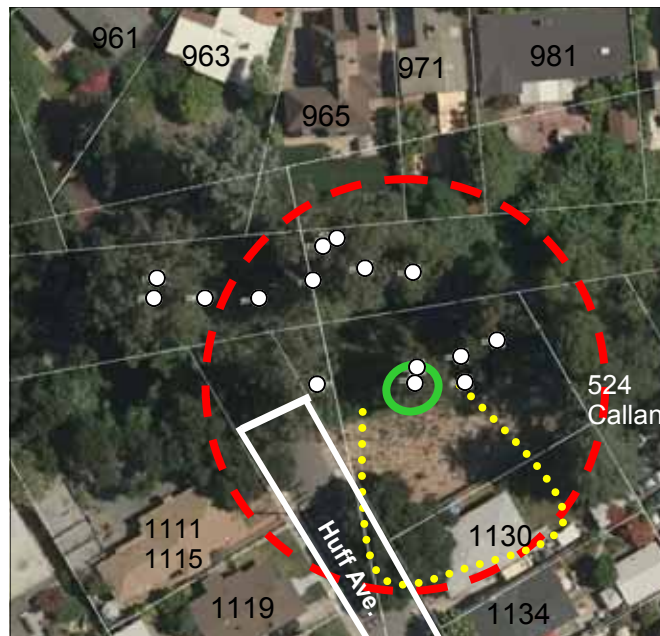
Potential Impact Zone

Possible targets	Private property (1111, 1115, 1119, 1130, Huff Ave., 965, 971 Lee, parking at 524 Callan); parking on Huff Ave., creek, bank
Most likely failure mode	Whole tree failure during storm: tall, asymmetric tree exposed to strong winds on steep slope with wet soil.
Most likely targets	Heavy weight on S will likely direct failure towards 1130 Huff Ave, parking on Huff, bank
Failure potential	2
Size of part	2
Target rating	4
Risk rating	8
Risk reduction options	To reduce risk, prune to reduce weight on S.; to eliminate risk, remove tree.

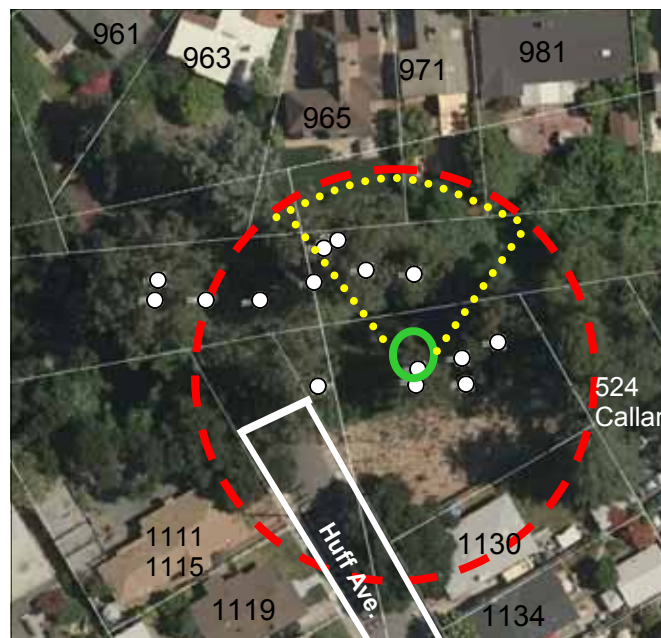
Potential Impact Zone

Possible targets	Private property (1111, 1115, 1119, 1130 Huff Ave., 965, 971, 981 Lee, parking at 524 Callan); parking on Huff Ave., creek, bank
Most likely failure mode	Whole tree failure during storm; tall tree exposed to strong winds on steep slope with wet soil.
Most likely targets	Tree will most likely fall across the creek onto 965, 971, 981 Lee Ave., bank, creek
Failure potential	3
Size of part	2
Target rating	3
Risk rating	8
Risk reduction options	To eliminate risk, remove tree.

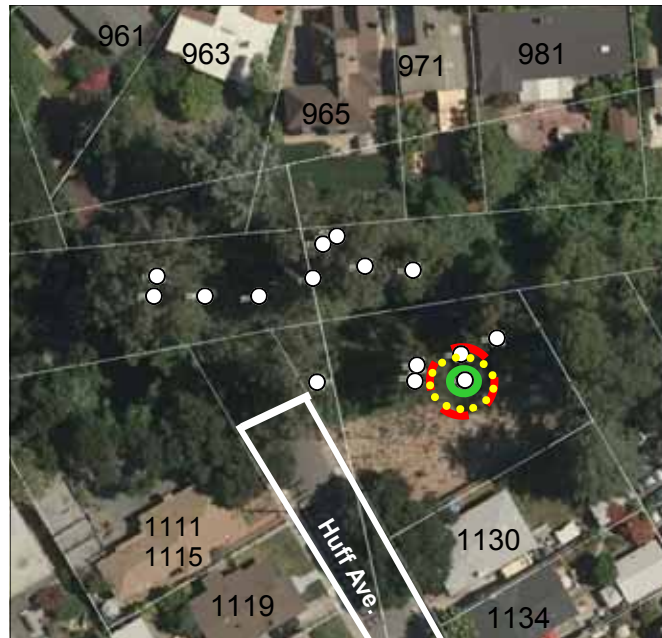
Potential Impact Zone

Possible targets	Creek bank
Most likely failure mode and target	Dead frond falling onto bank
Failure potential	1
Size of part	1
Target rating	1
Risk rating	3
Risk reduction options	none

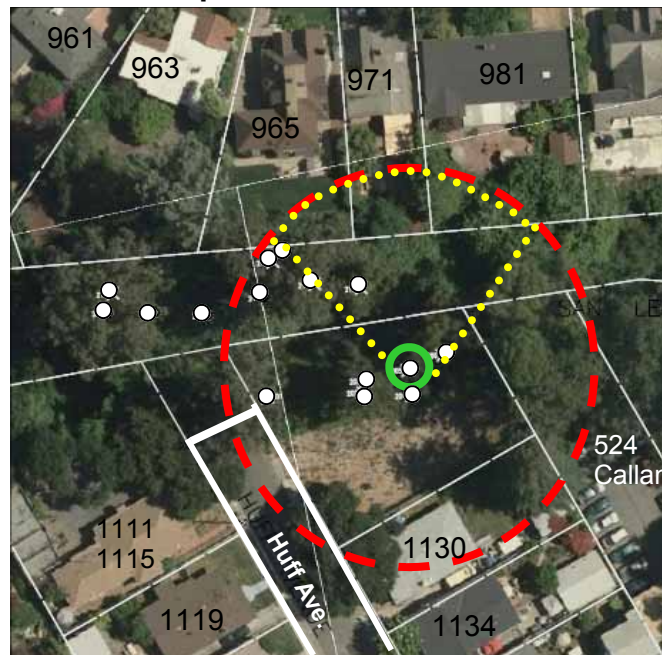
Potential Impact Zone

Possible targets	Private property (1130 Huff Ave., 965, 971, 981 Lee; parking at 524 Callan); parking on Huff Ave., creek, bank
Most likely failure mode	Whole tree failure during storm: tall, tree exposed to strong winds on steep slope with wet soil.
Most likely targets	Tree will most likely fall across the creek onto 965, 971, 981 Lee Ave., bank, creek
Failure potential	3
Size of part	2
Target rating	3
Risk rating	8
Risk reduction options	To eliminate risk, remove tree.

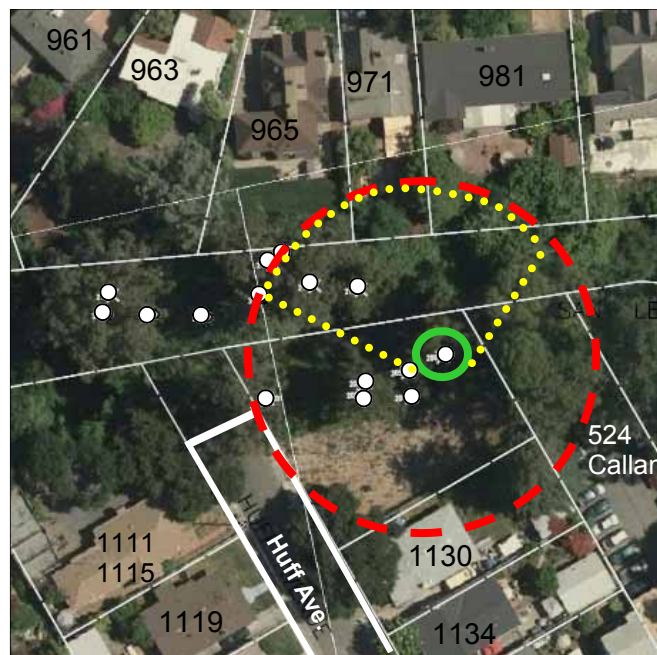
Potential Impact Zone

Possible targets	Private property (1130 Huff Ave., 965, 971, 981 Lee, parking at 524 Callan); creek, bank
Most likely failure mode	Whole tree failure during storm: tall, tree exposed to strong winds on steep slope with wet soil.
Most likely target	Tree will most likely fall across the creek on 965, 971, 981 Lee Ave., bank, creek
Failure potential	4
Size of part	2
Target rating	3
Risk rating	9
Risk reduction options	To eliminate risk, remove tree.

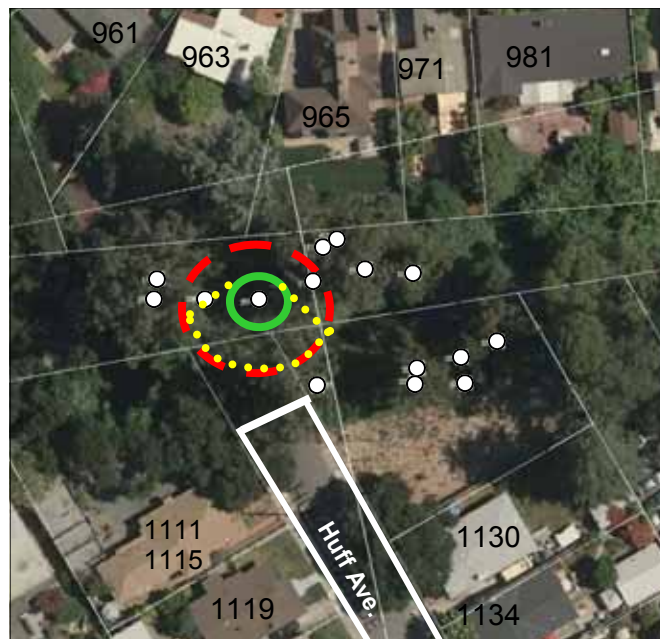
Potential Impact Zone

Possible targets	bank, creek
Most likely failure mode	Decayed trunk break at weakest point
Most likely targets	Trunk falling into creek, bank
Failure potential	3
Size of part	2
Target rating	1
Risk rating	6
Risk reduction options	Coppice tree to reduce risk

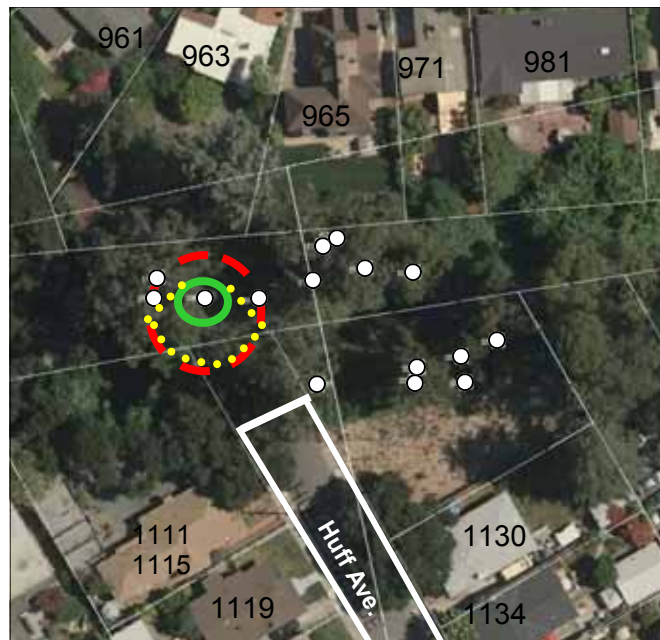
Potential Impact Zone

Diameter class	6-12"
# trunks	1
Height	34'
Position	bench
Bank; slope	north; 2:1
Vines on trunk?	yes
Comments	Leaning south; stump sprout; extensive decay

Possible targets	bank, creek
Most likely failure mode	Decayed trunk break at weakest point
Most likely targets	Trunk falling into creek, bank
Failure potential	3
Size of part	2
Target rating	1
Risk rating	6
Risk reduction options	Coppice tree to reduce risk.

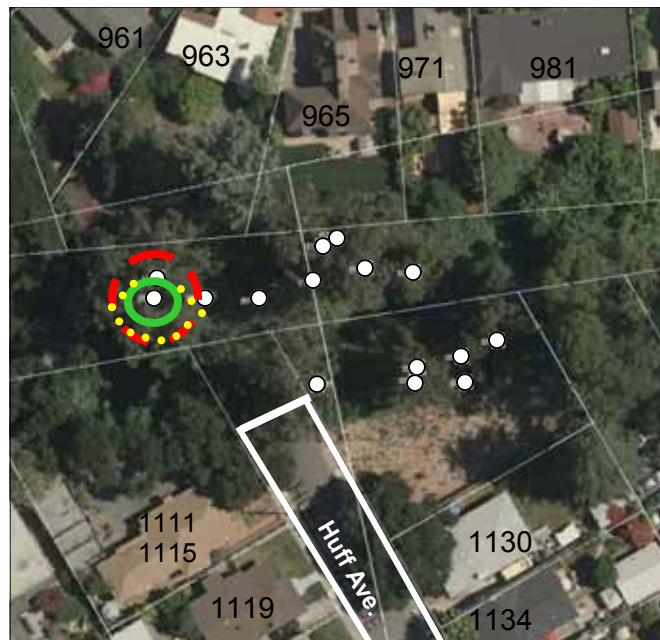
Potential Impact Zone

Diameter class	6-12"
# trunks	1
Height	27'
Position	lower bank
Bank; slope	north; 1.5:1
Vines on trunk?	yes
Comments	Leaning south over creek; stump sprout; extensive decay

Possible targets	bank, creek
Most likely failure mode	Decayed trunk break at weakest point
Most likely targets	Trunk falling into creek, bank
Failure potential	3
Size of part	2
Target rating	1
Risk rating	6
Risk reduction options	Coppice tree to reduce risk.

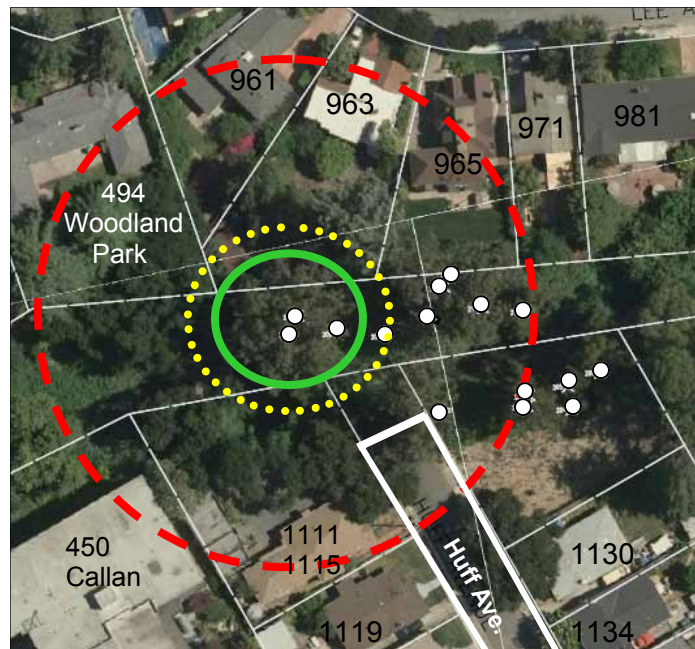
Potential Impact Zone

Diameter class	48-60"
# trunks	1
Height	138'
Position	upper bank
Bank; slope	north, 1.5:1
Vines on trunk?	yes
Comments	Wide-spreading crown with many large branches arising from old pruning cuts; previously topped; trunk obscured by ivy; small pocket trunk decay.

Possible targets	Private property (1111, 1115 Huff Ave., 961, 963, 965, Lee, 450 Callan, 494 Woodland Park); parking on Huff Ave., creek, bank.
Most likely failure mode	Failure of one or more large scaffold branches arising at old topping cut, under strong winds.
Most likely targets	Large scaffold branch falling onto 963 Lee, bank, creek.
Failure potential	3
Size of part	3
Target rating	3
Risk rating	9
Risk reduction options	To eliminate risk, remove tree.

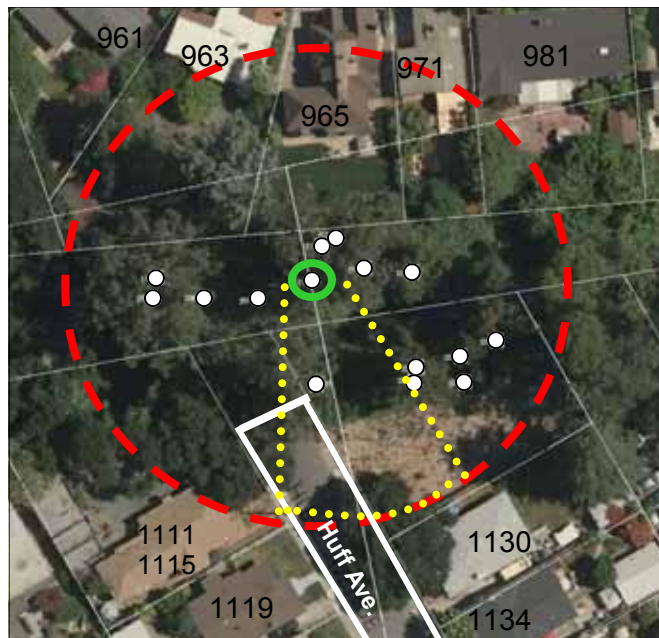
Potential Impact Zone

Possible targets	Private property (1111, 1115 Huff Ave., 963, 965, 971, 981 Lee); parking on Huff Ave., creek, bank.
Most likely failure mode	Trunk failure due to decay that is common present in old sycamores (trunk obscured by vines) and/or soil failure in storm.
Most likely targets	Whole tree failure onto parking on Huff, bank, creek.
Failure potential	2
Size of part	1
Target rating	3
Risk rating	6
Risk reduction options	Coppice tree to reduce risk.

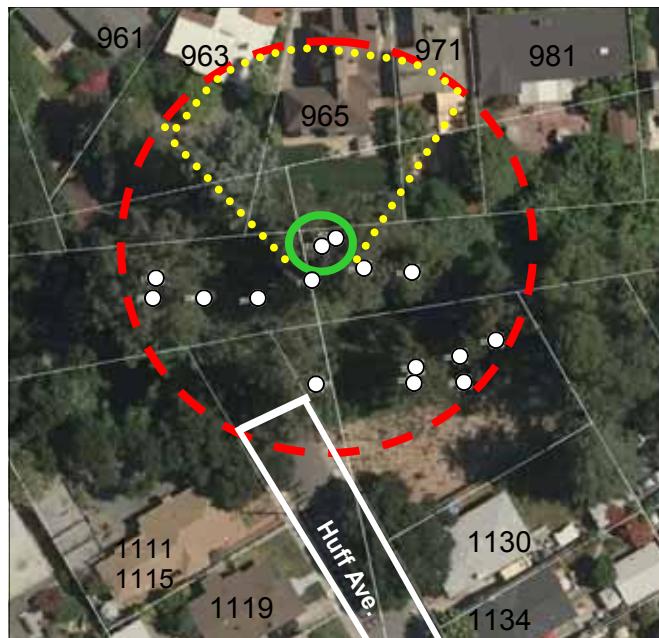
Potential Impact Zone

Diameter class	48-60"
# trunks	1
Height	105'
Position	upper bank
Bank; slope	north, 1.5:1
Vines on trunk?	yes
Comments	Leaning north; trunk decay; trunk obscured by ivy.

Possible targets	Private property (1111 Huff Ave., 963, 965, 971, 981 Lee); parking on Huff Ave., creek, bank.
Most likely failure mode	Whole tree failure during storm; aggravated by lean; tall, tree exposed to strong winds on steep slope with wet soil.
Most likely targets	Because of N lean, whole tree is most likely to fail onto 963, 659, 971 Lee Ave., bank.
Failure potential	4
Size of part	3
Target rating	4
Risk rating	11
Risk reduction options	To eliminate risk, remove tree.

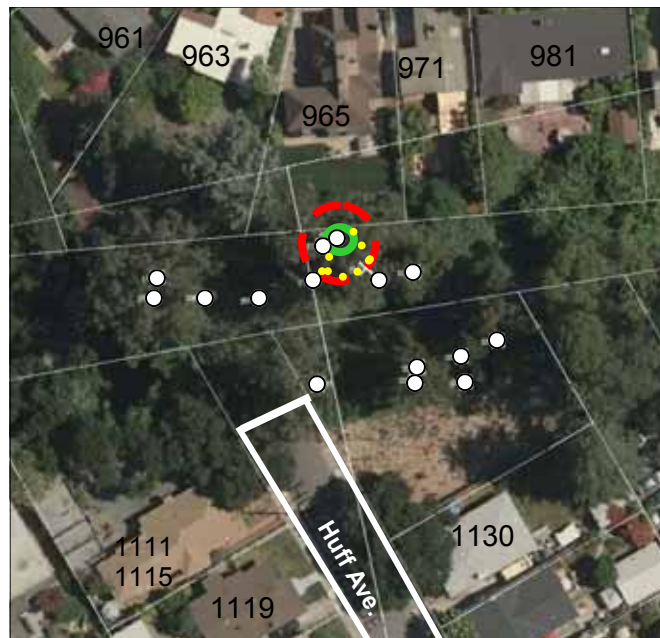
Potential Impact Zone

Diameter class	18-24"
# trunks	2
Height	32'
Position	upper bank
Bank; slope	north, 1.5:1
Vines on trunk?	yes
Comments	Extensive decay; completely over-grown with ivy.

Possible targets	bank, creek
Most likely failure mode	Decayed trunk break at weakest point
Most likely targets.	Trunk falling onto bank
Failure potential	4
Size of part	2
Target rating	1
Risk rating	7
Risk reduction options	Coppice tree to eliminate risk

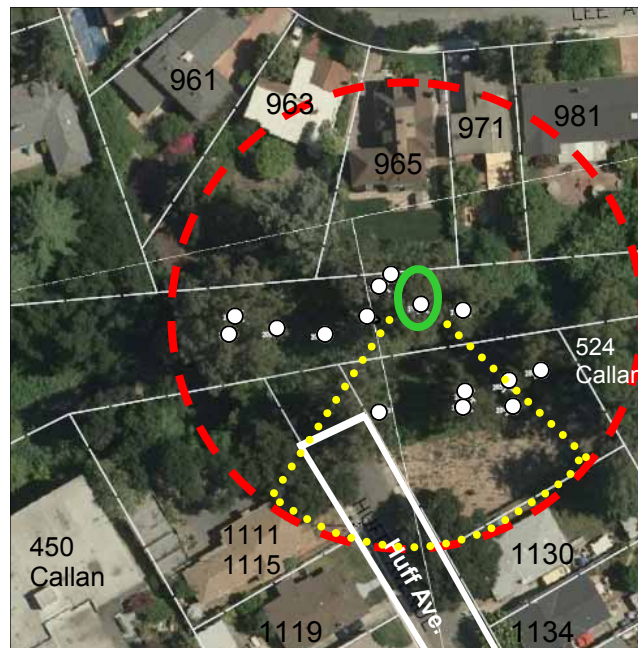
Potential Impact Zone

Possible targets	Private property (1111, 1115, 1130 Huff Ave., 963, 965, 971, 981 Lee, parking at 524 Callan); parking on Huff Ave., creek, bank
Most likely failure mode	Whole tree failure during storm: tall, tree exposed to strong winds on steep slope with wet soil.
Most likely targets	Tree will most likely fall across the creek onto 1111, 1115, 1130 Huff Ave., bank, creek
Failure potential	2
Size of part	2
Target rating	3
Risk rating	7
Risk reduction options	To eliminate risk, remove tree.

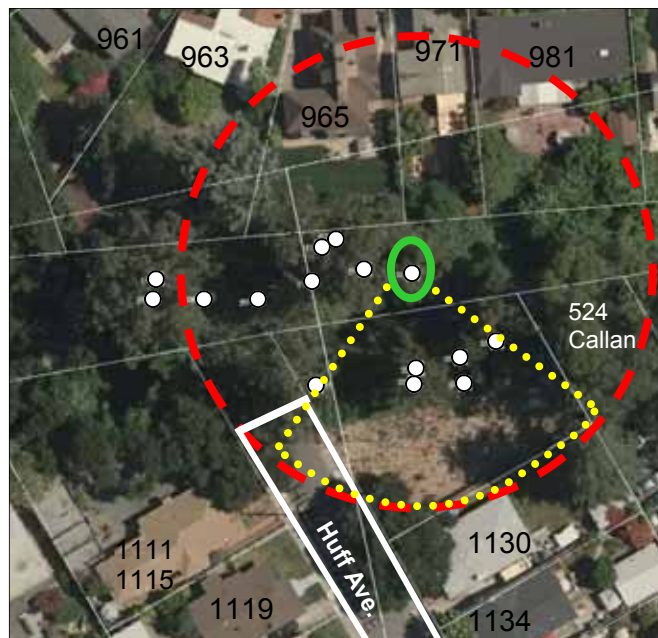
Potential Impact Zone

Possible targets	Private property (1130 Huff Ave., 963, 965, 971, 981 Lee, parking at 524 Callan); parking on Huff Ave., creek, bank
Most likely failure mode	Whole tree failure during storm: tall, tree exposed to strong winds on steep slope with wet soil.
Most likely targets	Tree will most likely fall across the creek onto Huff Ave., parking, bank, creek
Failure potential	2
Size of part	2
Target rating	3
Risk rating	7
Risk reduction options	To eliminate risk, remove tree.
