INVESTMENT ADVISORY FACILITY CONDITION REPORT

County of Alameda – MLKJ Way
1918 Martin Luther King Jr. Way
Oakland, California 94612

December 6, 2022
Partner Project Number: 22-388732.1

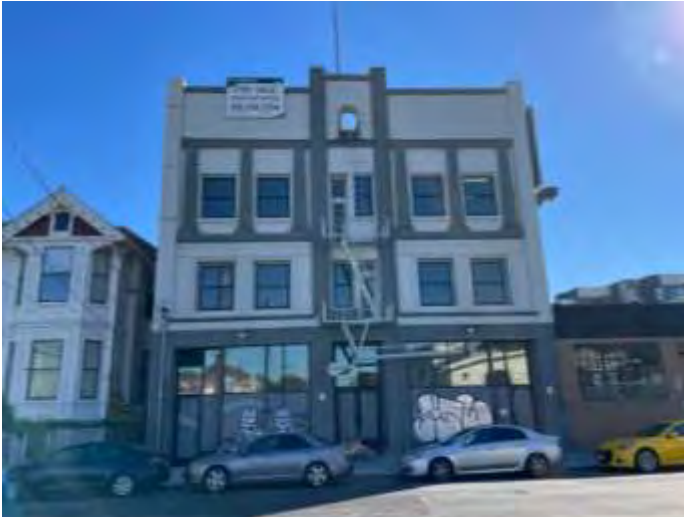
1. Front elevation of subject property

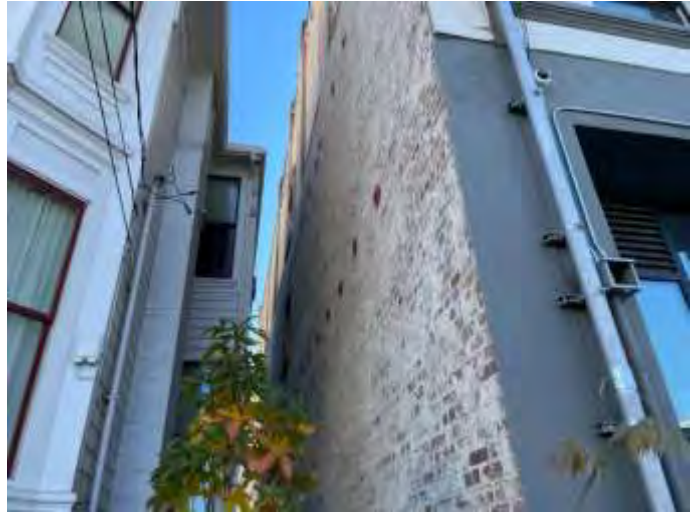
2. North elevation of subject property

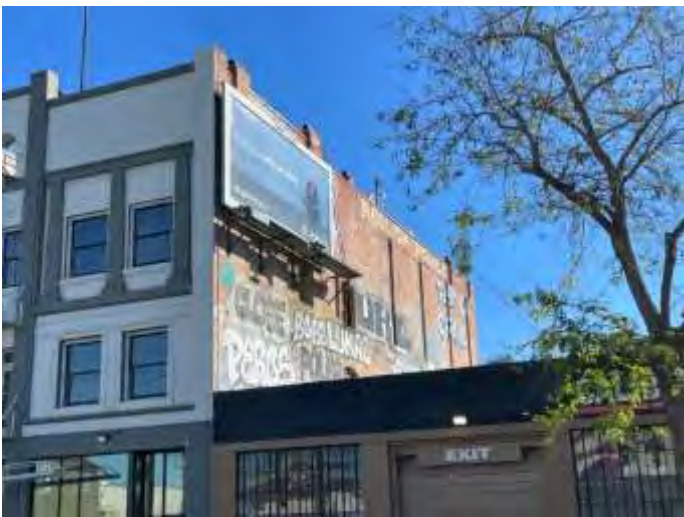
3. South elevation of subject property

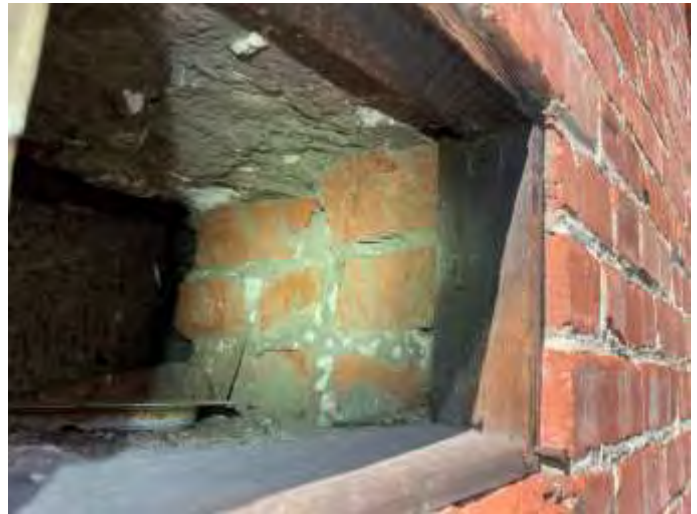
8. Four wythe wide brick at ground level

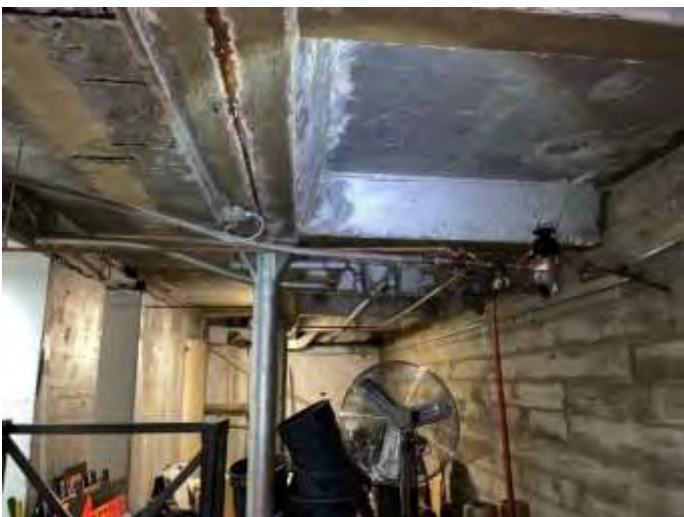
9. Concrete at perimeter of basement

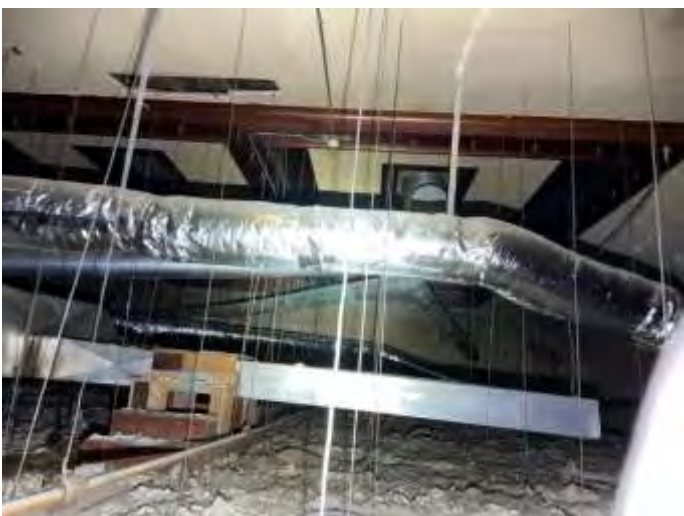
11. Two ceiling systems above the auditorium

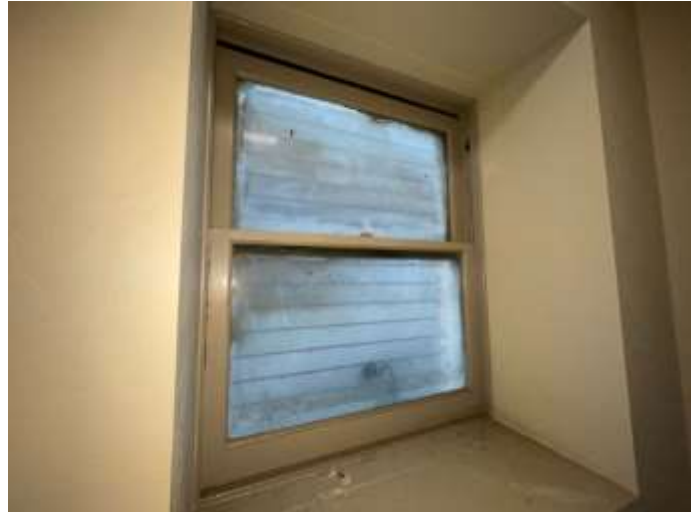
14. Typical wood framed exterior window

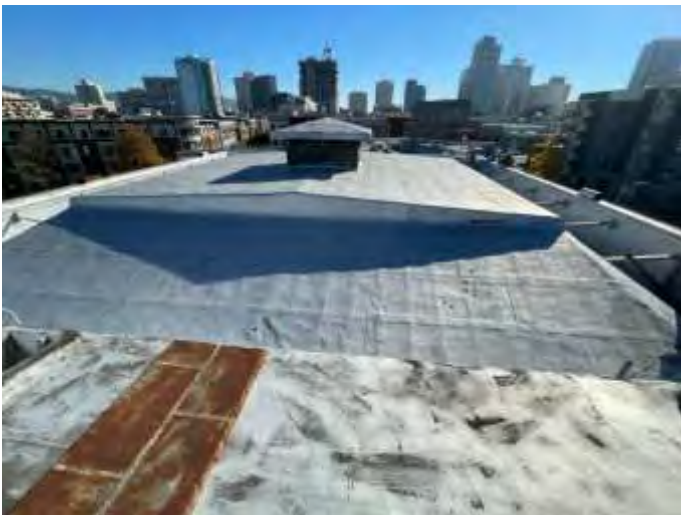
15. BUR with aluminized emulsion coating

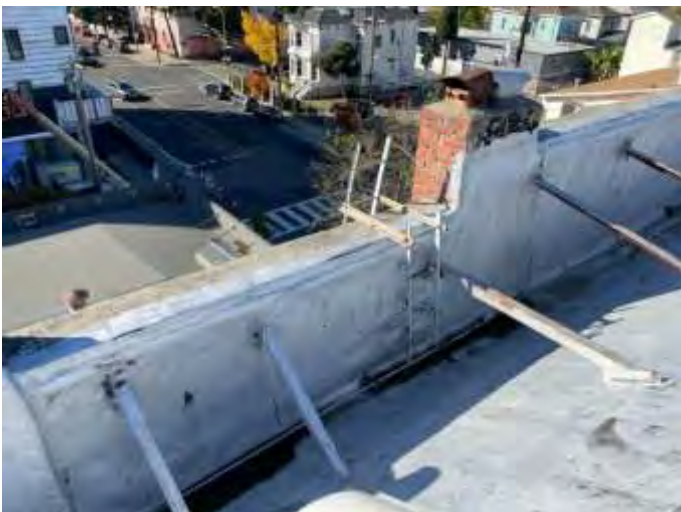
17. Two wythe wide parapet walls

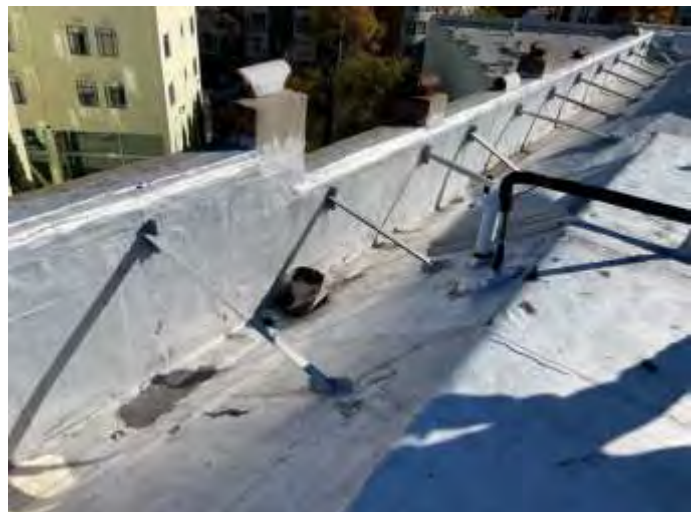
18. Parapet wall bracing

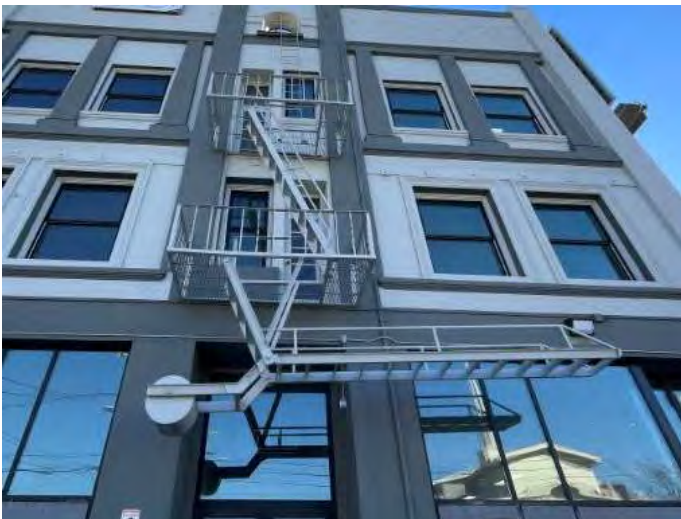
21. Steel fire escape on front elevation with water tank counterbalance ladder/stairs

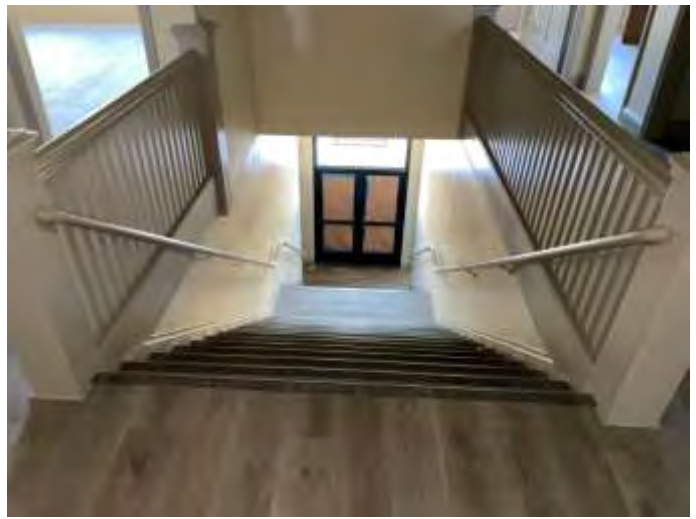
22. Main interior wood stairway to upper floors

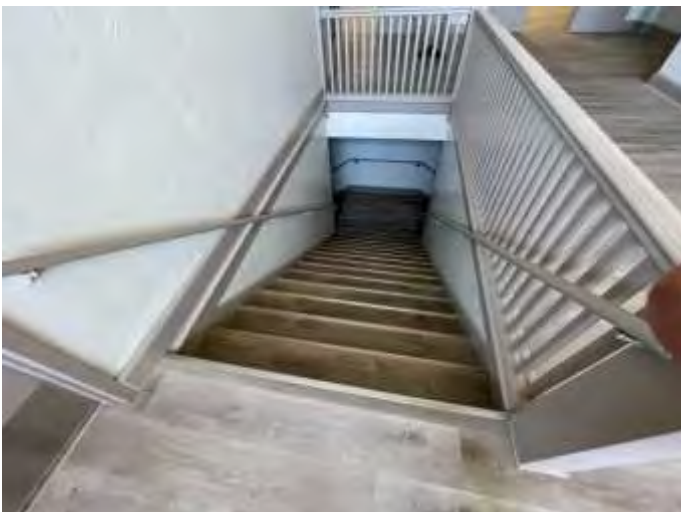
23. Wood stairway to basement

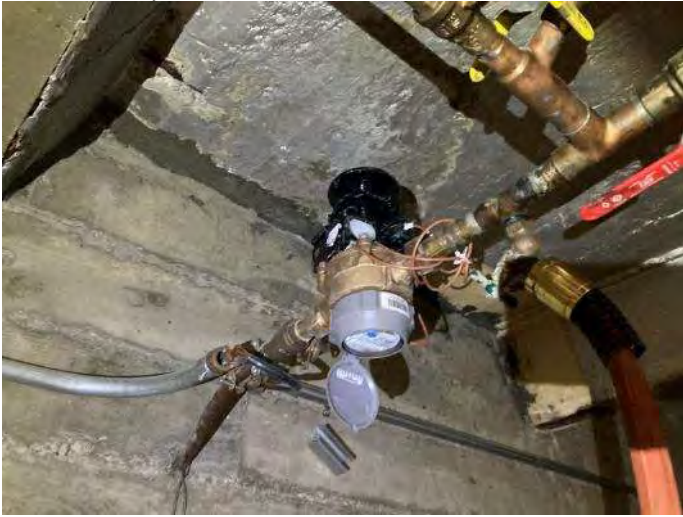
25. Water service entrance in the basement

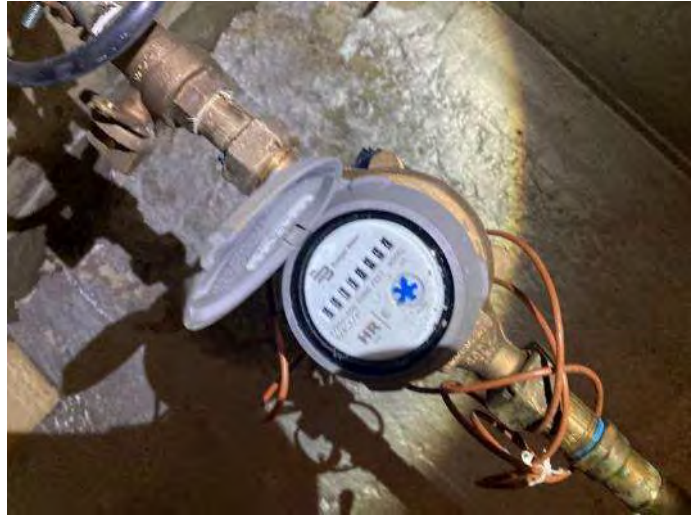
26. Water meter in the basement

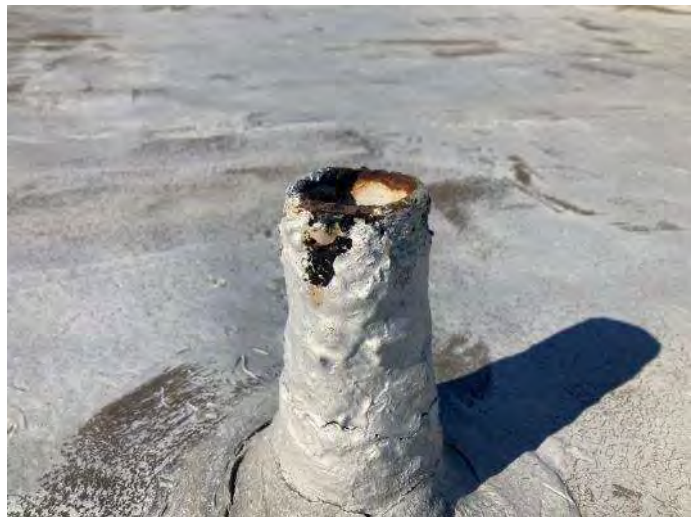
28. Cast iron sanitary vent

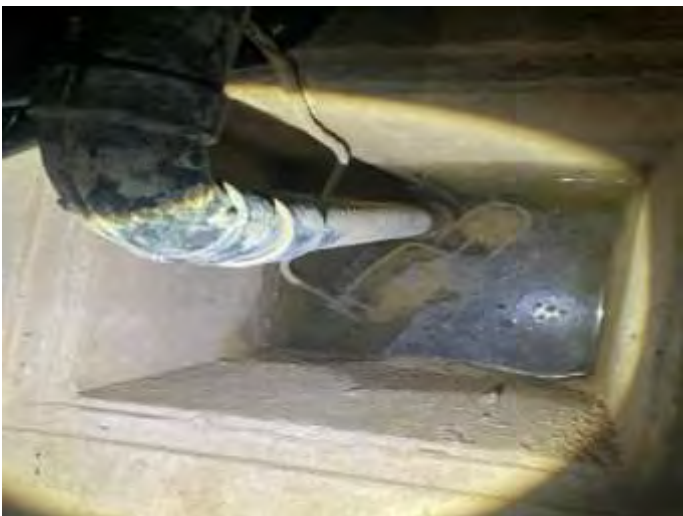
29. Sump pump in the basement

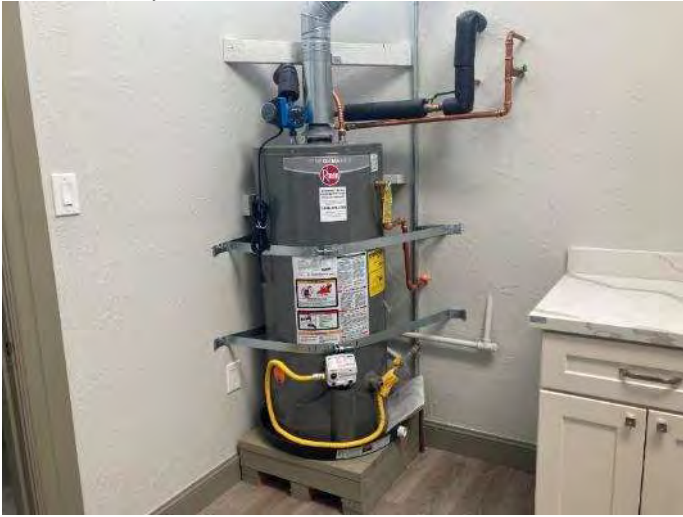
31. Gas storage-type water heater

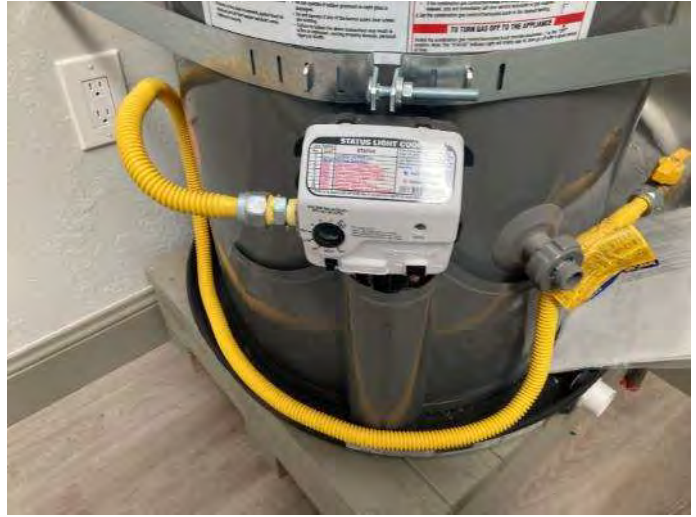
32. Floor pan for water heater

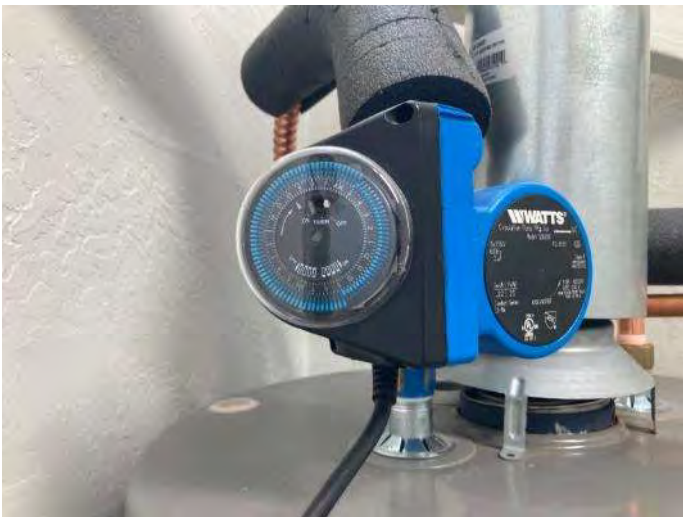
33. Timer controlled recirculation pump

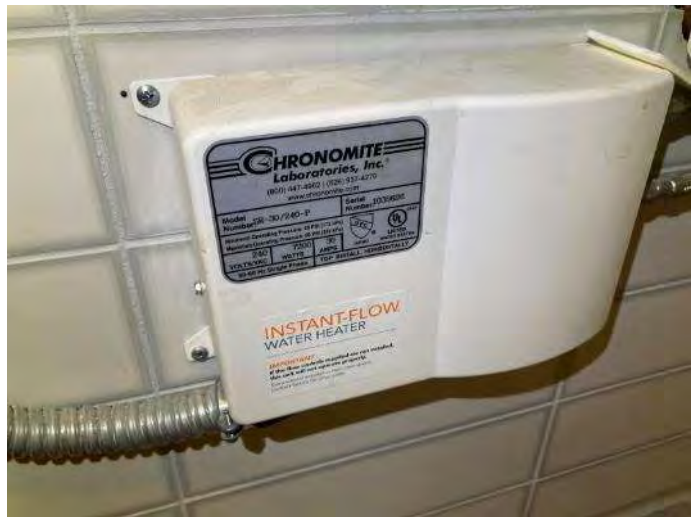
34. Electric instantaneous water heater in the first-floor bathroom

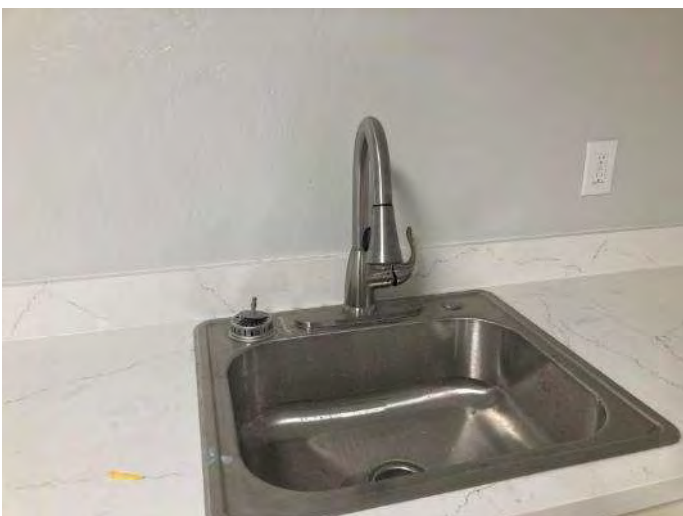
35. 1.8 gpm kitchen faucet in the basement

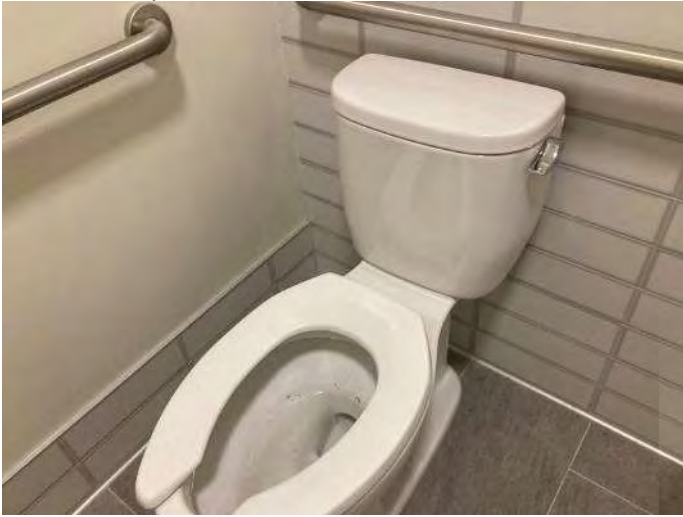
37. 1.28 gallon per flush toilet in first floor bathroom

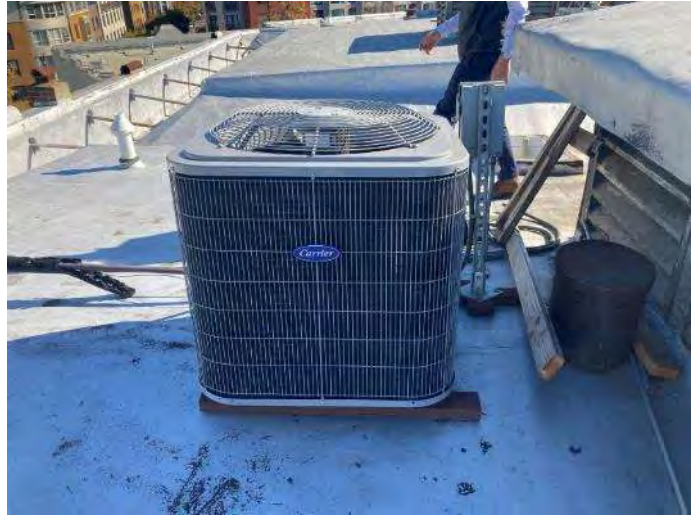
38. Rooftop condensing unit for split-AC system

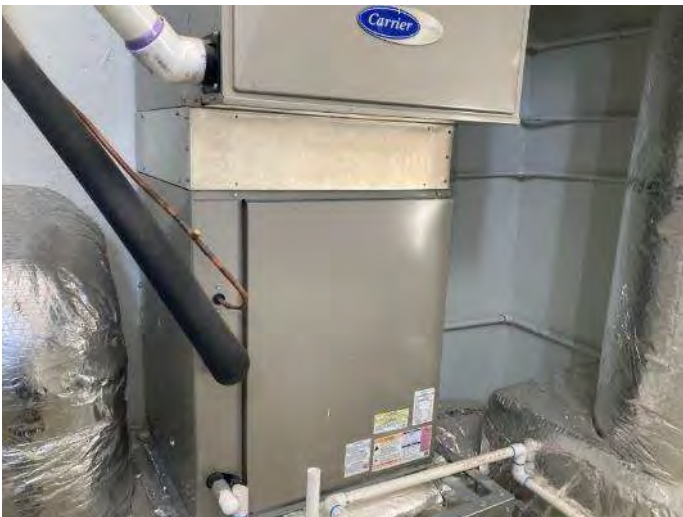
39. Split-AC system indoor fan coil unit

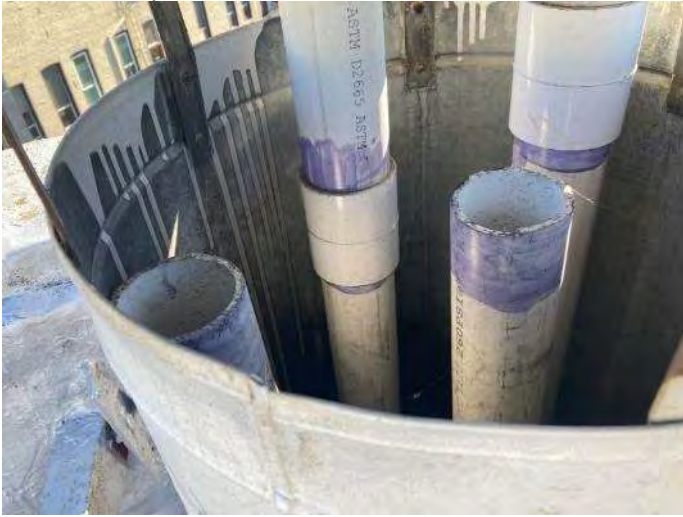
43. Gas furnace units' exhaust flue termination at the roof

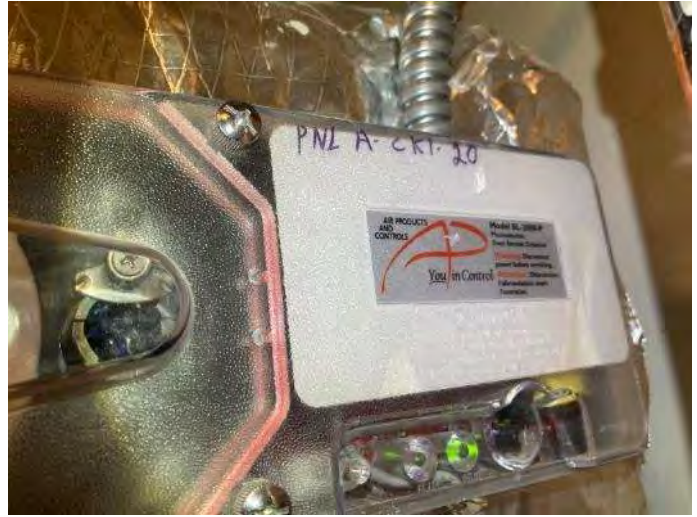
44. Gas furnace unit discharge duct smoke detector

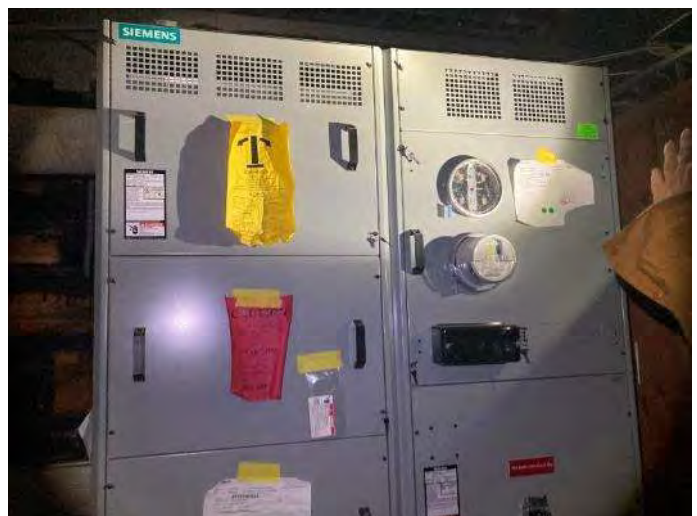
48. Electrical switchboard in the basement

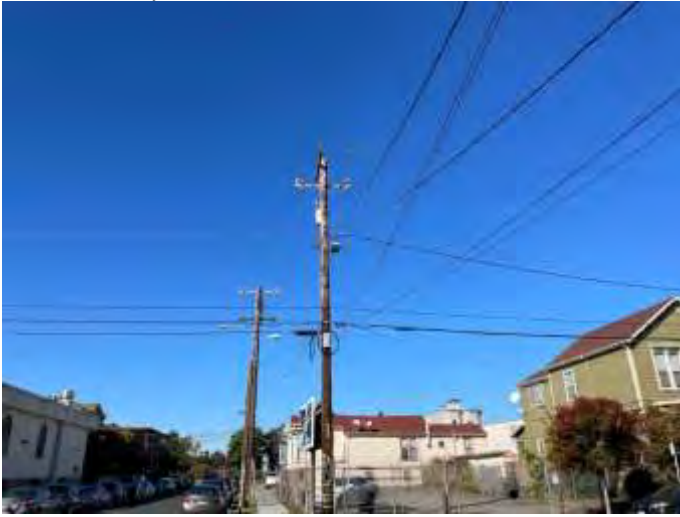
49. Pole mounted transformer

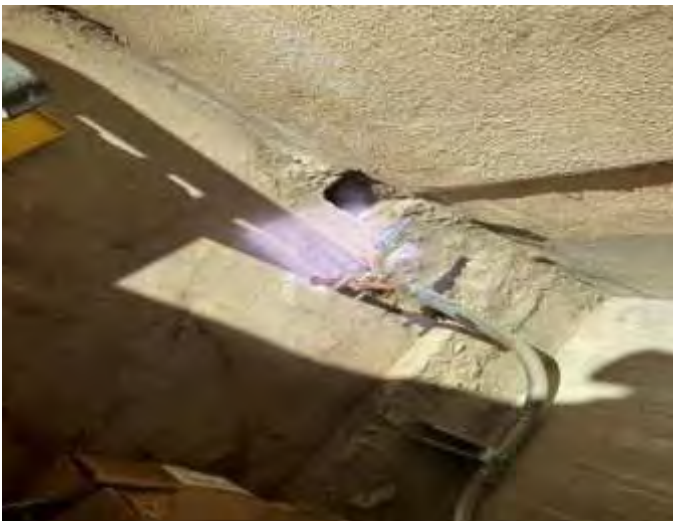
51. Copper wiring ground system

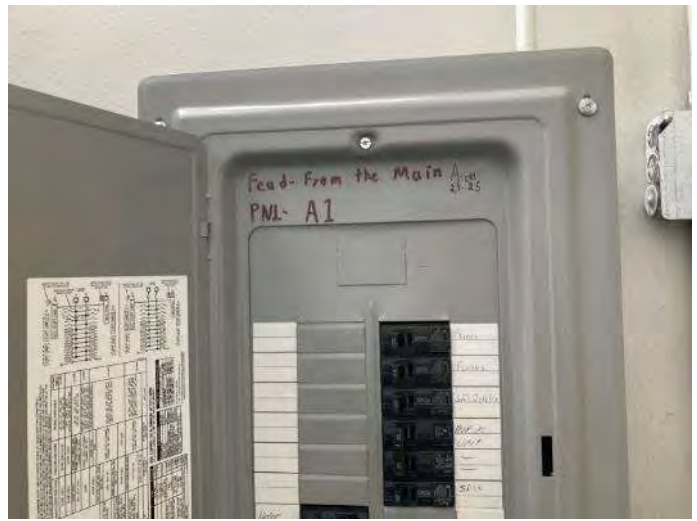
52. Electrical breaker in the furnace room at the roof level

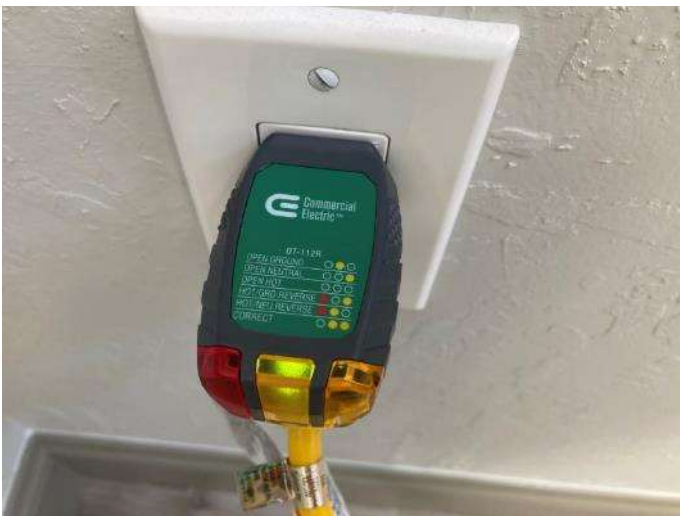
53. Functioning GFCI in the water heater room

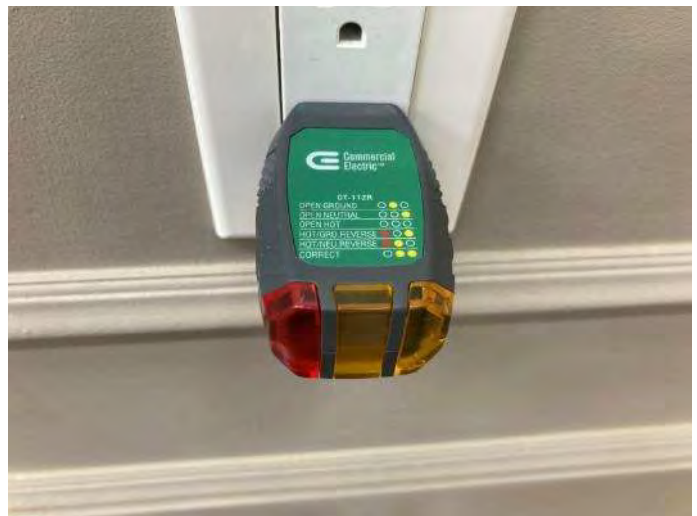
54. Open hot GFCI outlet in the 3rd floor open area

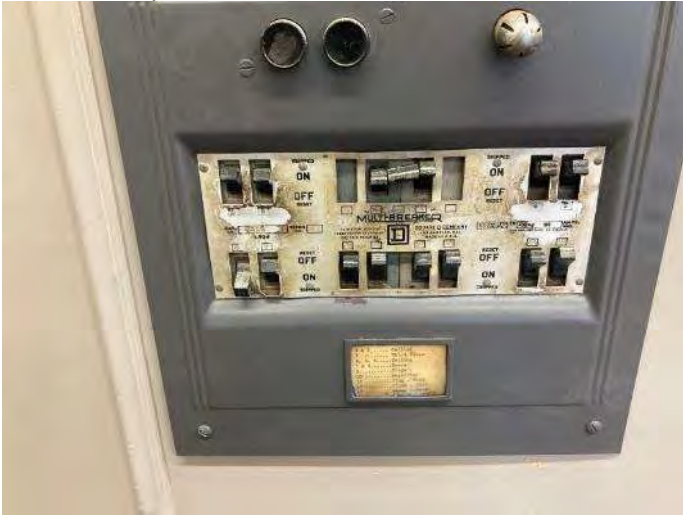
55. Old breaker panel in the 3rd floor open area

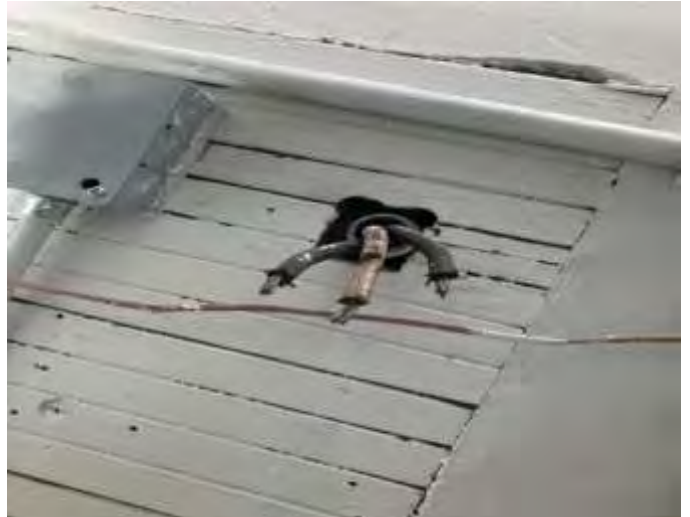
56. Exposed electrical wiring in furnace room on the roof level

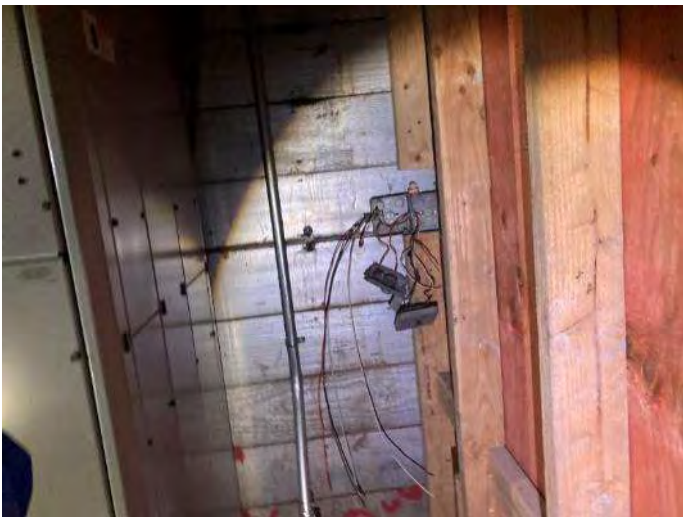
57. Exposed junction box

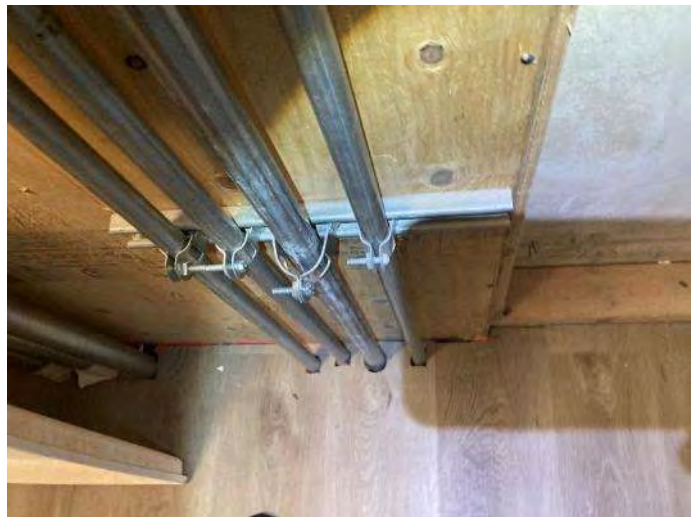
58. Uncaulked electrical pipes on 1st floor

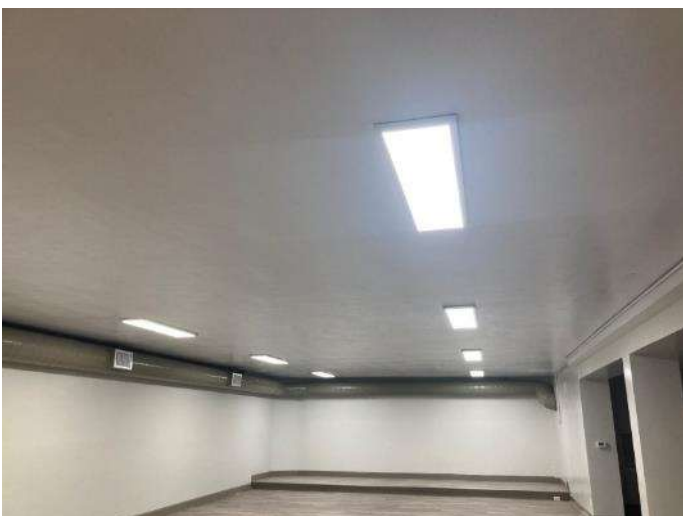
59. LED lighting in the basement

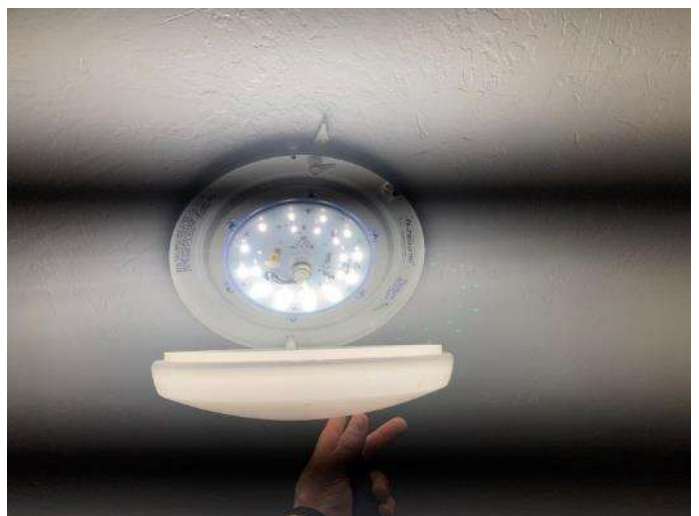
60. LED lighting in closet

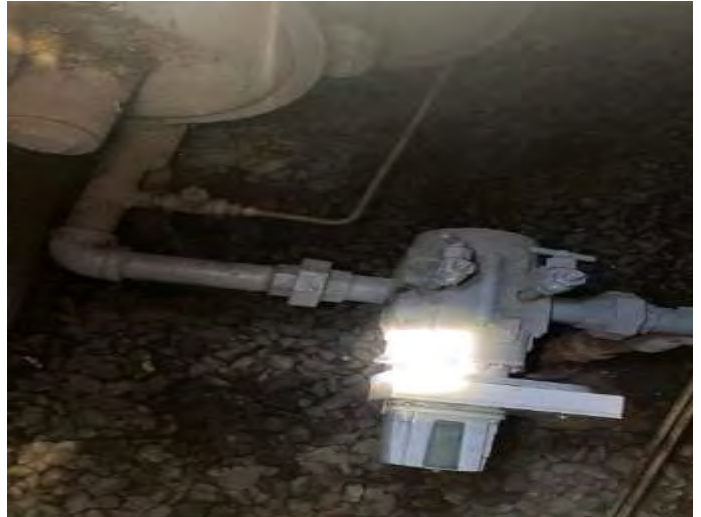
62. Gas meter in underground vault

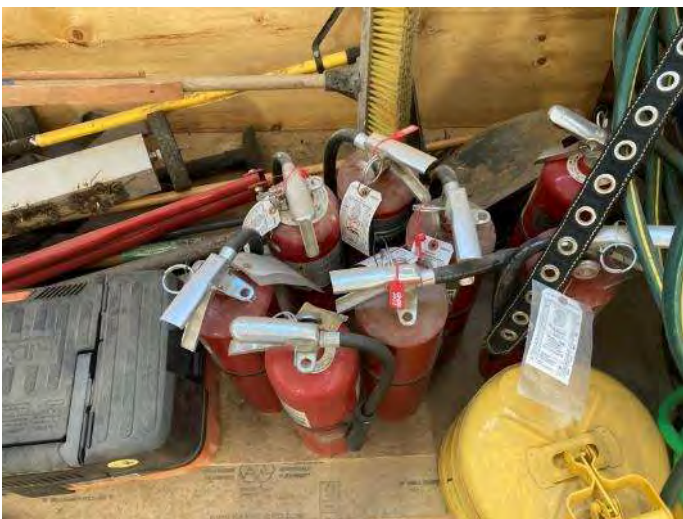
63. Inventoried fire extinguishers

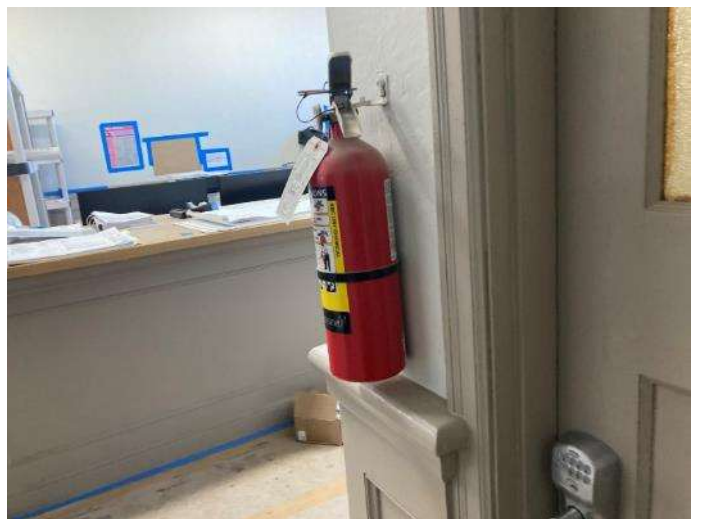
64. Fire extinguisher in the lobby office

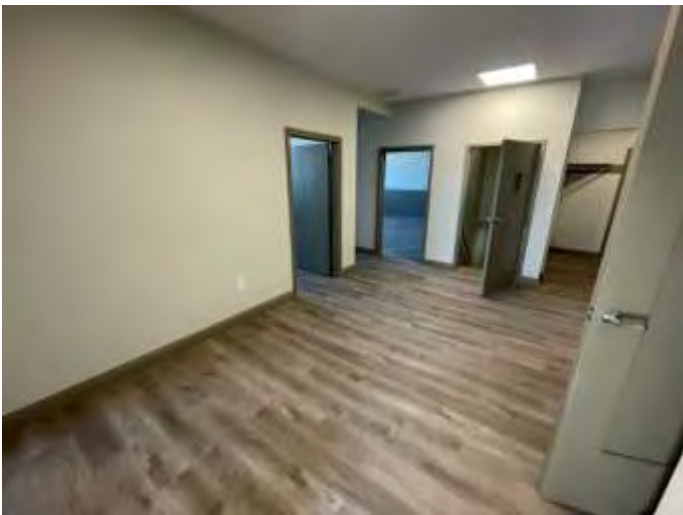
69. Typical hallway finishes

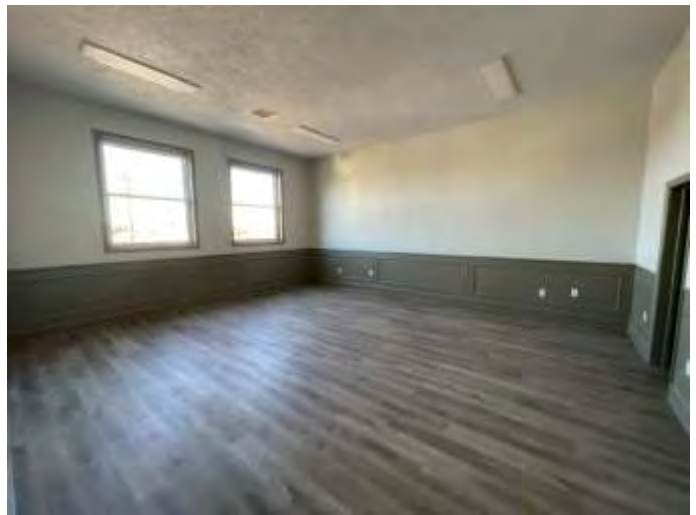
70. Typical office space finishes

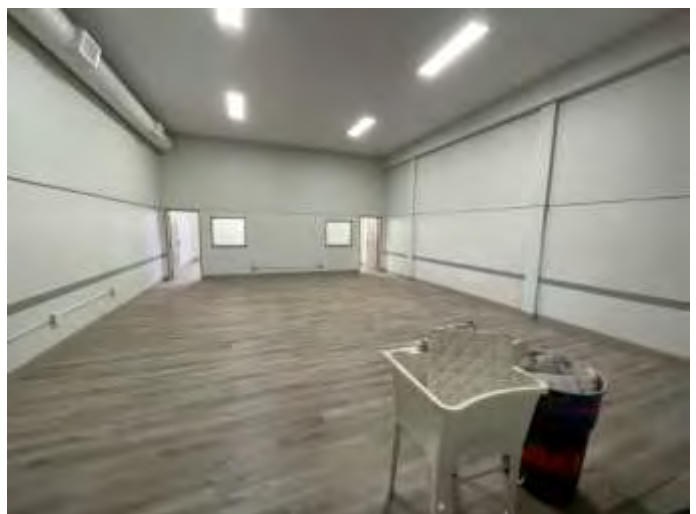
72. Back room on ground floor with 1x1 acoustic tile walls

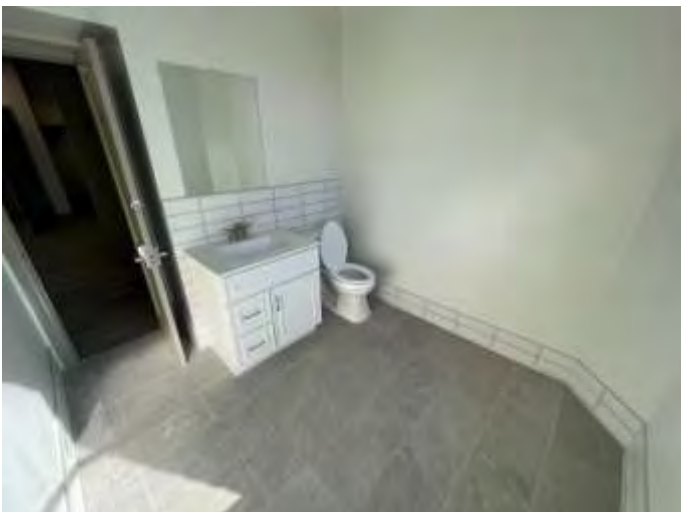
77. Typical upper-level restroom finishes

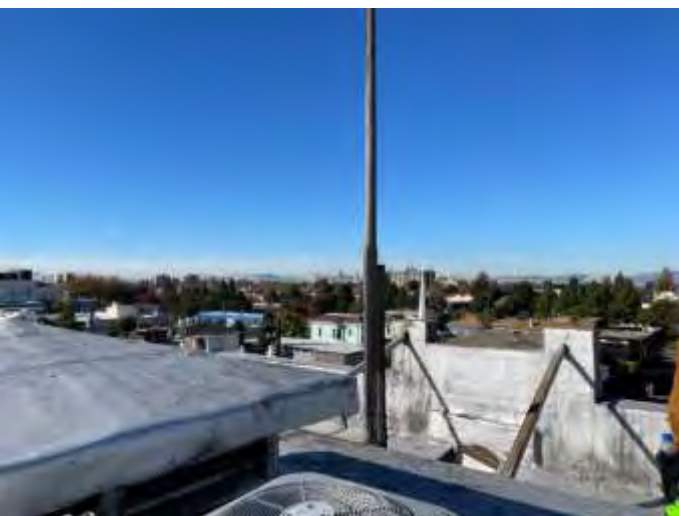
95. Flagpole needs to be removed

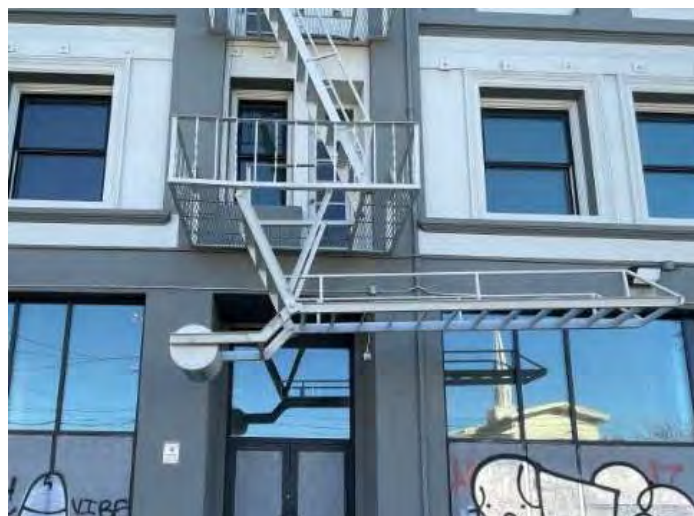
96. Certification and making the fire escape safe is required
