G E O T E C H N I C A L E N G I N E E R I N G
I N V E S T I G A T I O N R E P O R T

GEOTECHNICAL ENGINEERING INVESTIGATION REPORT
THE MOSAIC PROJECT
17015 CULL CANYON ROAD
CASTRO VALLEY, CALIFORNIA
September 16, 2019

**Reference: Geotechnical Engineering Investigation Report
The Mosaic Project
17015 Cull Canyon Road
Castro Valley, Alameda County, California**

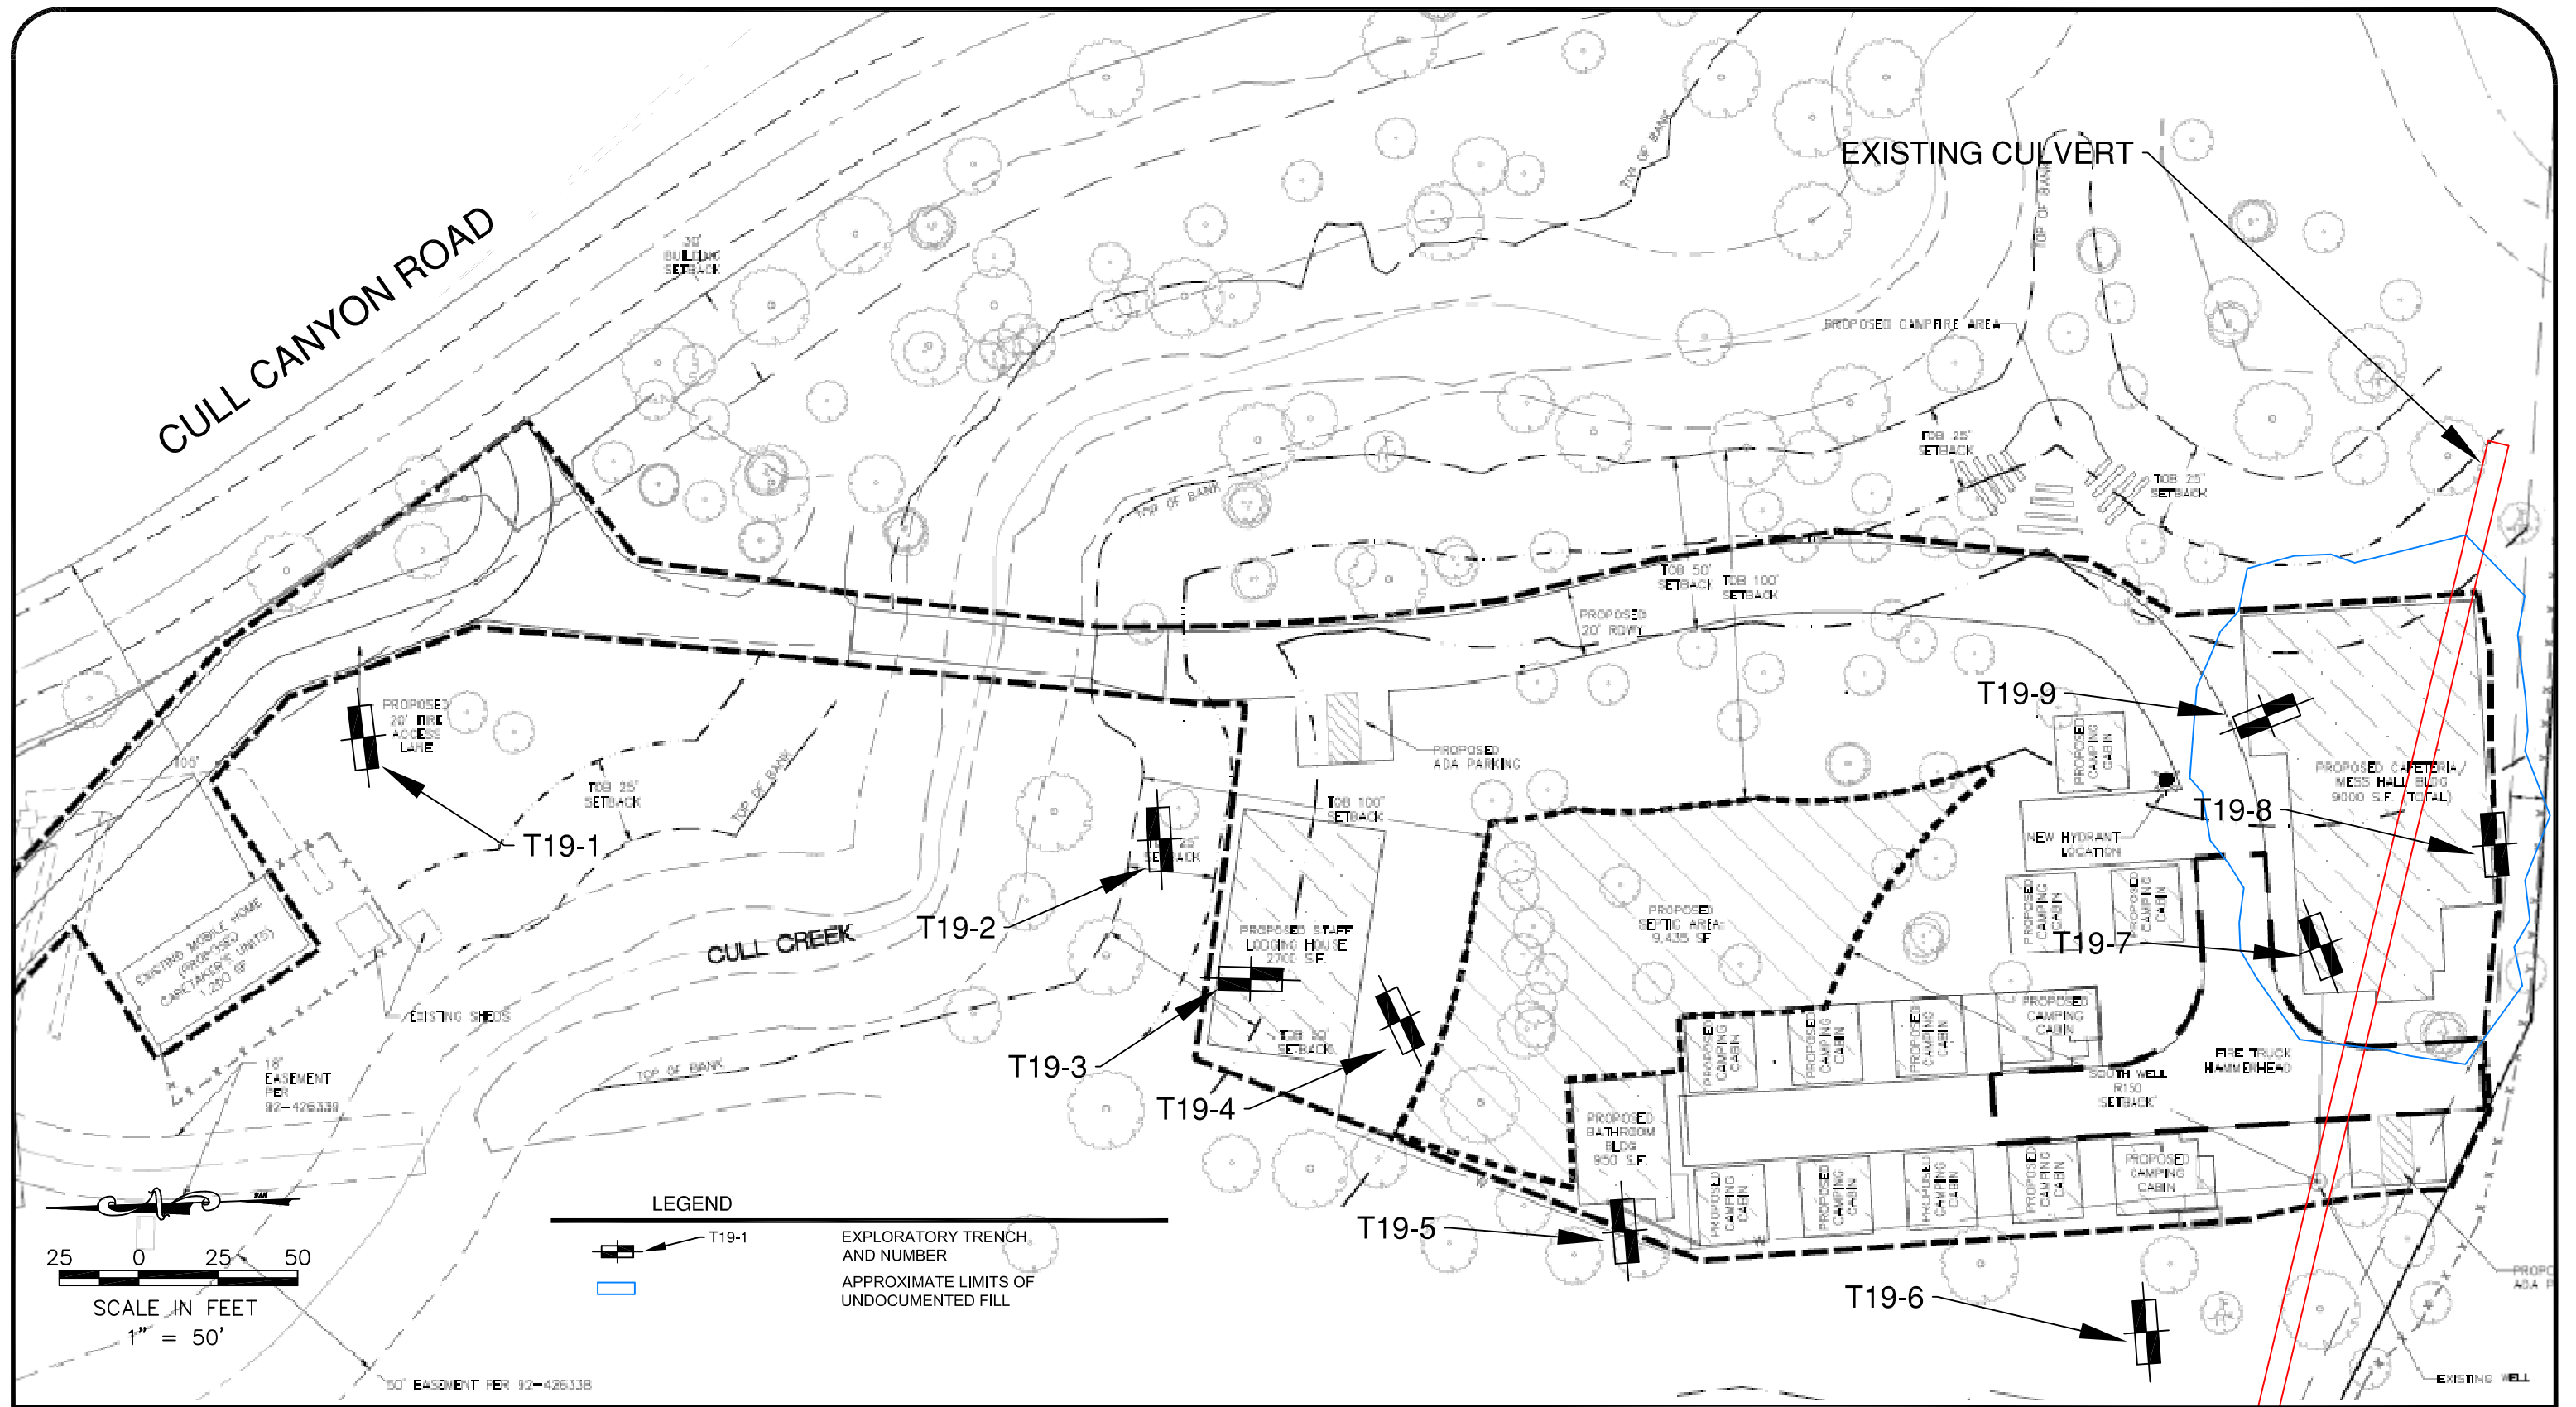
SITE PLAN AND EXPLORATORY TRENCH LOCATIONS
 THE MOSAIC PROJECT
 17015 CULL CANYON ROAD
 CASTRO VALLEY, ALAMEDA COUNTY, CALIFORNIA

Northstar, indicates site development will include construction of 12 new dormitory cabins for students, a new restroom/shower building approximately 950 square feet (sf) in size, a new cafeteria/mess hall building approximately 9,000 sf in size, and a new staff lodging house approximately 2,700 sf in size. NV5 anticipates the proposed structures will be constructed with wood or steel framed walls and supported on continuous spread and isolated foundations with an interior slab-on-grade, concrete floor. Associated development is indicated to include construction of retaining walls, underground utilities, a campfire area, asphalt concrete/concrete pavements, and exterior concrete slab-on-grade flatwork. Earthwork grading may include general site preparation and minor to moderate cuts and fills required to balance the site to meet the proposed building grades. Figure 2 shows the proposed site development.

NV5 observed the following surface conditions during the field investigation of the property. Figure 2 shows the project site boundaries and the approximate exploratory trench locations. At the time of NV5's site investigation, the site supported a single-family residence and outbuildings in the northeastern portion of the site and a large recreational building in the western portion of the site. Cull Creek meandered through the center of the site in a northwest to southeast trend. Mature trees also were observed throughout the project site.

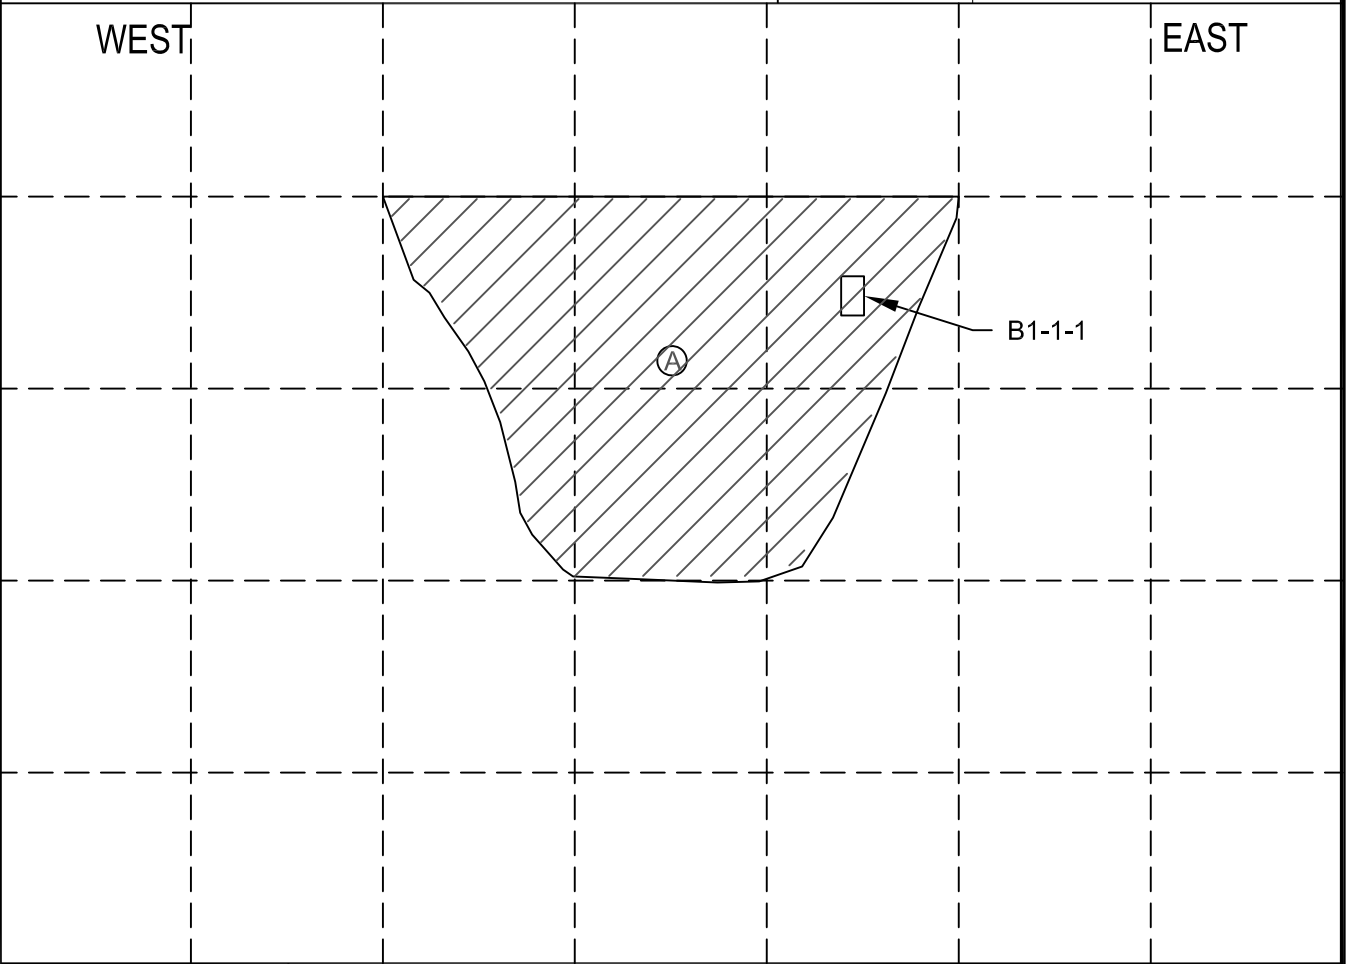
Project Name: THE MOSAIC		Ground Water Information	
Project No.: 70852.00	Task No.: .001	Date:	06-06-19
Location: 17015 CULL CANYON ROAD, CASTRO VALLEY, CALIFORNIA		Time (24 Hr. Clock):	10:00
Logged By: DOMINIC POTESIO	Date Logged: 06-06-19	Depth bgs (ft):	NONE
Backhoe Company: NV5		Trench Elev.:	Ft. AMSL
Backhoe Type: KUBOTA U35-4 EXCAVATOR WITH 24-INCH BUCKET		Trench Bearing:	Azimuth Compass = Degrees
Backfill Description: LOOSE SOILS		Scale:	1 In. = 3 Ft.

Unit No.	Sample		Soil And/Or Rock Material Descriptions
	Depth(Ft)	No.	
A	1-3	B1-1-1	(CL) LEAN CLAY; FLD. EST.: 85% LOW PLASTICITY FINES, 15% FINE SAND; DARK BROWN (7.5YR 3/2); MEDIUM STIFF; MOIST.

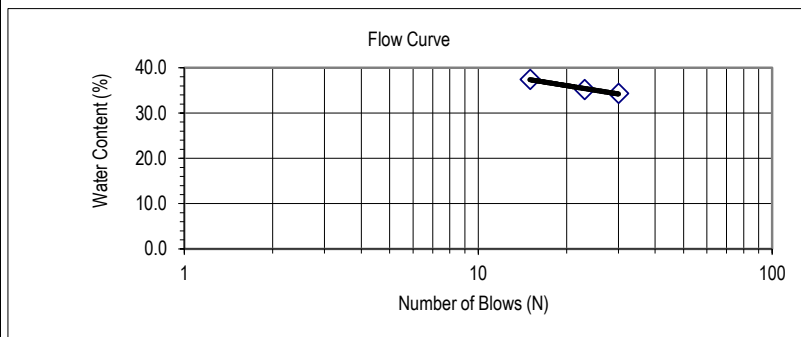
LIQUID LIMIT = 36 PLASTIC LIMIT = 23

Plasticity Index = 13

Group Symbol = CL

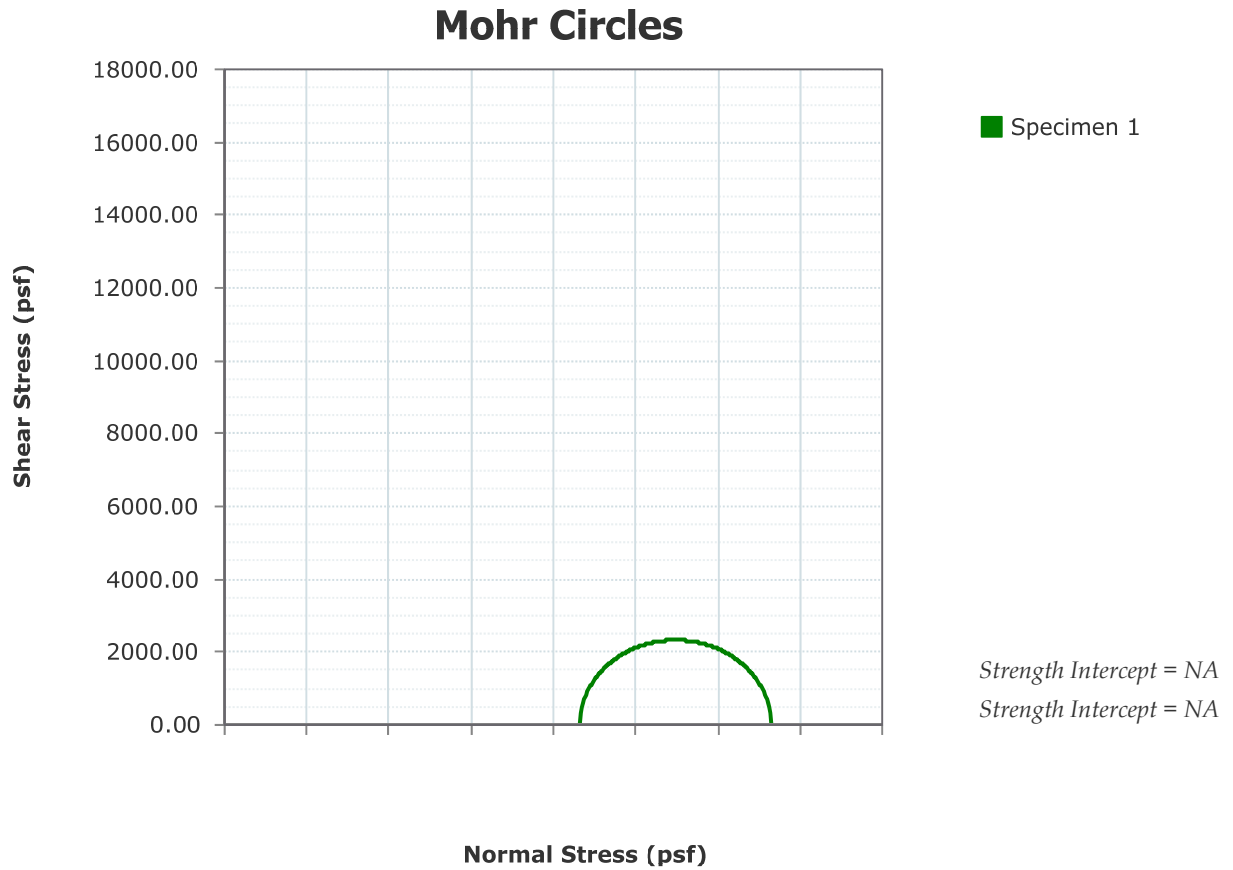
Unconsolidated Undrained Test

ASTM D2850

Project:	MOSIAC
Project Number:	70852
Sampling Date:	
Sample Number:	L-1
Sample Depth:	6.5
Location:	T19-5
Client Name:	
Remarks:

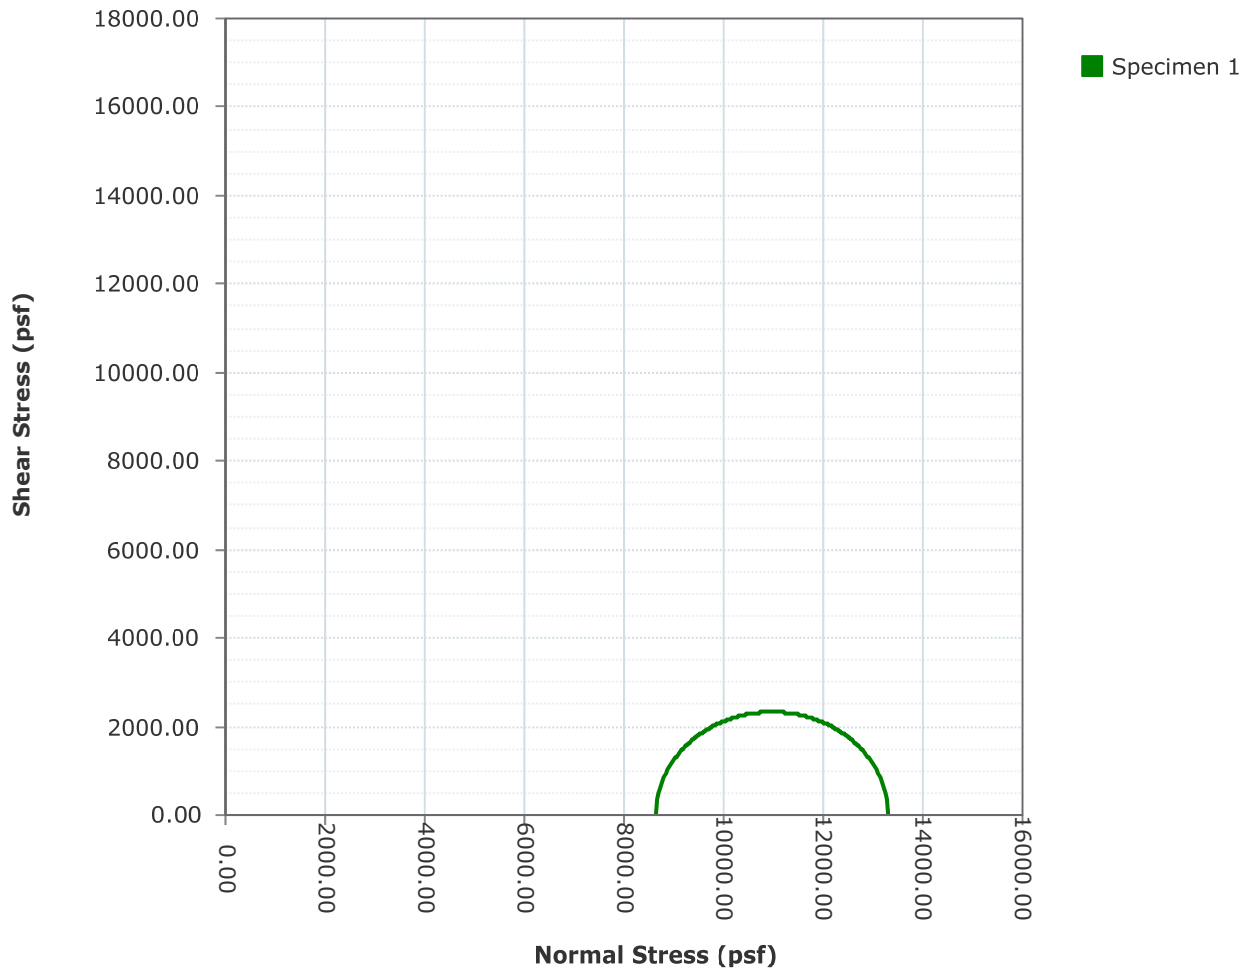
ASTM D2850

Tangent Results	
Strength Intercept (psi)	NA
Friction Angle (°)	NA

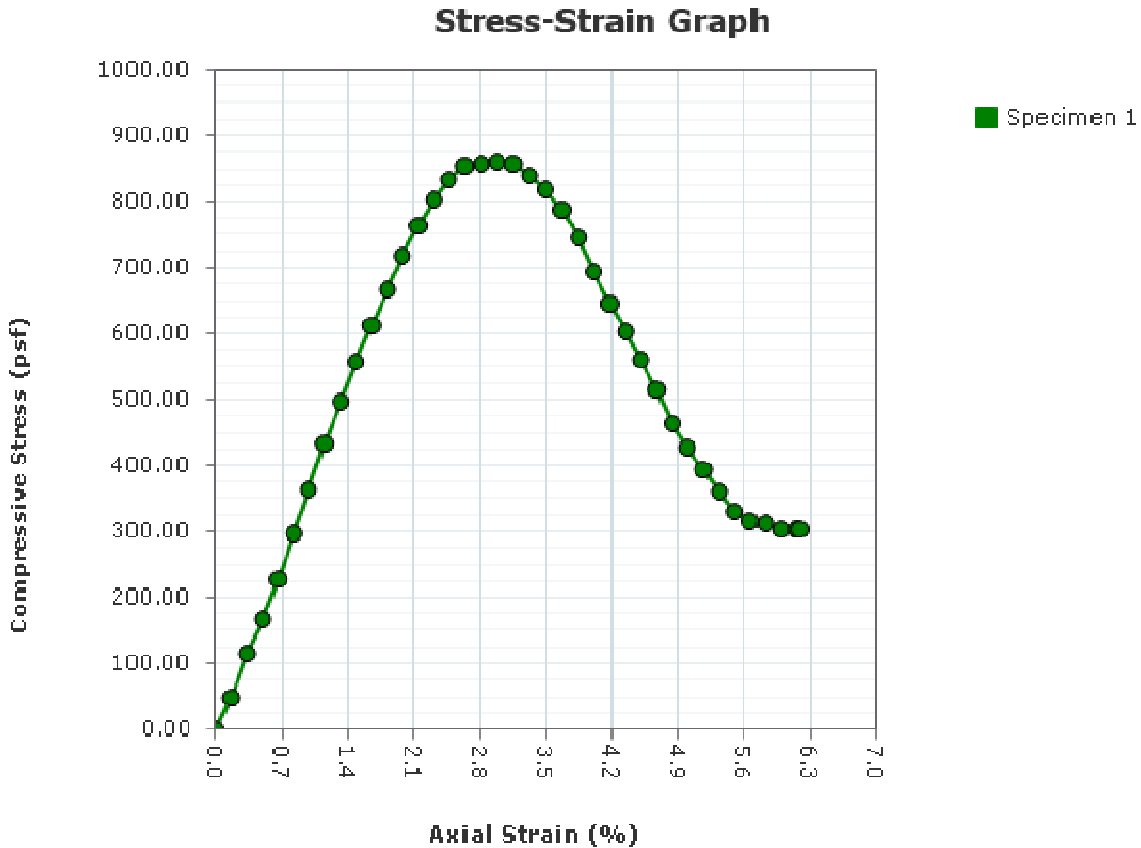
D2166

Project: Mosaic
 Project Number: 70852.00
 Received Date: 8/15/2019
 Sampling Date: 6/6/2019
 Sample Number: L1
 Sample Depth: 1.0 ft
 Boring Number: T19-4
 Location:
 Client Name: The Mosaic Project
 Remarks:
