INVESTMENT ADVISORY FACILITY CONDITION REPORT

County of Alameda – MLKJ Way
1918 Martin Luther King Jr. Way
Oakland, California 94612

December 6, 2022
Partner Project Number: 22-388732.1

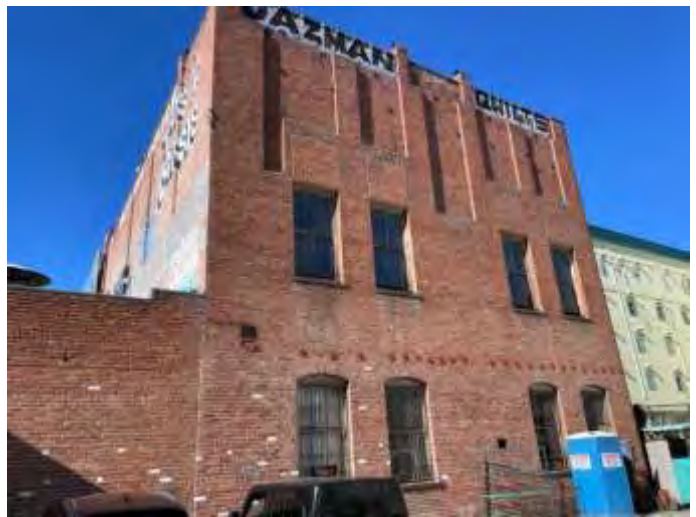
4. Rear elevation of subject property

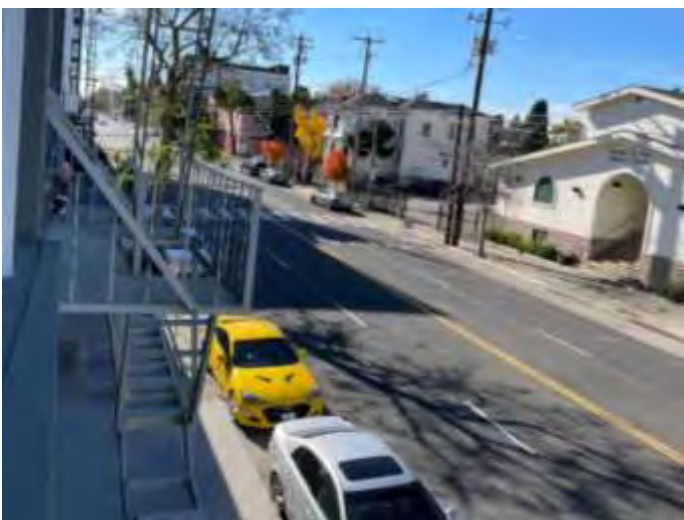
5. Martin Luther King Jr. Way street frontage

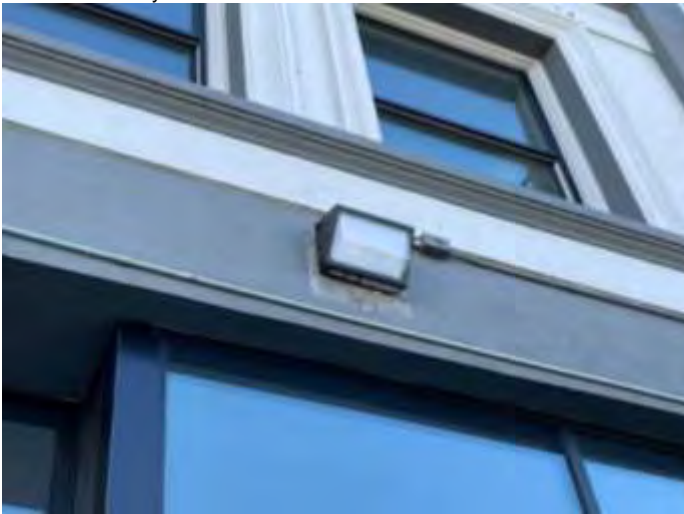
7. Typical front elevation façade mounted light fixture

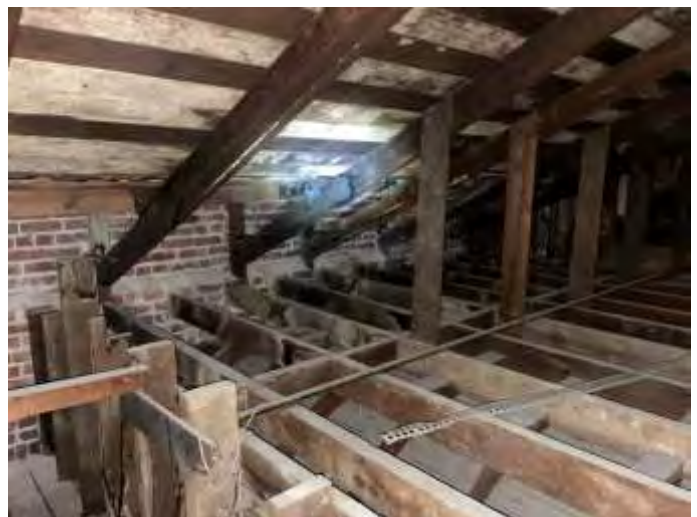
10. Wood frame

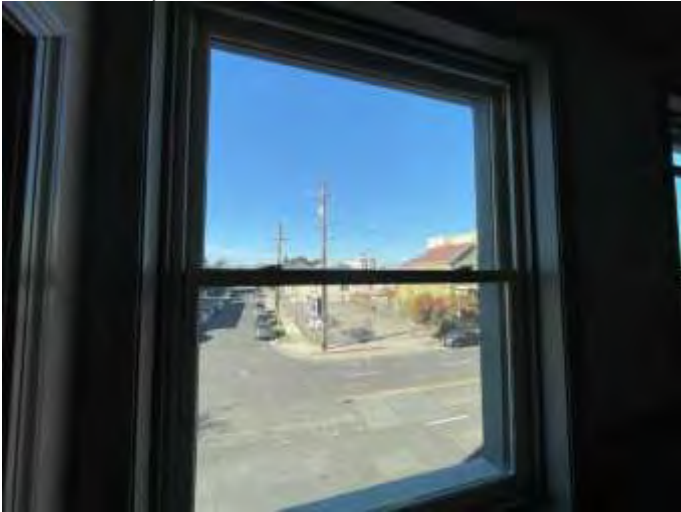
13. Typical aluminum framed exterior window

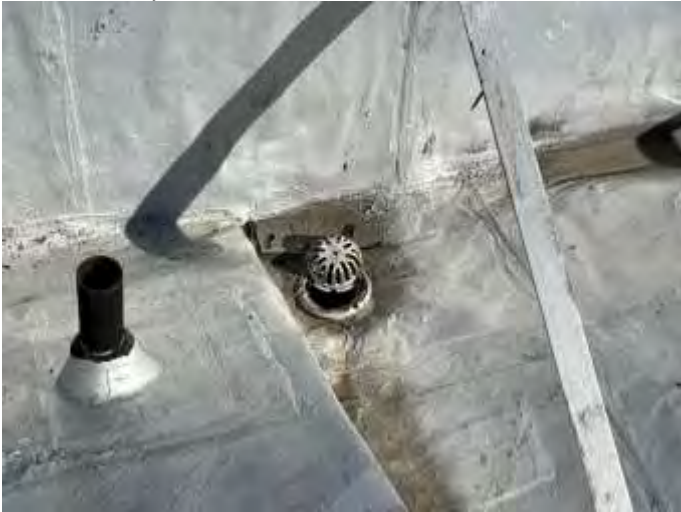
19. Internal drain

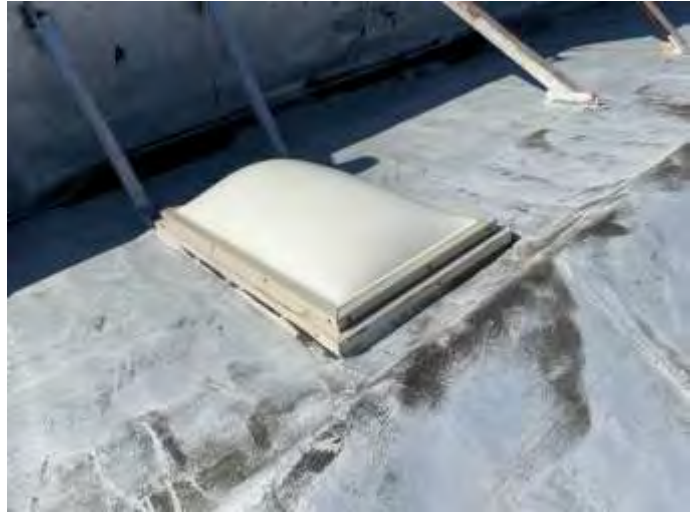
20. Self-flashed skylight

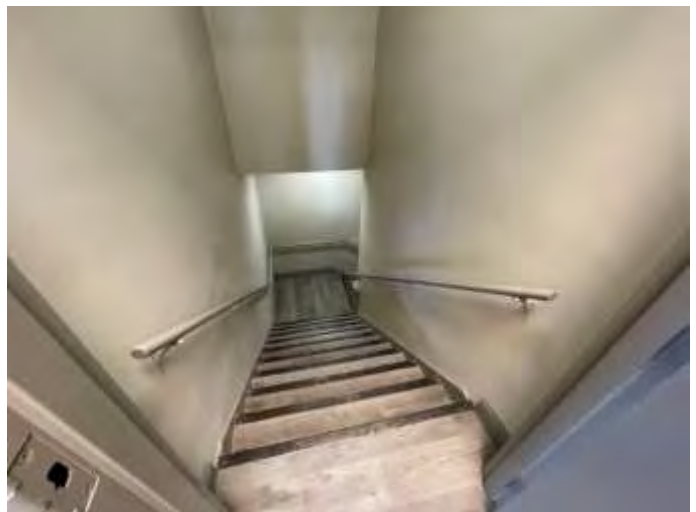
24. Wood stairway to upper floors

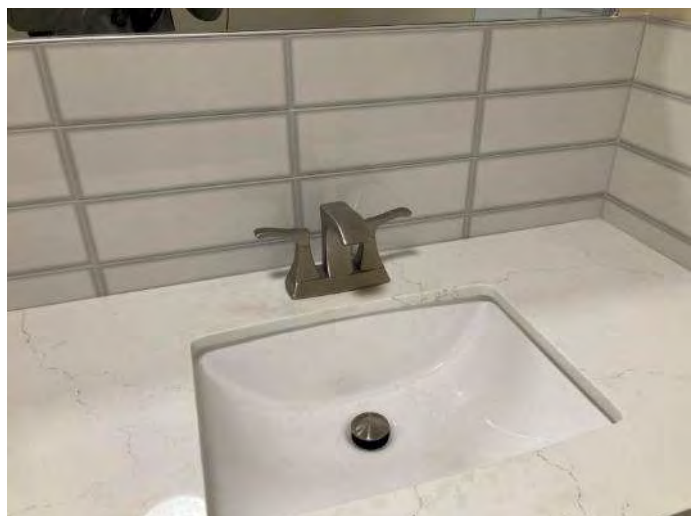
36. 1.2 gallon per minute bathroom faucet

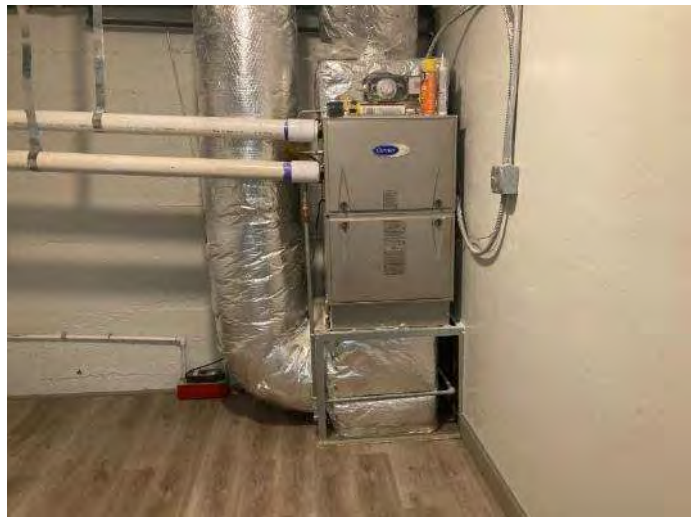
40. Typical condensing gas furnace unit

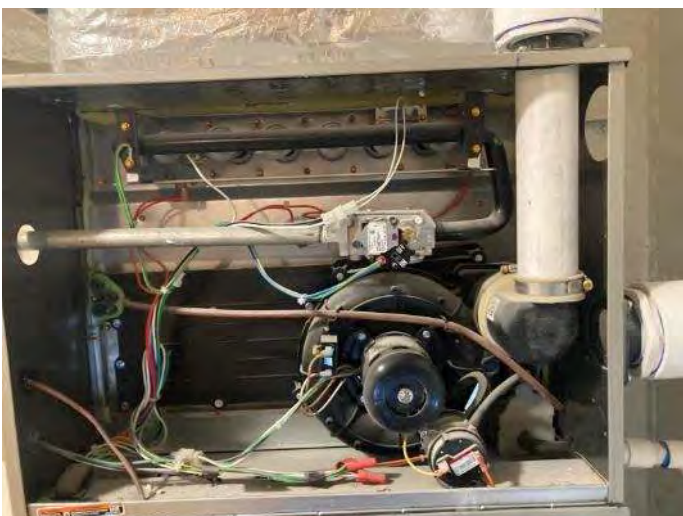
41. Gas furnace blower

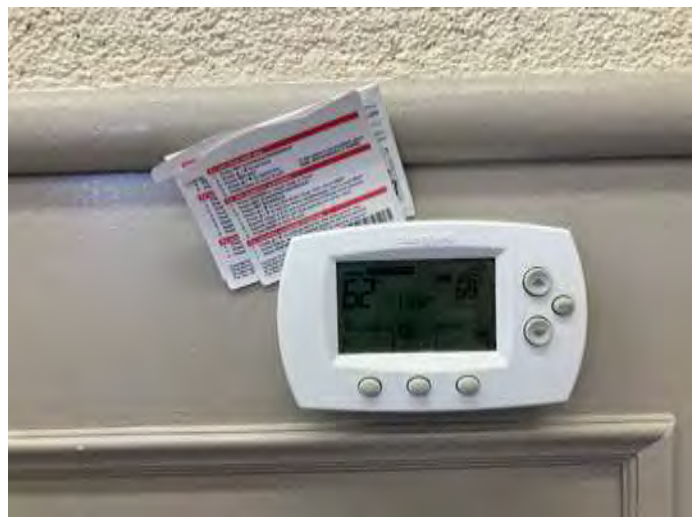
46. Programmable thermostat

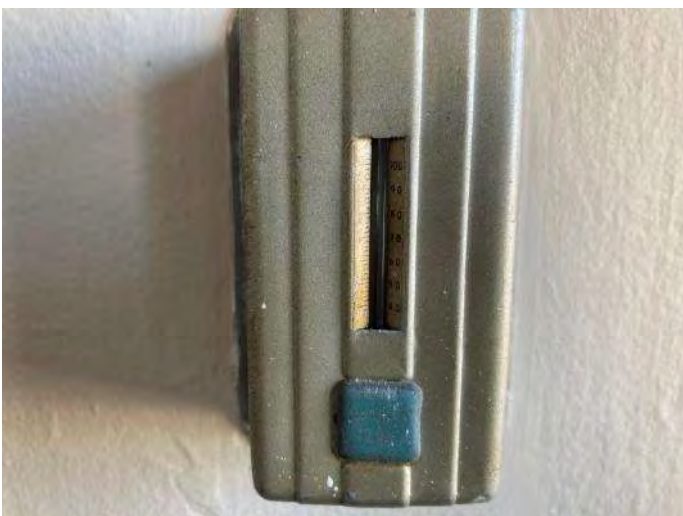
47. Decommissioned mercury thermostat

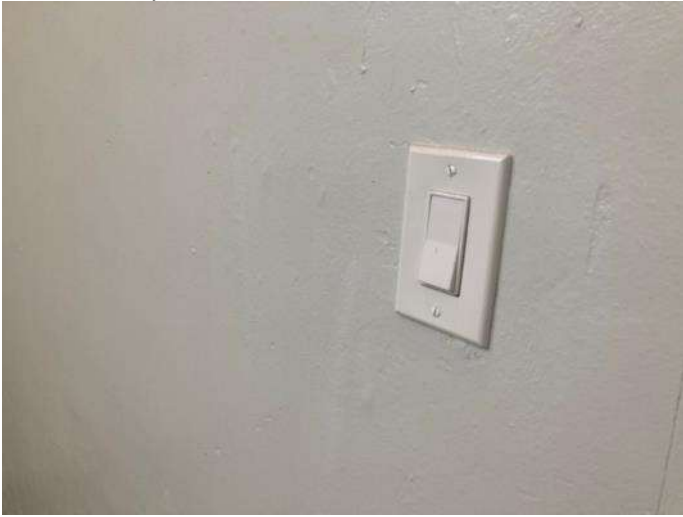
61. Light switch

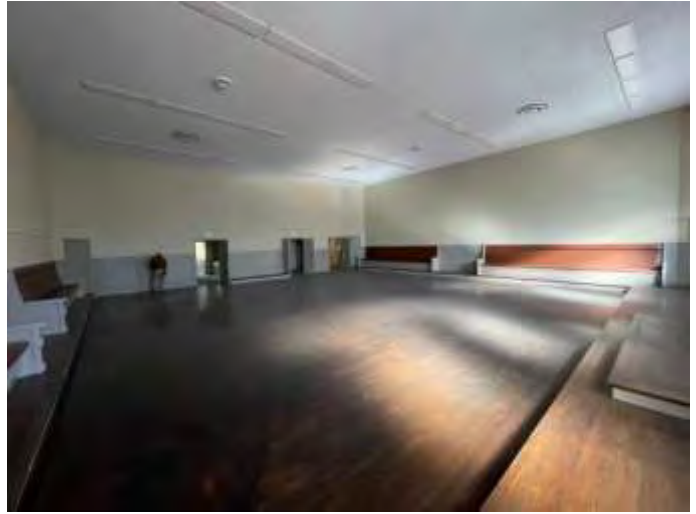
68. Auditorium finishes

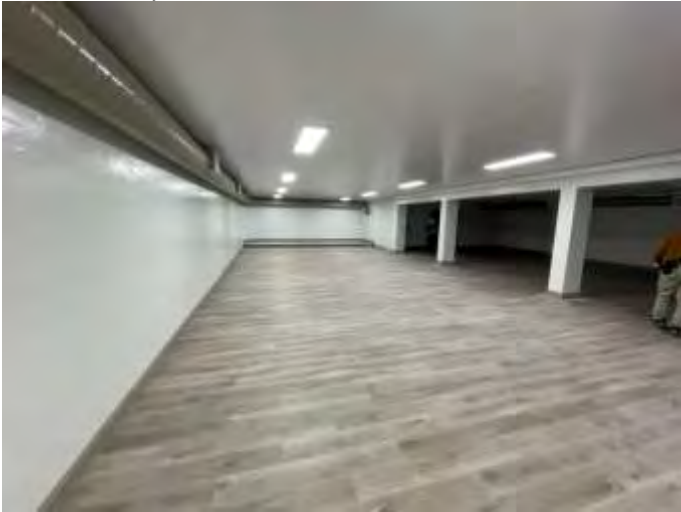
73. Basement finishes

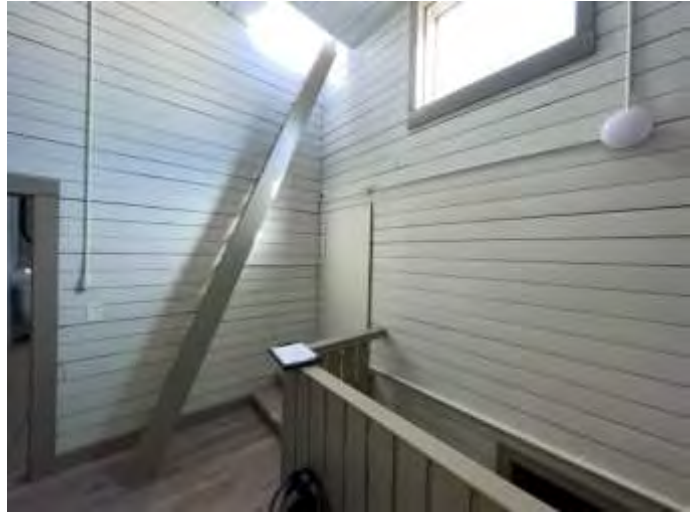
74. Attic finishes

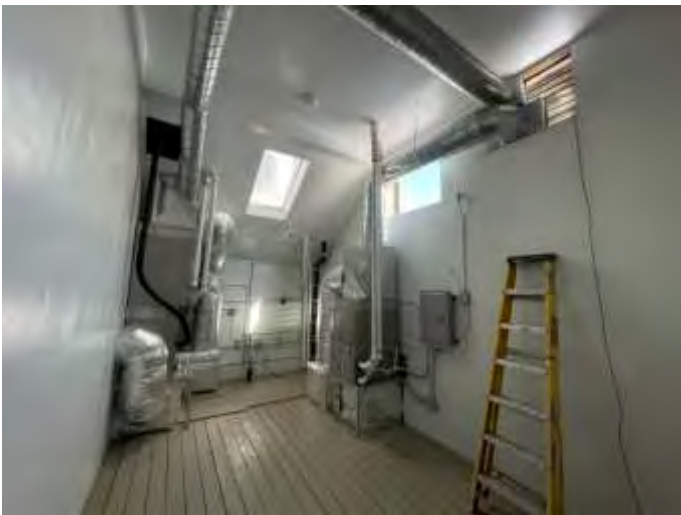
75. Attic finishes

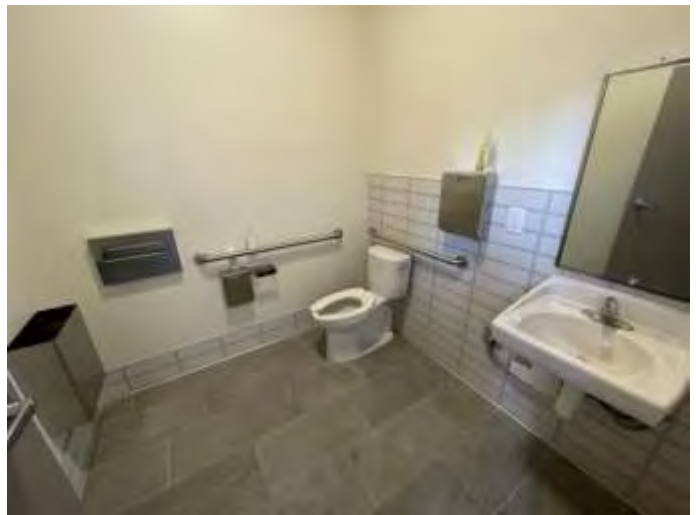
76. Typical ADA ground floor restroom finishes
